RUCKER LAKE: A HISTORY OF RECENT CONDITIONS AFFECTING A SOUTHEASTERN ARIZONA WATERSHED

Robert E. Lefevre¹ and Daniel G. Neary²

Recently, Rucker Lake has not been maintained due to changes in the watershed condition and sediment load caused by the 1994 Rattlesnake Fire, and the rising cost of dredging. It is currently full of alluvial deposits and there is no open water. This paper documents the current status of Rucker Lake and will assist managers on the Coronado National Forest in making decisions about future management of the lake.

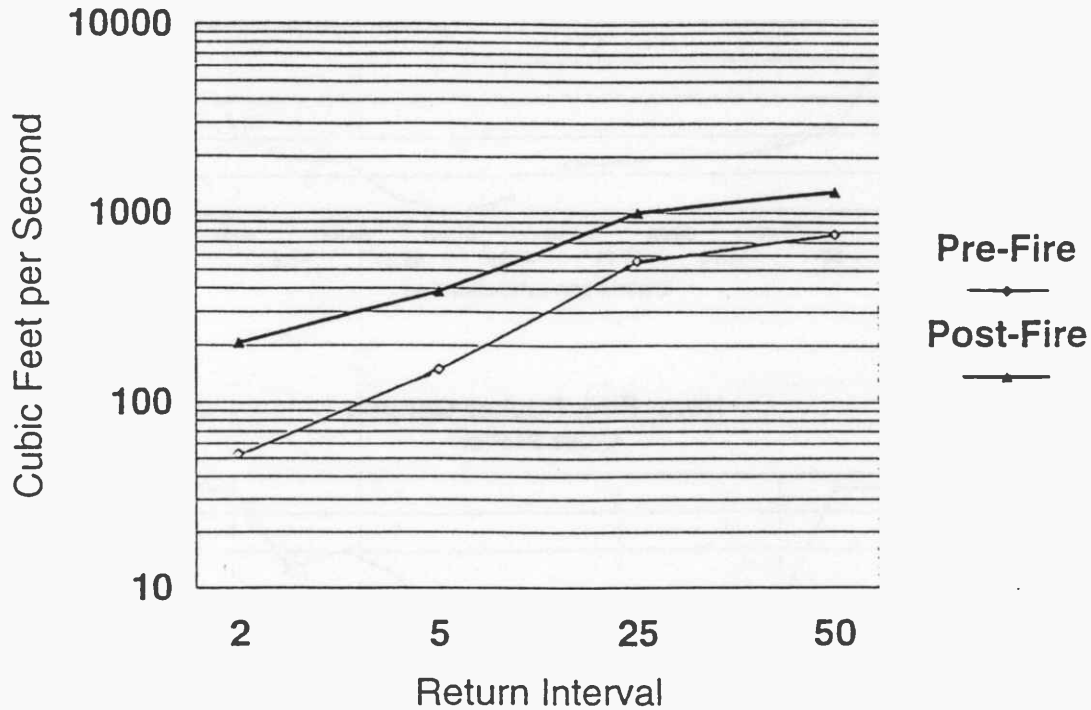
Post-fire runoff was predicted to be dramatically higher than pre-fire conditions (Figure 2). The stream channel was inspected and appeared stable in the reach immediately upstream from the lake. There were no signs of large amounts of deposition except in the campground and lake. It was about time to dredge the lake again based on the history of dredging, but the sediment yield from the burned watershed was much greater than any previously witnessed. The lake filled in quickly and aggraded up the channel, completely covering the campground area with about 76 cm (30 inches) of new material.

Figure 2. Predicted pre-fire and post-fire peak flows in Rucker Canyon.

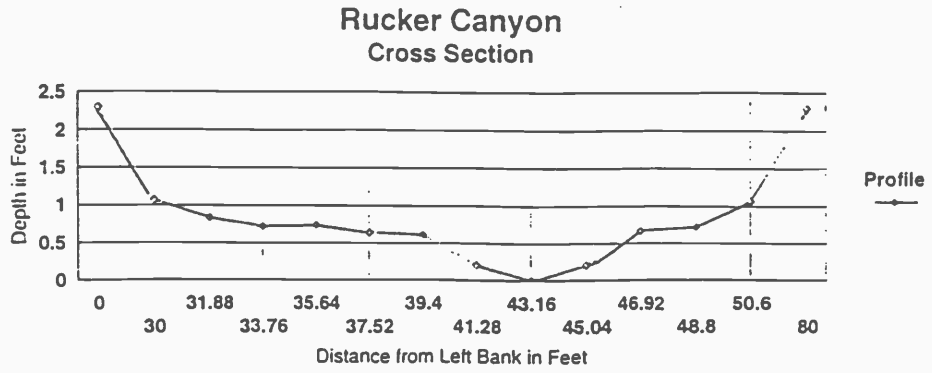
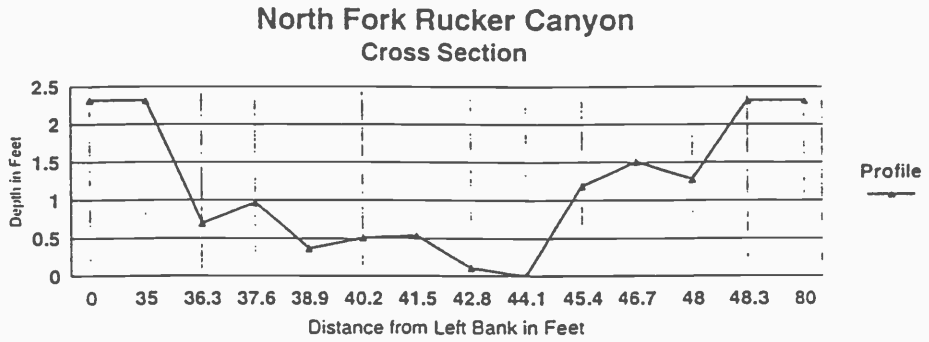
Channel cross sections and pebble counts in Rucker Canyon and the North Fork of Rucker Canyon (a nearly unburned tributary to Rucker Canyon) provide some important information about the current sedimentation situation (Figure 3). Cross-section data (Figure 4) indicate that in the burned watershed the entire flood-prone area is covered with water more often than the expected 1.5-year interval (bankfull discharge; Moody et al. 1998). The unburned watershed has the more desirable situation of bankfull flooding outside the channel occurring about every 1.5 years. For the Rucker Canyon Creek channel to stabilize, the banks will have to continue to build with available sediment. This should happen as fresh material is deposited on old terraces, resulting in a deeper channel. Observations of old terraces away from the active channel indicate that any new, post-fire terraces

Figure 3. Cross-sections of Rucker Canyon Creek (burned) and the North Fork of Rucker Canyon Creek (unburned).

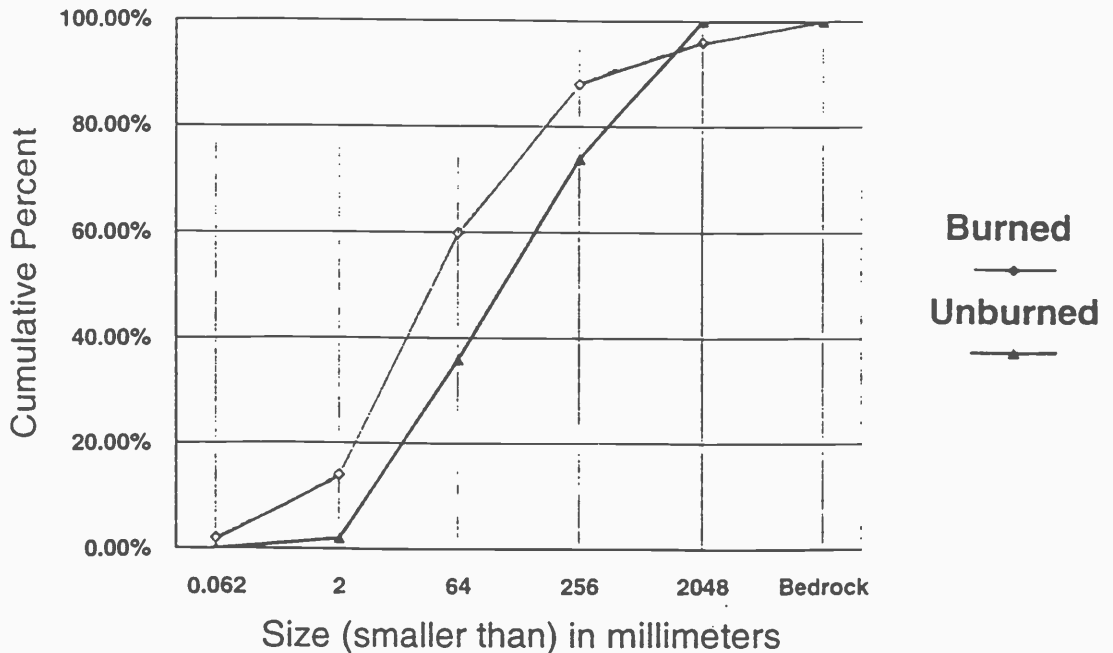
Channel substrate is dominated by sand and gravel in Rucker Creek, and by cobbles in the North Fork of Rucker Canyon (Figure 4). Most exposed material in Rucker Canyon appears new by its color, but previous observations of more angular material in the channel than in the lake are no longer true. Apparently new material is being transported all the way to the lake and deposited on top of the older material. In addition, small-sized older sediments from the slopes and terraces of the channel are being mixed with new material throughout the channel. Because of the smaller size of the alluvial material currently in the channel of the burned watershed, much more sediment moves with every runoff event compared to the unburned watershed.

Figure 4. Stream substrate composition of Rucker Canyon Creek (burned) and the North Fork of Rucker Canyon Creek (unburned).
