# Contamination Knowledge Report:

## BRDF fabric

**May 27, 2015**

## SEM Imaging and Chemical Analysis of a Fluorinated Hydrocarbon Impregnated Glass Cloth

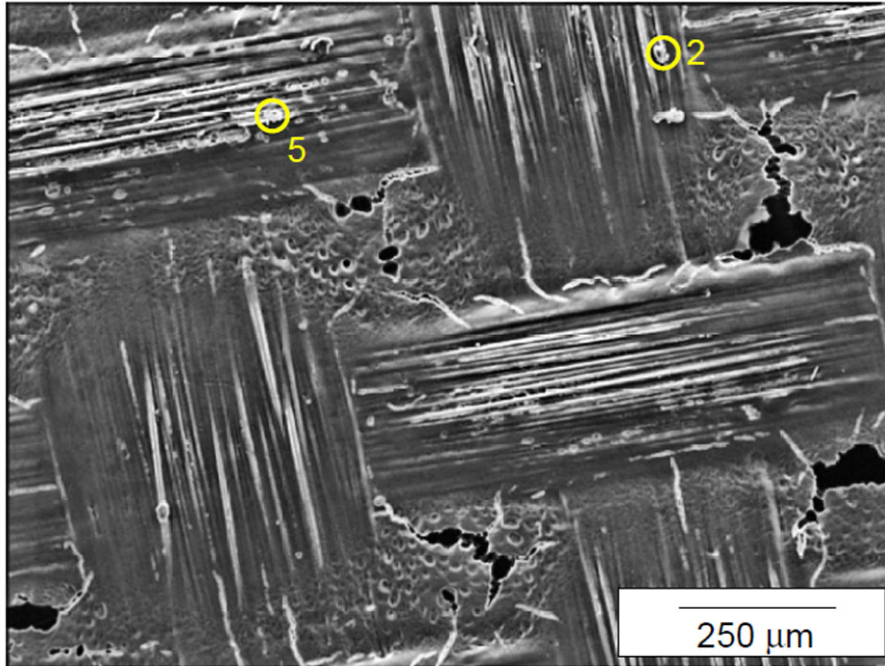
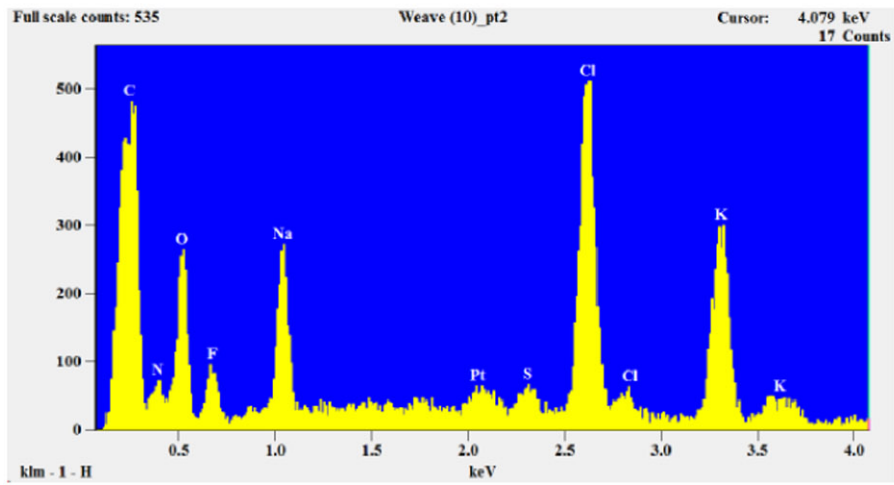
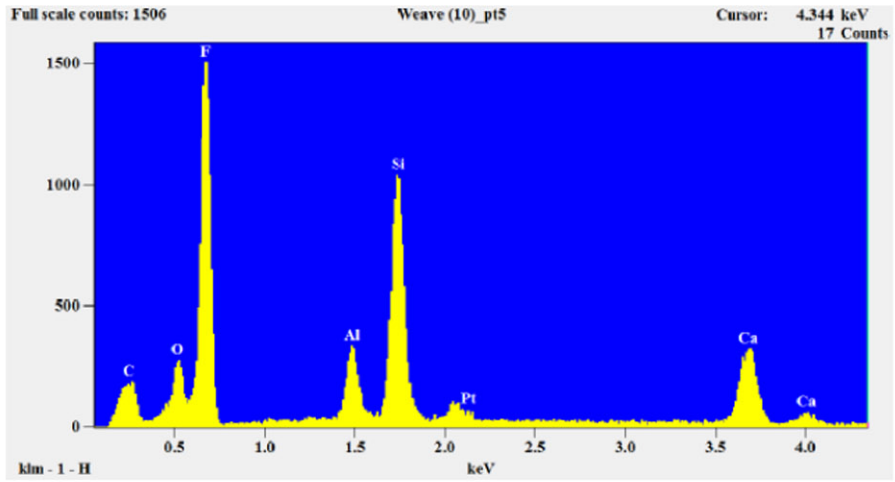
Weave 10

Note: Fragment from filament (see spt Weave 17\_pt2)

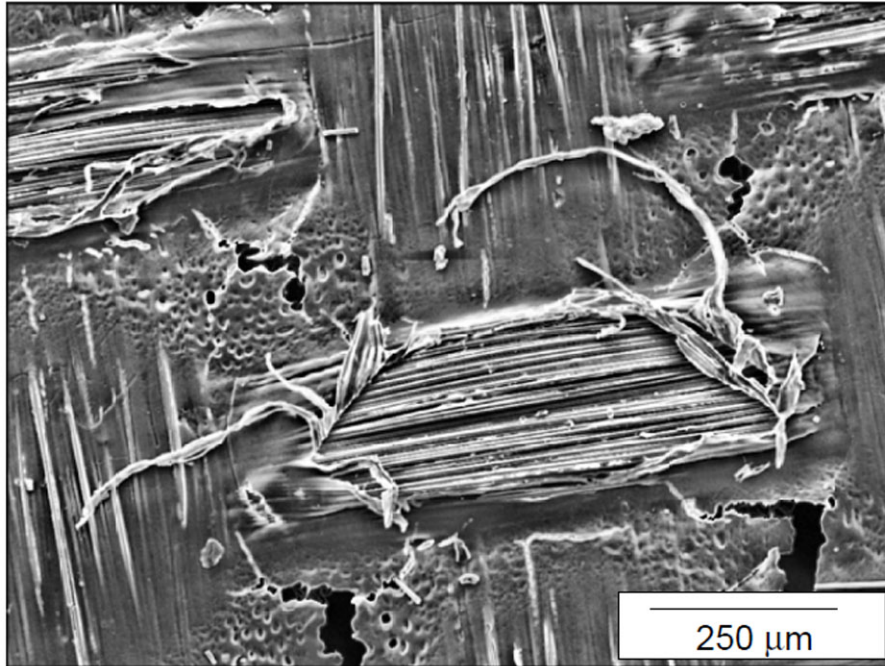
Weave 13  
Abraded coating reveals subsurface, elongated Si-rich filaments

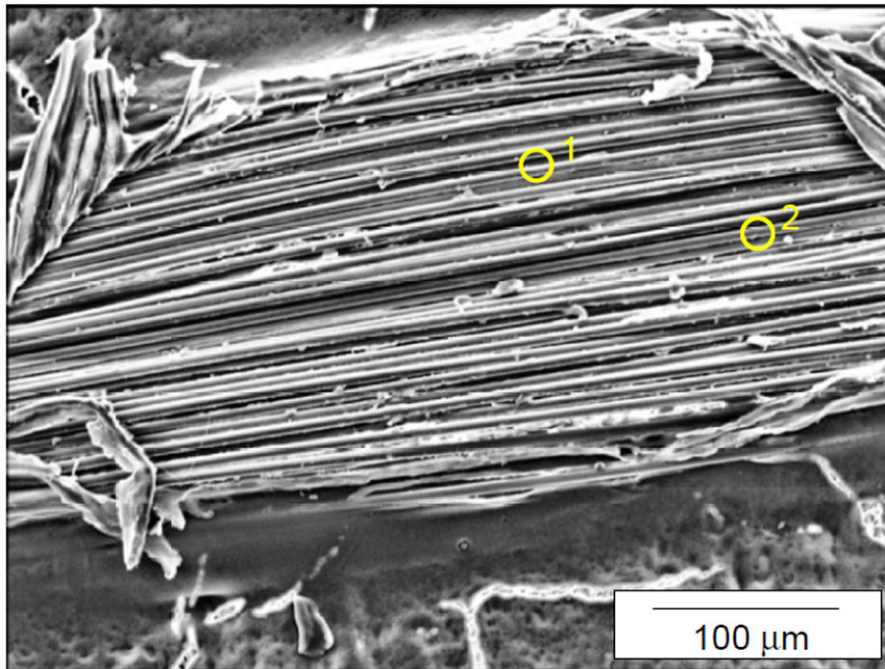
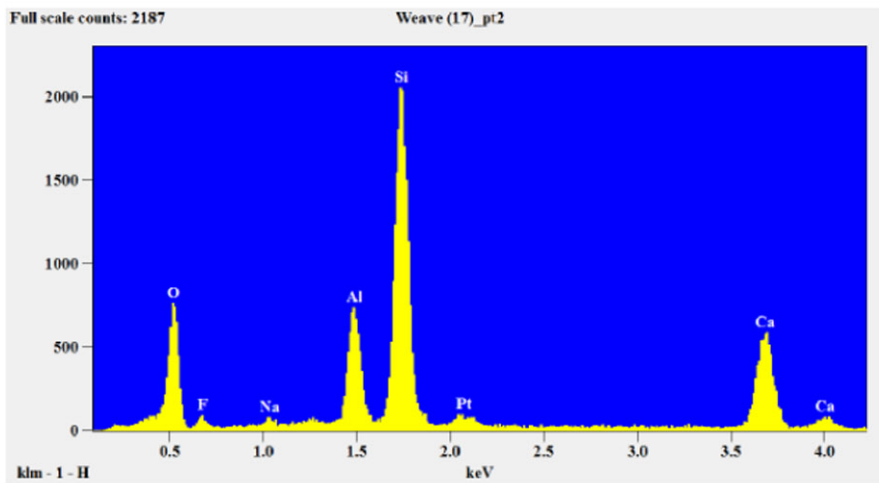
Weave 17

Note: This spt also representative for point 1 shown in image above

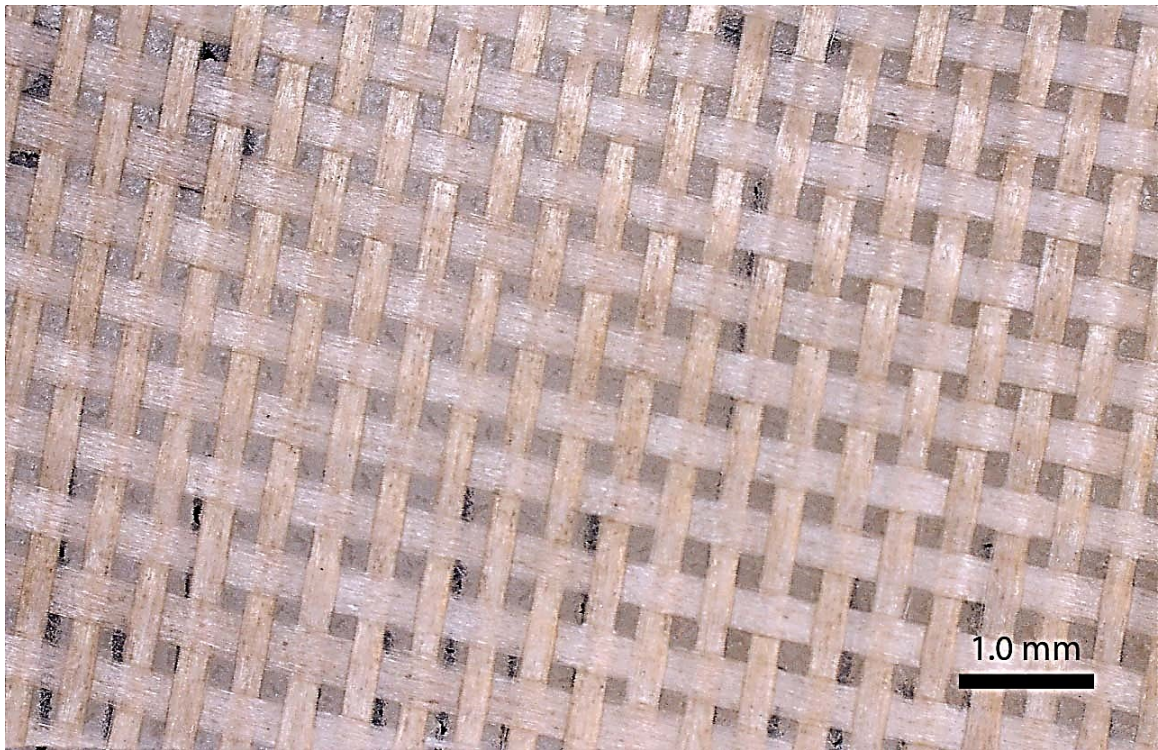
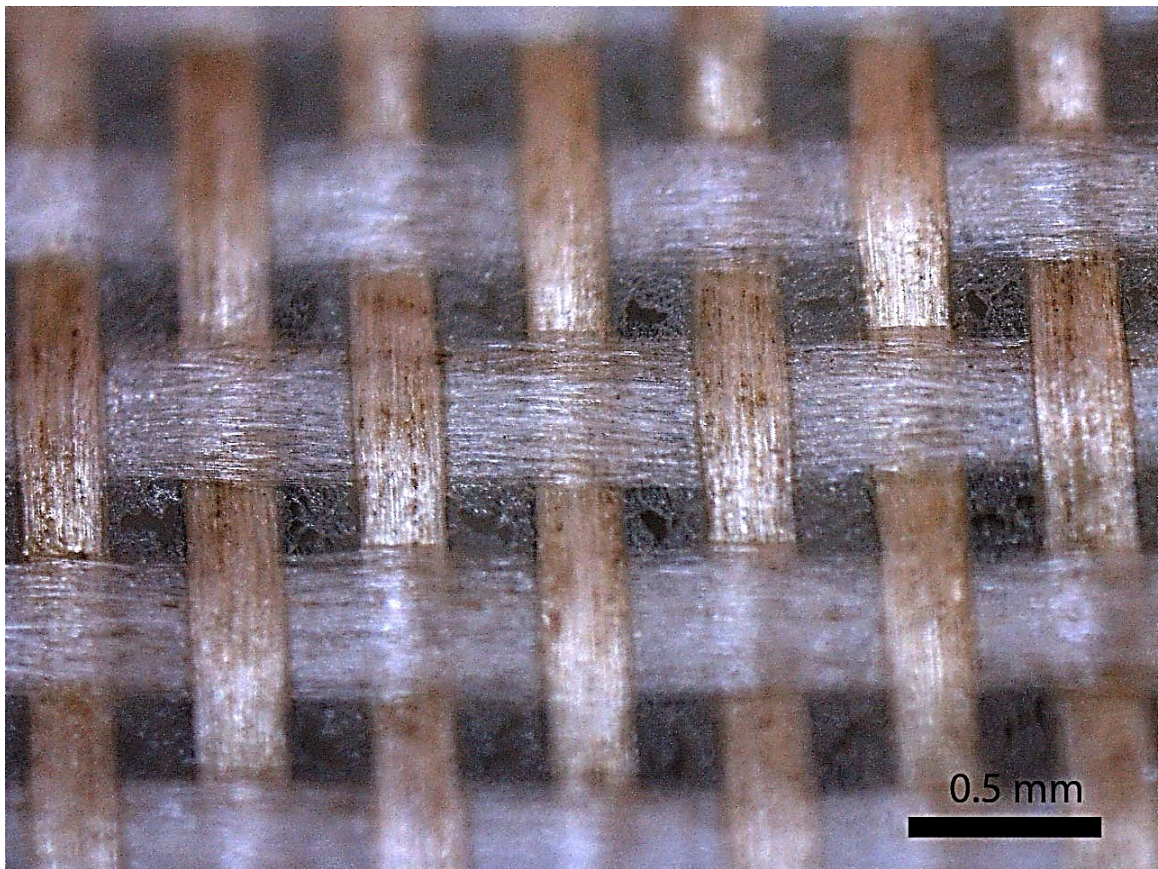
From optical imaging, extended damages on Teflon coating were observed. (See last page of this report). SEM imaging revealed significant shedding and abrasion of Teflon coating and fiberglass strands. Particles ranging from 1 – 100  $\mu\text{m}$  occurring on the surface of the BRDF fabric include fragments of fiberglass, Teflon, carbonaceous particles, and salts. EDX analysis of these materials revealed the following compositions:

If the BRDF material is used, we are confident that the Sample Analysis team will be able to identify and distinguish these particles. However, the varied contaminants associated with the material requires us to recommend that the material be cleaned before usage on any part of the spacecraft.
