DETERIORATION OF BARBWIRE BY LIGHTNING

E. H. McILVAIN AND M. C. SHOOP
Research agronomist and research range conservationist, Crops Research Division, Agricultural Research Service, U.S.D.A., U.S. Southern Great Plains Field Station, Woodward, Okla.

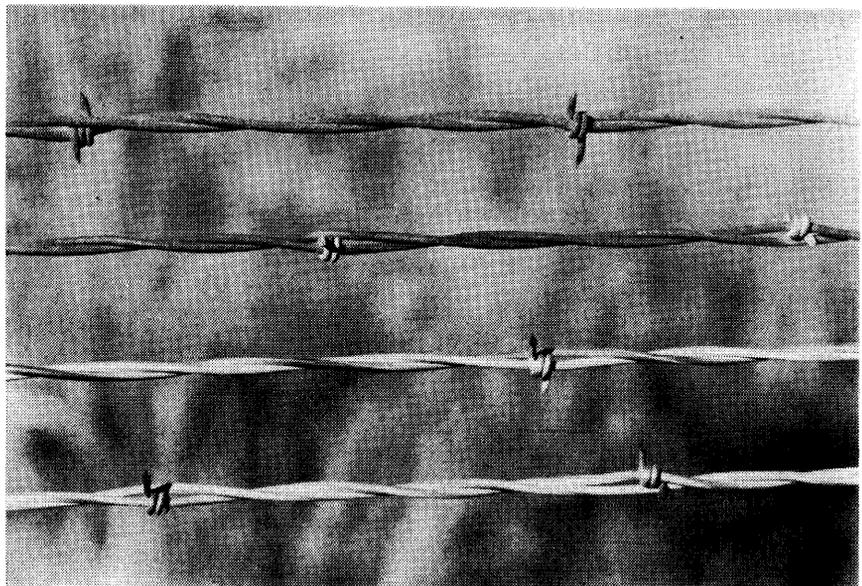
By 1963, the top wire on the standard fence was severely rusted and pitted; and the lower wires showed much more deterioration than in 1955 (Figure 1). All four wires on the boundary fence with stays still had their protective galvanized coating (Figure 2). Although the same was true of all four wires of the lane fence protected from lightning by

FIGURE 1. By 1963, the top wire on standard fences was rusted, pitted, and without temper. The second wire from the top was badly rusted but not yet pitted. The other two wires still retained some of their galvanized coating.

either side of those wires used as hold-downs in the draws. Apparently, the wooden posts also acted as grounds to dissipate some electrical energy, since the galvanizing remained longer on all four wires for about 3 inches on either side of many posts. Sagebrush, forbs, and tall grass growing in the fence line apparently grounded the bottom wire effectively, but grounded each higher wire less effectively. This grounding effect was confirmed on numerous occasions by the presence of dead sage foliage along the fences.

We conclude from these observations that *thorough* grounding of barbwire fences is essential. We do not know the optimum spacing for the grounds, but believe it should be frequent. Hold-downs 100 yards apart did not prevent electrical deterioration of the top wires on standard fences. Until more is known, we suggest that twisted-wire stays be installed every 16 to 20 ft, or between each two posts, in most fences in the West. These stays should make firm contact with the soil.

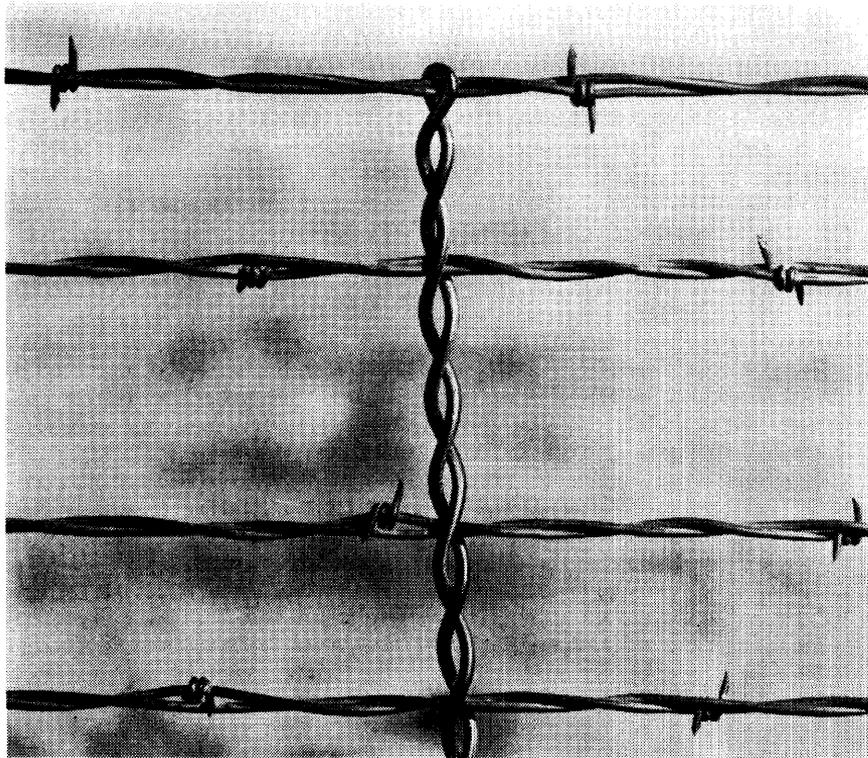
FIGURE 2. By 1963, all wires on the fences grounded by twisted wire stays still retained their galvanized coating, and they showed but little deterioration.

Wire stays not only protect the fence wire and posts from electrical deterioration, but reduce livestock losses from lightning along the fence lines. They also make a sturdier fence that requires less maintenance.
