HYDROLOGIC INVESTIGATION OF THE DRY LAKE REGION  
IN EAST CENTRAL ARIZONA

James J. Lemmon, Thomas R. Schultz and Don W. Young

This report is a combination of on-site field investigations and the review of available literature and aerial photography. The investigation was undertaken in connection with a proposed land exchange between the Arizona State Land Department and Southwest Forest Industries, Inc. (SWFI) during the late summer and fall of 1978.

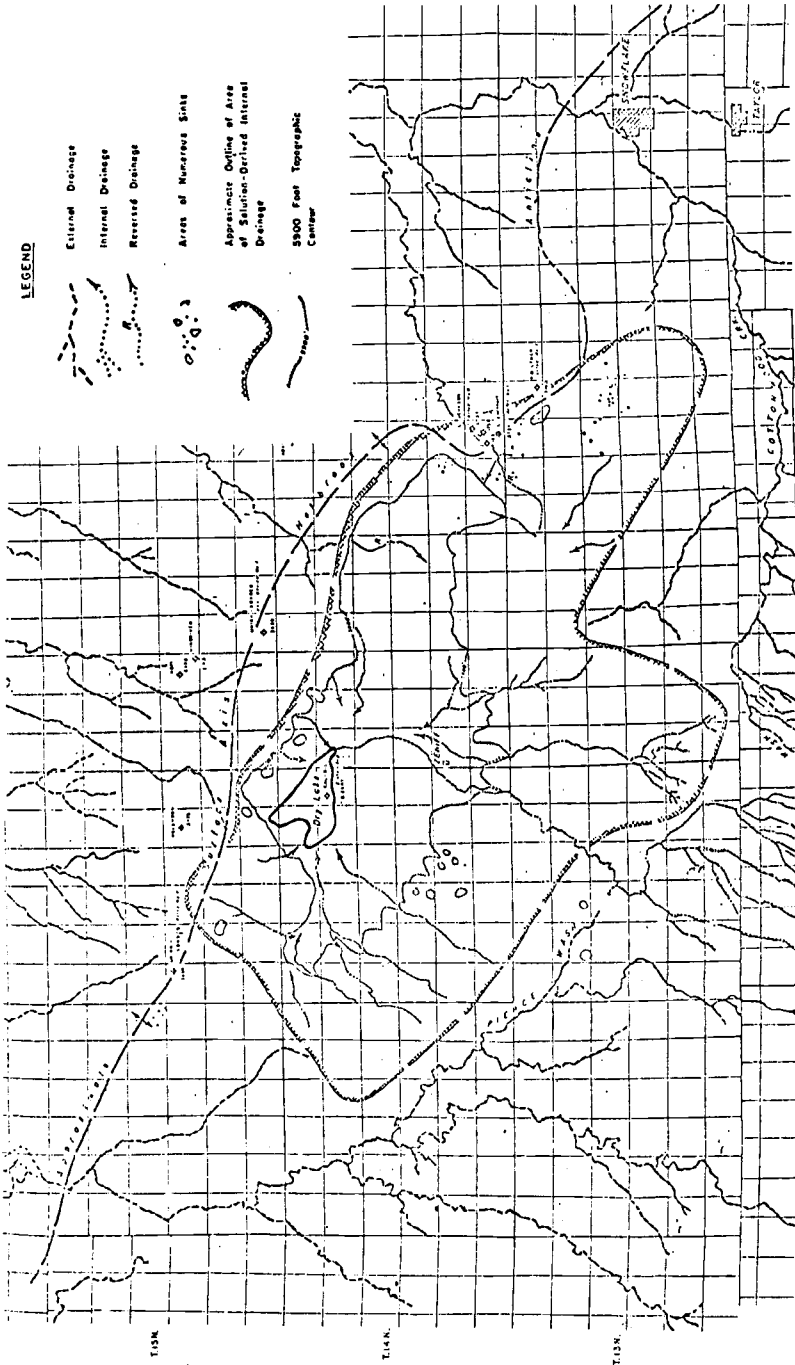
Dry Lake lies equidistant between the surface expression of the Holbrook Anticline to the north and the Dry Lake Syncline to the south (see Figure 2). The Lake overlies approximately 60 feet of Quaternary alluvium. Beneath the alluvium is a thin veneer of Kaibab Limestone (Arizona Bureau of Mines, 1960). The Kaibab and the underlying Coconino Sandstone are the principal aquifer in the area (Mann, 1976). The Coconino is 729 feet thick beneath Dry Lake (California Oil Co., 2 test holes). Beneath the Coconino is the Supai Formation, an interbedded sequence of shales, siltstones, and evaporites comprising some 1400 feet of thickness.

Internal drainage patterns developed within the subsiding Dry Lake basin. Some older drainage channels show evidence of reversal as the gradient reversed (refer back to Figure 2). The major drainage pattern of the basin does not appear to be fault aligned; however, Phoenix Park Wash, which is a major drainage within the basin, exhibits a dendritic pattern.

Drainage Map of the Dry Lake Basin Showing Reversed Drainages and Other Collapse Features

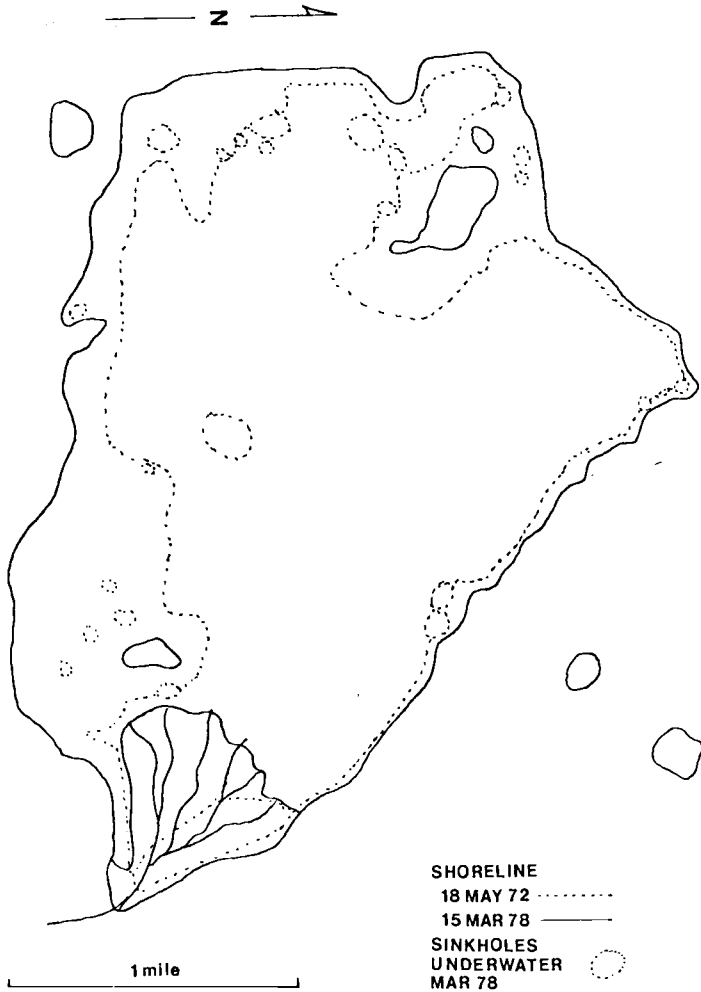
**FIGURE 3**

Interpretation of Aerial Photography  
 Showing Dry Lake, Sinkholes and Other Changing Features

The photographic interpretation of linear features and sinkholes in the Dry Lake playa leads to a conclusion that there are geologic conditions that could allow contamination of the ground water system by the surface disposal of effluent. There are

no less than 25 sinkhole-like structures in the present wetted portion of the lake (Figure 3). While the ground verification or truthing of the aerial photographic interpretation cannot be done under the water in the playa, there are some areas on the southern and western margins of the basin that could be reached. The geologic conditions that are evident in the area include sinkholes of varying sizes from several feet across to several hundred feet wide. The linear features, or surface expressions of fractures, faults or cracks, show that there are subsurface geologic conditions that are influencing surface topography and possibly ground water movement.

2) The interpretation of the U-2 aerial photography resulted in a number of sinkholes being identified in the wetted portions of the lake. Field investigations of the area did not confirm or deny any observable downward flow of surface water. The use of currently available geophysical methods should be employed to determine the extent of the openings and the rate of downward water flow, if any, for each sinkhole and fracture site.
