HYDROLOGIC CHARACTERISTICS  
OF A  
SEMIARID WATERSHED

by  
David Arthur Woolhiser

A Thesis Submitted to the Faculty of the  
DEPARTMENT OF CIVIL ENGINEERING  
In Partial Fulfillment of the Requirements  
For the Degree of  
MASTER OF SCIENCE  
In the Graduate College  
UNIVERSITY OF ARIZONA

1959

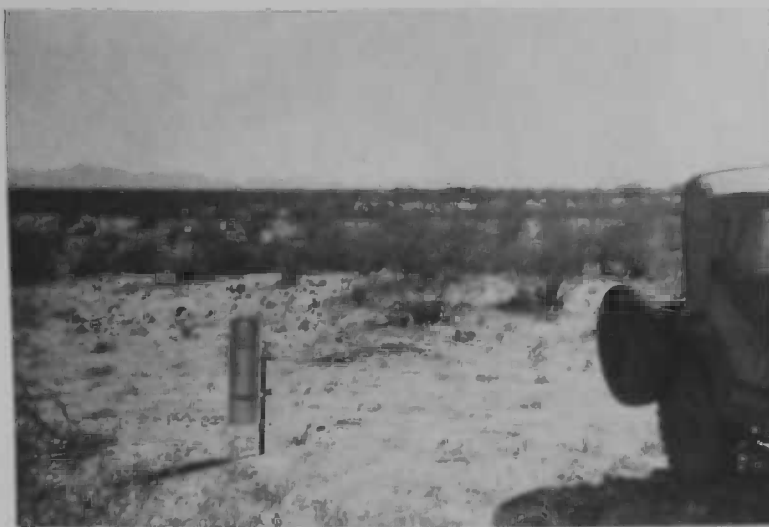
FIGURE 2.7

GROUP 1 VEGETATION--CREOSOTE BUSH DOMINANT

1. Creosote bush (*Covillea tridentata*) dominant (Figure 2.7). Scattered mesquite (*Prosopis velutina*) and cacti are also found in this group. There is often very sparse grass cover. This group is associated with highly calcareous soils, and covers by far the largest area of Subwatersheds II, III, and IV.
2. Cacti dominant (Figure 2.8). This group consists mostly of prickley pear cactus (*Opuntia* sp.) and cholla cactus with a few mesquite and palo verde trees. There is some annual grass and alfilaria. The vegetation of Subwatershed I is composed almost entirely of this group.
3. Palo verde (*Cercidium microphyllum* and *Parkinsonia torreyana*) dominant (Figure 2.9). This group includes some creosote bush and cacti, mostly saguaro. There is very little annual grass. Group 3 vegetation is found in a strip

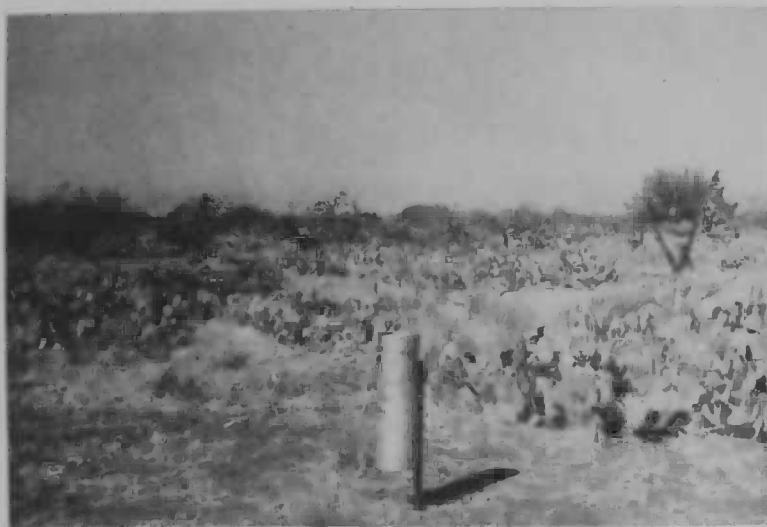
FIGURE 2.8

GROUP 2 VEGETATION--CACTI DOMINANT

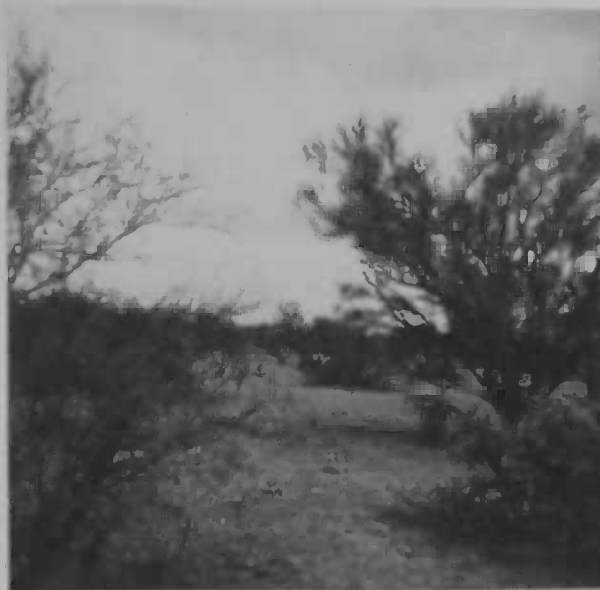
FIGURE 2.9

GROUP 3 VEGETATION--PALO VERDE DOMINANT

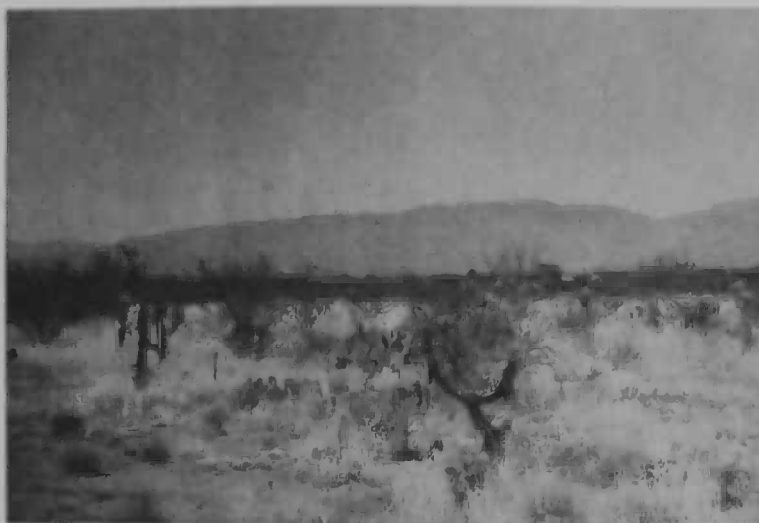
FIGURE 2.10

UPSTREAM CHANNEL VEGETATION

4. Channel vegetation (Figures 2.10 and 2.11). In the upper reaches of the watershed where channels are often wide and flat, grass is dominant. Mesquite is dominant in the lower reaches. This channel vegetation group is the most significant in hydrologic studies of semiarid regions.

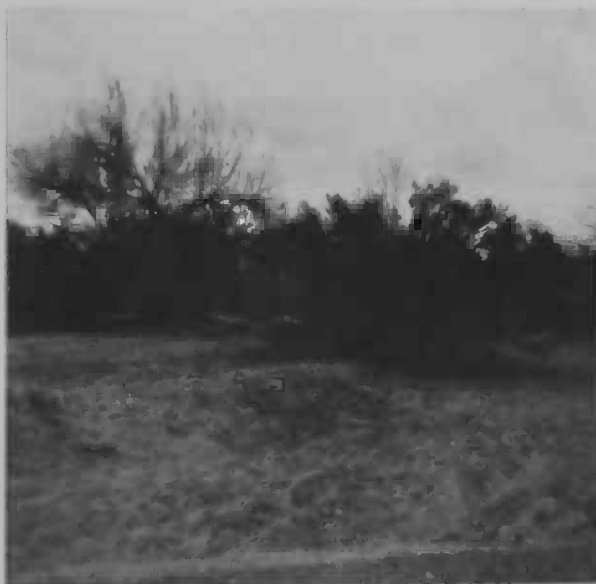
FIGURE 2.11  
DOWNSTREAM CHANNEL VEGETATION

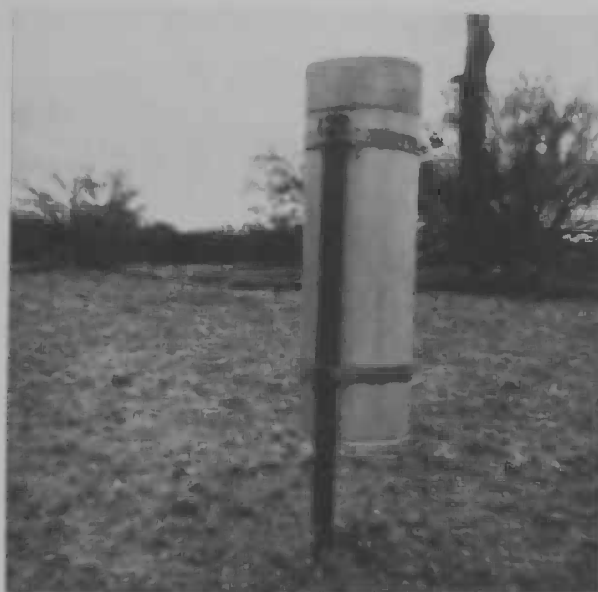
FIGURE 3.2  
STANDARD RAIN GAGE AND SUPPORT

The support for the standard rain gages consisted of half of a steel tee-post, to which the gage was clamped with two sheet metal straps (Figure 3.2). This support has proved to be satisfactory in this area. It was initially inexpensive, and its sturdy construction prevented cattle from upsetting the gages and also discouraged theft. Since the measuring tubes held only two inches of rain, the gage had to be dismantled when more than two inches of rain fell in a single storm. This was a time-consuming operation, and would make the support impractical where two-inch storms are a common occurrence. In this area the recurrence interval for a two-inch storm at a point is around six years, so it was necessary to dismantle an average of only four or five gages each year.

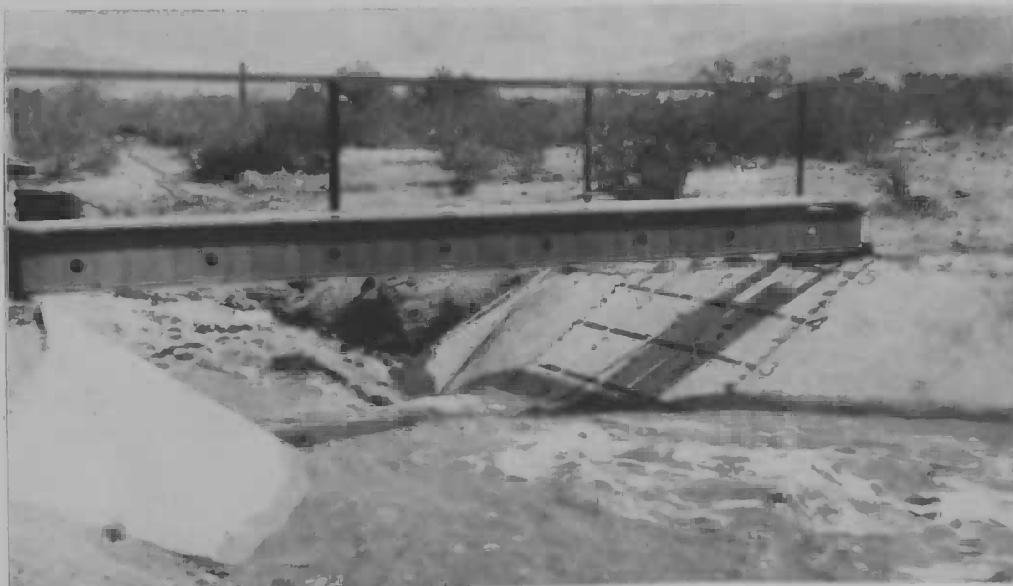
FIGURE 3.10  
FLOW CONDITIONS--FLUME NUMBER 1

Water surface profiles at several depths are shown in Figure 3.9. The photograph, Figure 3.10, shows flow conditions with a discharge of approximately 43 cfs. Critical depth theoretically occurs at the point of inflection in the water surface. In the photograph and in Figure 3.9, the point of inflection appears to be near the entrance to the throat, upstream from the measuring section. One explanation of this apparent contradiction of the current meter results, is that the water surface profiles and the photograph show the water surface at the wall of the flume. The transverse water surface is concave due to convergence, so that the "average" point of inflection occurs downstream from its apparent location. Another possibility is that the pressure at the measuring section is greater than hydrostatic because the streamlines are concave upward. If this

were true, the flow at the measuring section would be supercritical; but the water surface in the stilling well would be higher than that in the measuring section, so that the flume would tend to be self-correcting.
