# Using the Termiticide Transport<sup>®</sup> 50 WP to Control Subterranean Termites around Structures in Southern Arizona

Paul Baker & Ruben Marchosky  
Department of Entomology

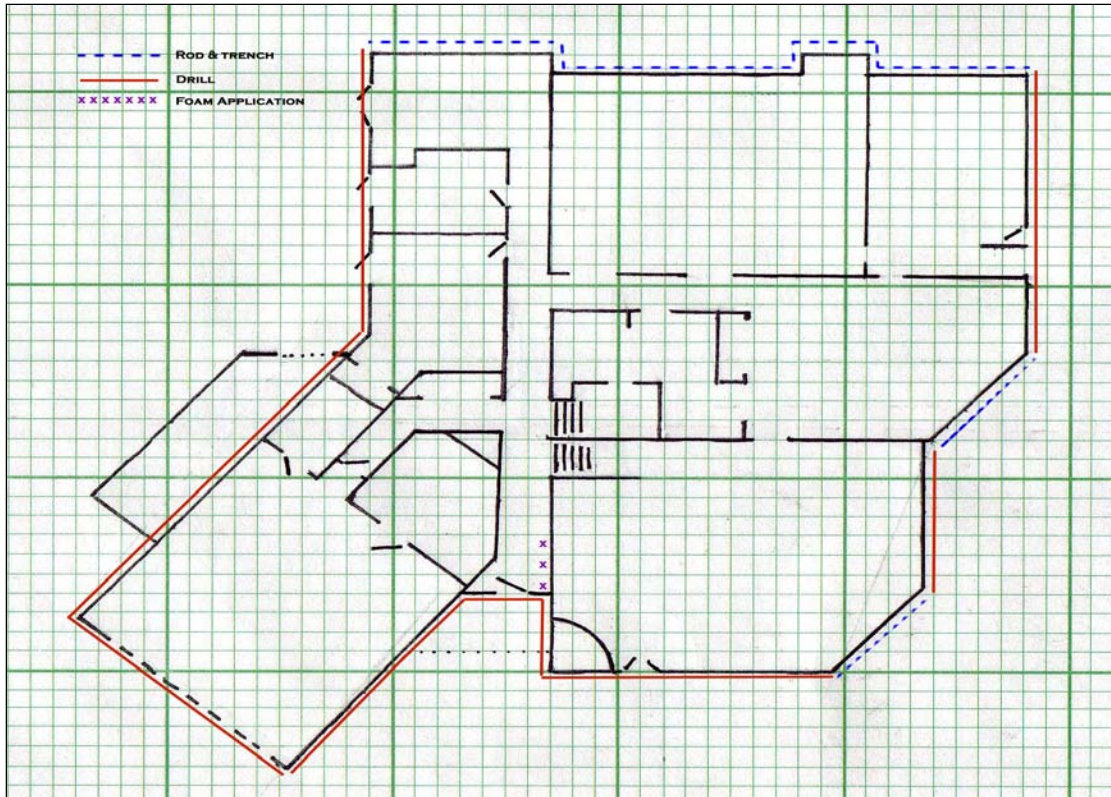
Figure 1

a) Schematic diagram of the application of Transport<sup>®</sup> to Site 1.

Site 1 was a multi-level home with 416 linear feet of treatable area around the structure. At the time of treatment, five (5) termite tubes were active in an interior wall at the entry of the home. A schematic diagram of the treatment of this structure is represented in Figure 1a. A total of 166.4 gallons of finished product of 1% solution were applied by rod and trench or sub-slab applications. One and ¼ gallons of foam were also applied to an interior wall. The wall represented in Figure 1b was the main site of infestation within the structure. Pestfinder monitoring reported persistent termite activity in the wall following treatment. The homeowner had scheduled reconstruction of several interior walls and allowed inspection of the area by removal of the drywall. This action revealed multiple termite tubes radiating from near the initial termite infestation. This confirmed the accuracy of Pestfinder that had indicated on-going activity in this area. A follow-up application of Transport<sup>®</sup> was made on July 10, 2005. A week later no termites were found in the structure based on visual and Pestfinder readings. A total of 9

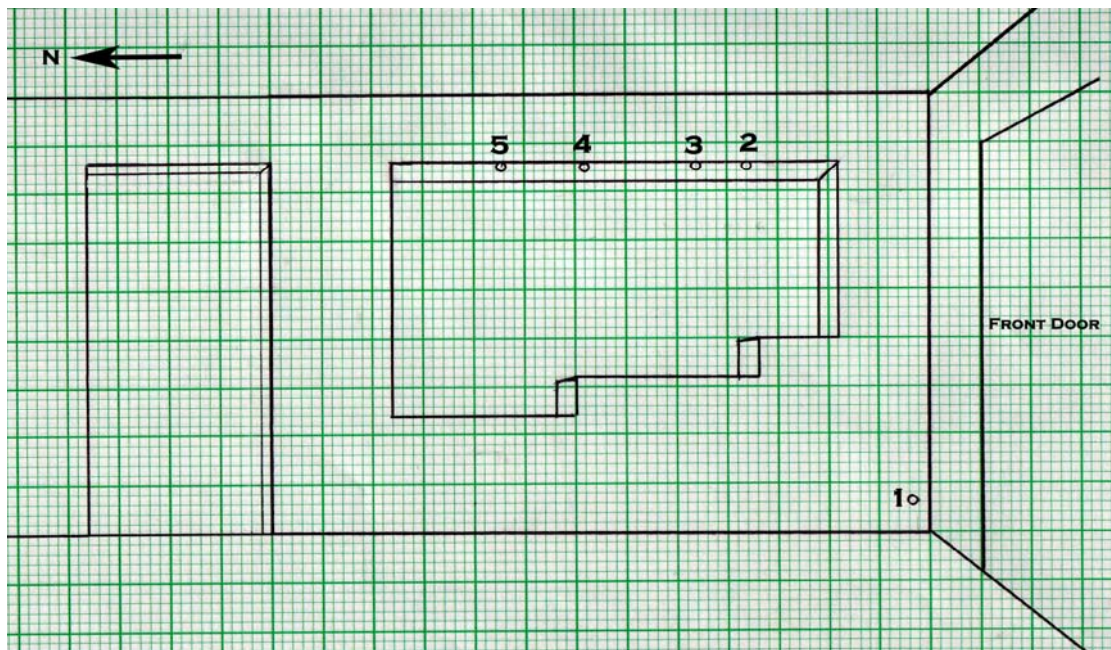
b) Diagram of the termite infestation of an interior wall in Site 1 with entry points at 1-5.

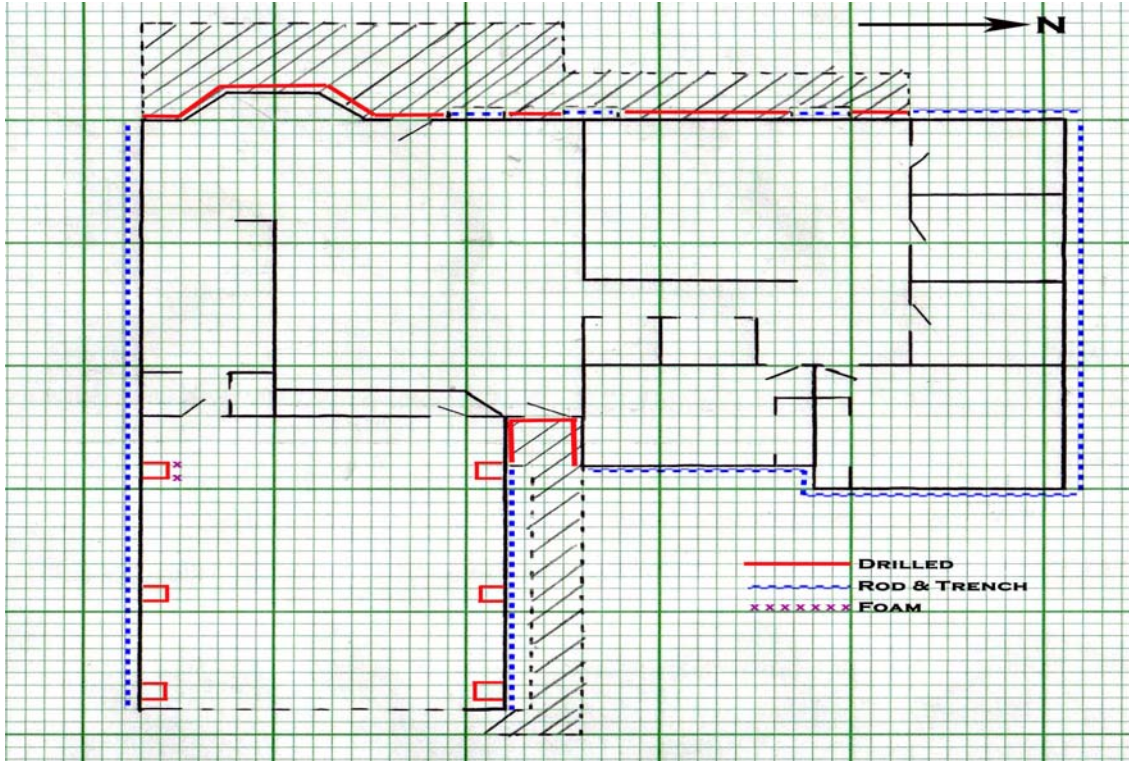
Figure 2

a) Schematic diagram of the application of Transport<sup>®</sup> to Site 2

Site 2 was a relatively small structure of 180 linear feet with five (5) termite tubes located in the garage. A schematic diagram of the treatment of this structure is represented in Figure 2a. A total of 72 gallons of finished product of 1% solution were applied. Five and ½ ounces of foam were also applied to columns in the garage. The initial follow-up inspection less than 3 weeks later revealed no termites. All subsequent inspections over a 2-year period revealed the structure remained free of termite activity.

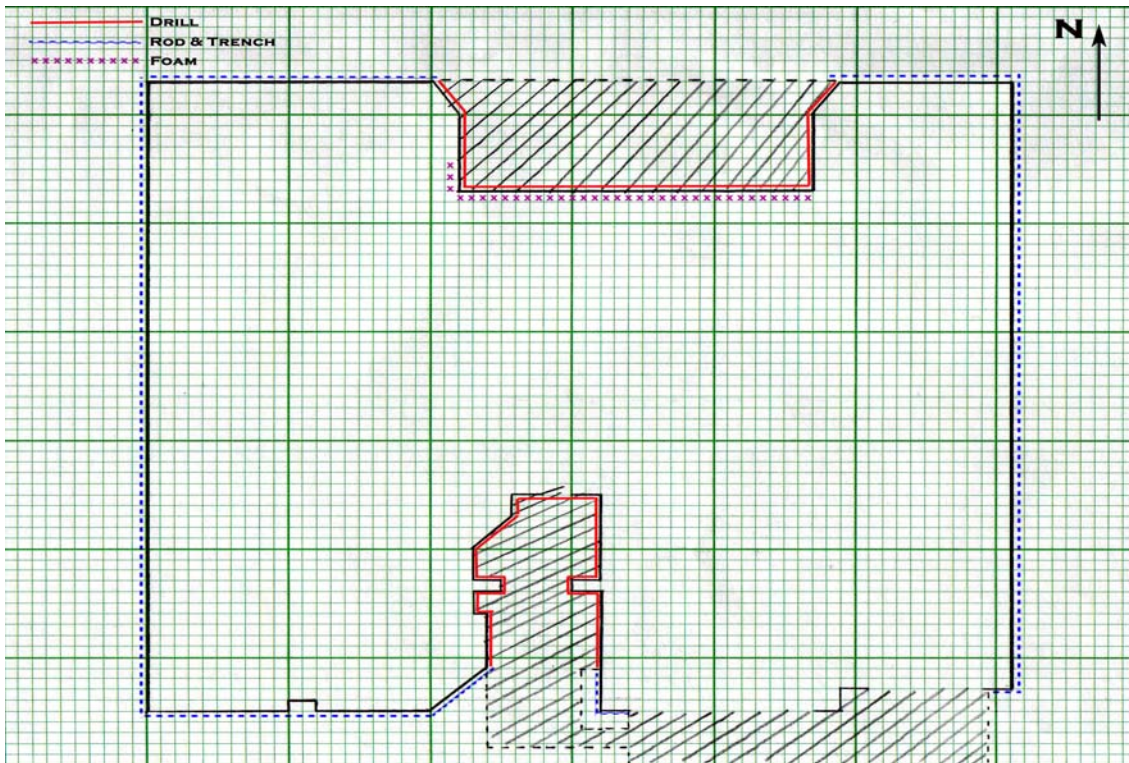
b) Schematic diagram of the application of Transport<sup>®</sup> to Site 3

Site 3 was a structure with a monolithic slab foundation with ten (10) termite entry points both inside and outside the structure. The structure was treated by rod and trench and sub-slab applications of Transport<sup>®</sup>. One gallon of foam was applied to the rear interior wall facing the patio. A total of 109 gallons of finished product was applied to 388 linear feet of the structure. A schematic diagram of the treatment of this structure is represented in Figure 2b. The house quickly cleared of termites. Follow-up inspections revealed no live termites during 2 years of subsequent inspections.

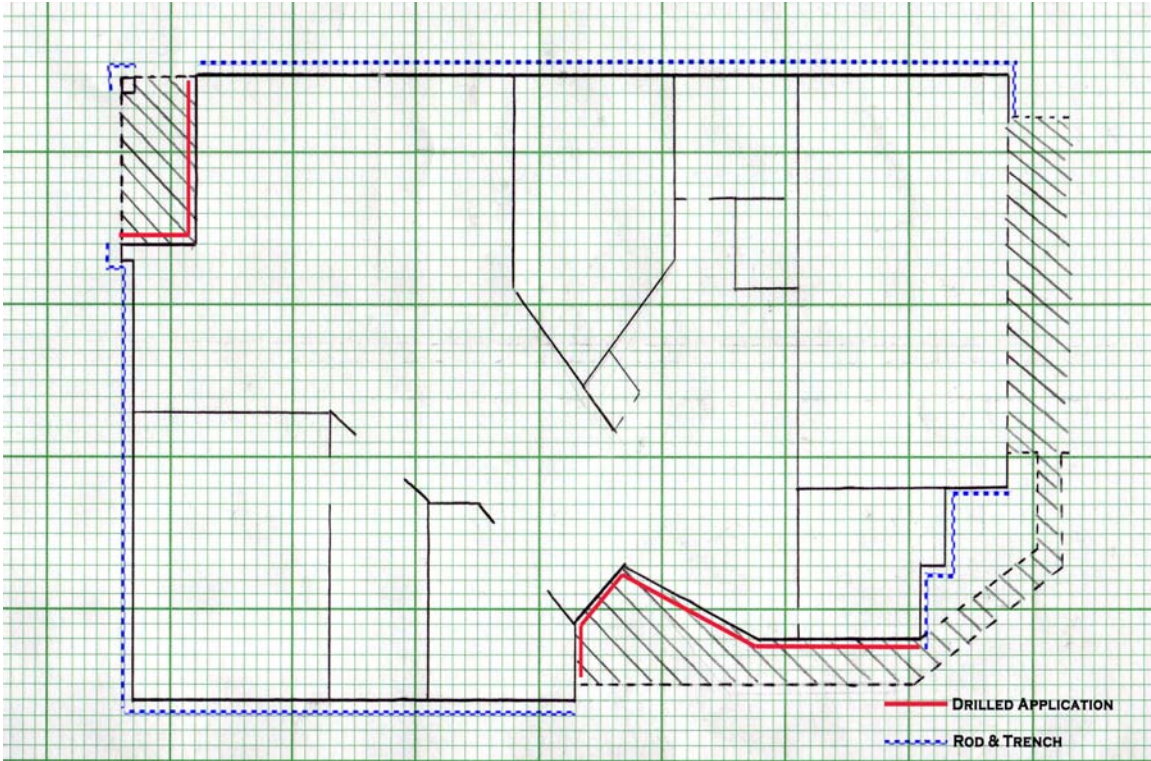
Figure 3

a) Schematic diagram of the application of Transport<sup>®</sup> to Site 4

Site 4 was a small structure with a post-tension foundation with multiple entry points on the outside stem wall and in the garage. A total of 85.2 gallons of finished product of 1% solution were applied to 213 linear feet. A schematic diagram of the treatment of this structure is represented in Figure 3a. A follow-up inspection within 3 weeks revealed the structure was free of live termites. Subsequent inspections over the next two years reported no termite activity and effective protection of the structure.

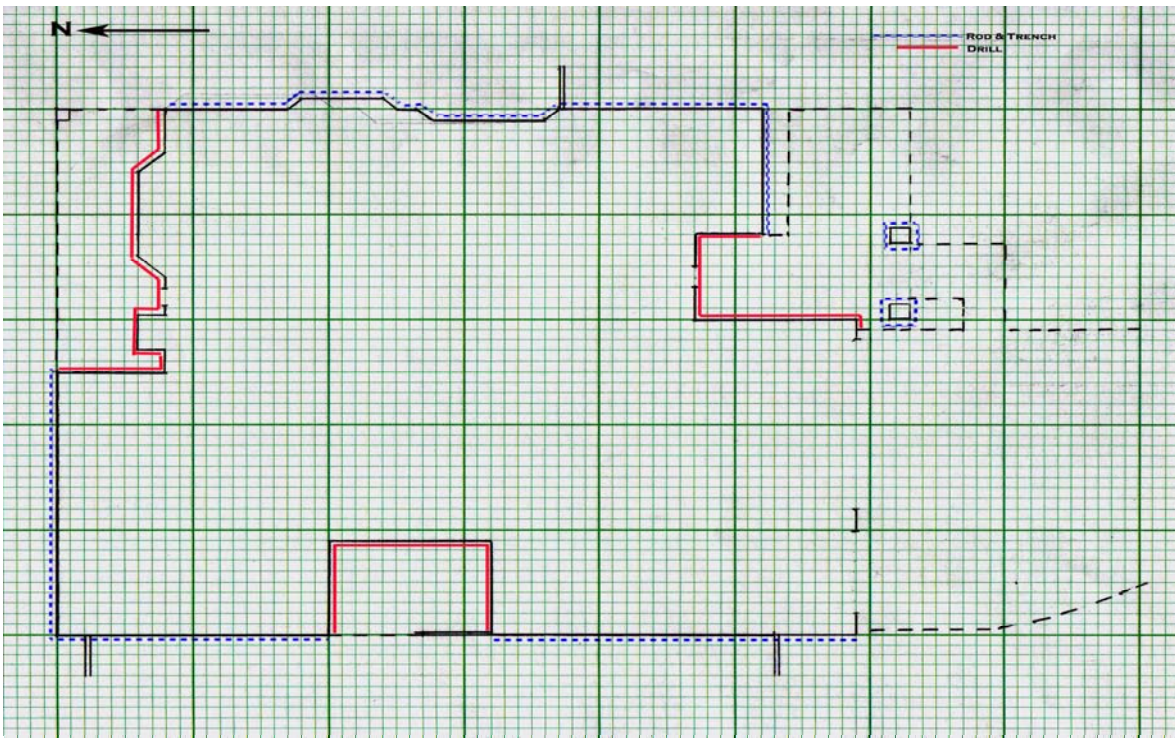
b) Schematic diagram of the application of Transport<sup>®</sup> to Site 5.

Site 5 was structure with a monolithic slab foundation with twenty termite (20) tubes and entry points on the exterior of the house, porch, and the garage. Transport<sup>®</sup> was applied by rod and trench and sub-slab applications. A schematic diagram of the treatment of this structure is represented in Figure 3b. A total of 116.4 gallons of finished product of 1% was applied to 488 linear feet. A follow-up inspection 2 weeks later revealed the house was clear of live termites. No live termites were reported during subsequent inspections over a 2-year period.

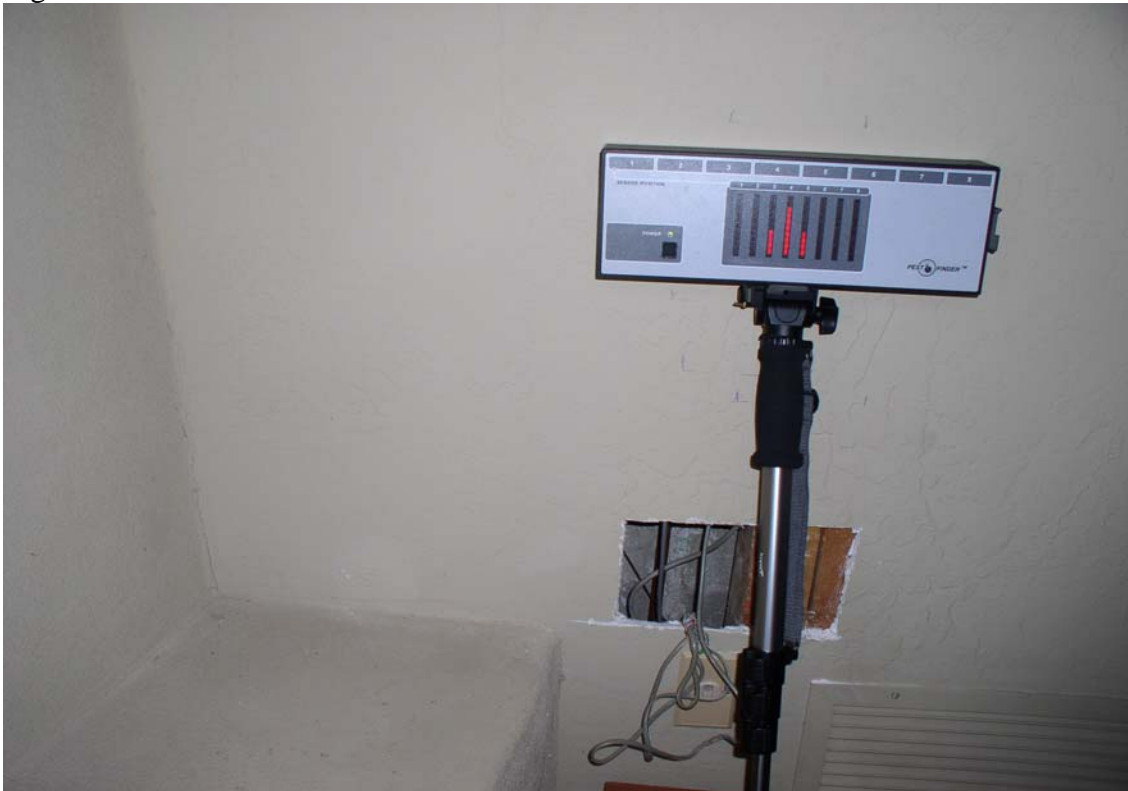
Figure 4

a) Motion detection of termites within a wall by Pestfinder.

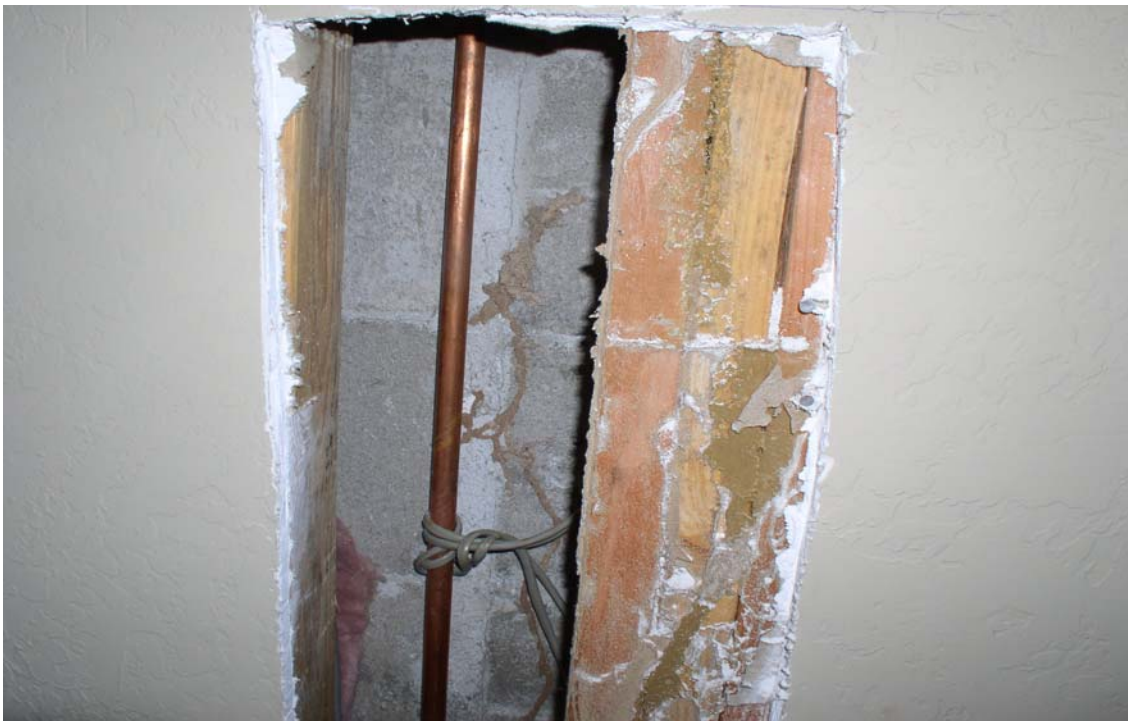
b) Exposed wall showing termite trails where Pestfinder detected motion.
