Using the Termiticide Transport[®] 50 WP to Control Subterranean Termites around Structures in Southern Arizona

Paul Baker & Ruben Marchosky
Department of Entomology

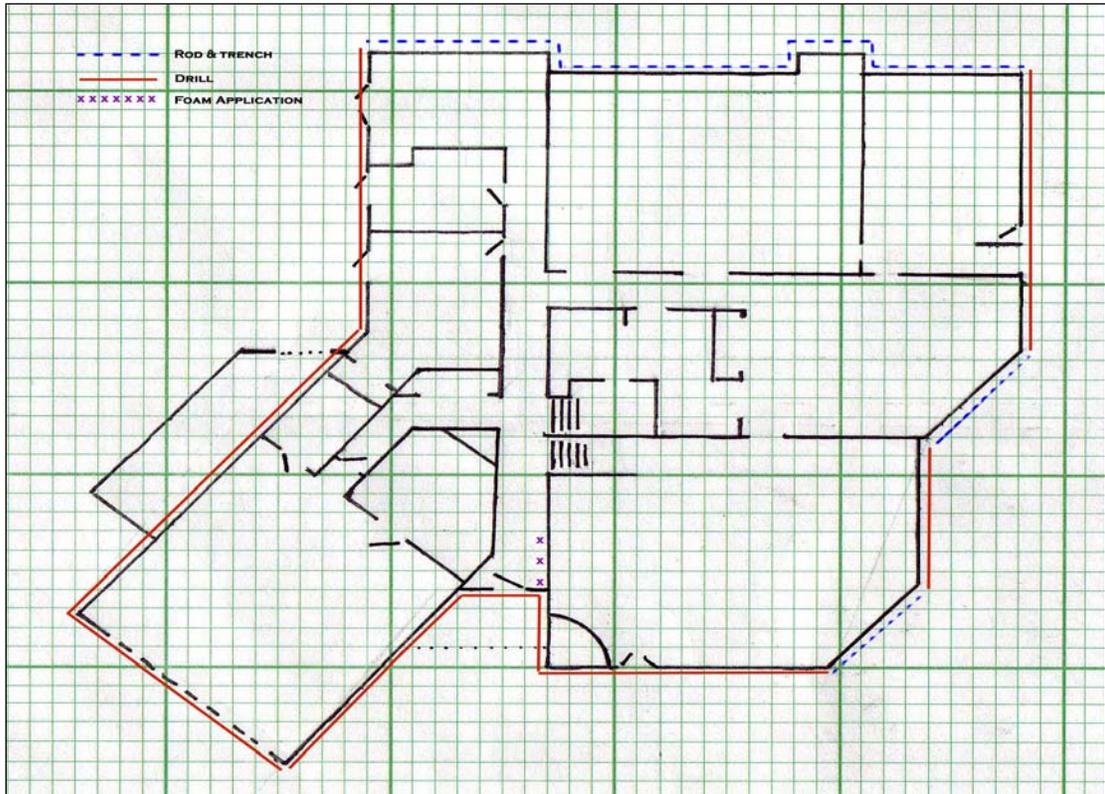
Figure 1

a) Schematic diagram of the application of Transport[®] to Site 1.

Site 1 was a multi-level home with 416 linear feet of treatable area around the structure. At the time of treatment, five (5) termite tubes were active in an interior wall at the entry of the home. A schematic diagram of the treatment of this structure is represented in Figure 1a. A total of 166.4 gallons of finished product of 1% solution were applied by rod and trench or sub-slab applications. One and ¼ gallons of foam were also applied to an interior wall. The wall represented in Figure 1b was the main site of infestation within the structure. Pestfinder monitoring reported persistent termite activity in the wall following treatment. The homeowner had scheduled reconstruction of several interior walls and allowed inspection of the area by removal of the drywall. This action revealed multiple termite tubes radiating from near the initial termite infestation. This confirmed the accuracy of Pestfinder that had indicated on-going activity in this area. A follow-up application of Transport[®] was made on July 10, 2005. A week later no termites were found in the structure based on visual and Pestfinder readings. A total of 9

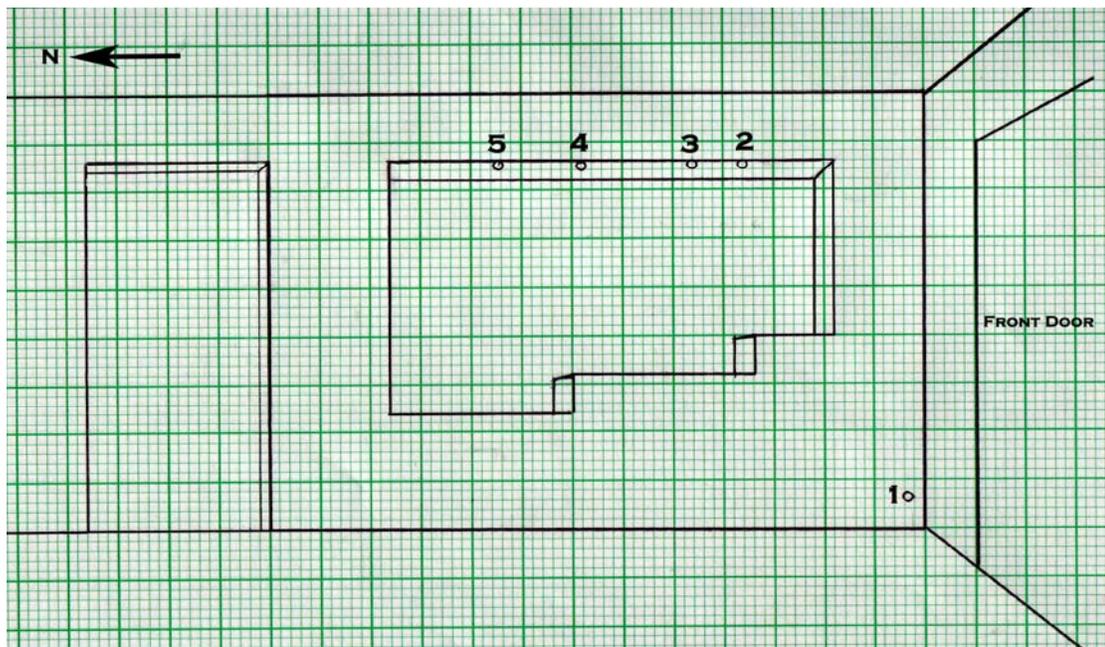
b) Diagram of the termite infestation of an interior wall in Site 1 with entry points at 1-5.

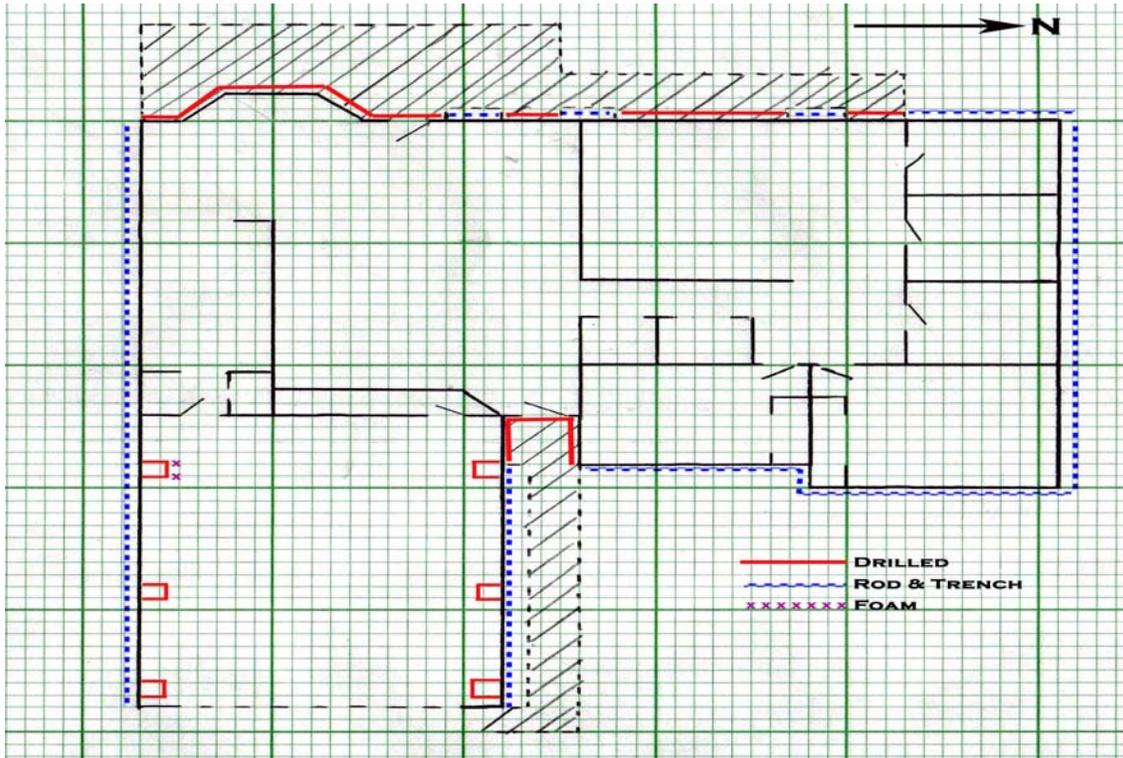
Figure 2

a) Schematic diagram of the application of Transport[®] to Site 2

Site 2 was a relatively small structure of 180 linear feet with five (5) termite tubes located in the garage. A schematic diagram of the treatment of this structure is represented in Figure 2a. A total of 72 gallons of finished product of 1% solution were applied. Five and ½ ounces of foam were also applied to columns in the garage. The initial follow-up inspection less than 3 weeks later revealed no termites. All subsequent inspections over a 2-year period revealed the structure remained free of termite activity.

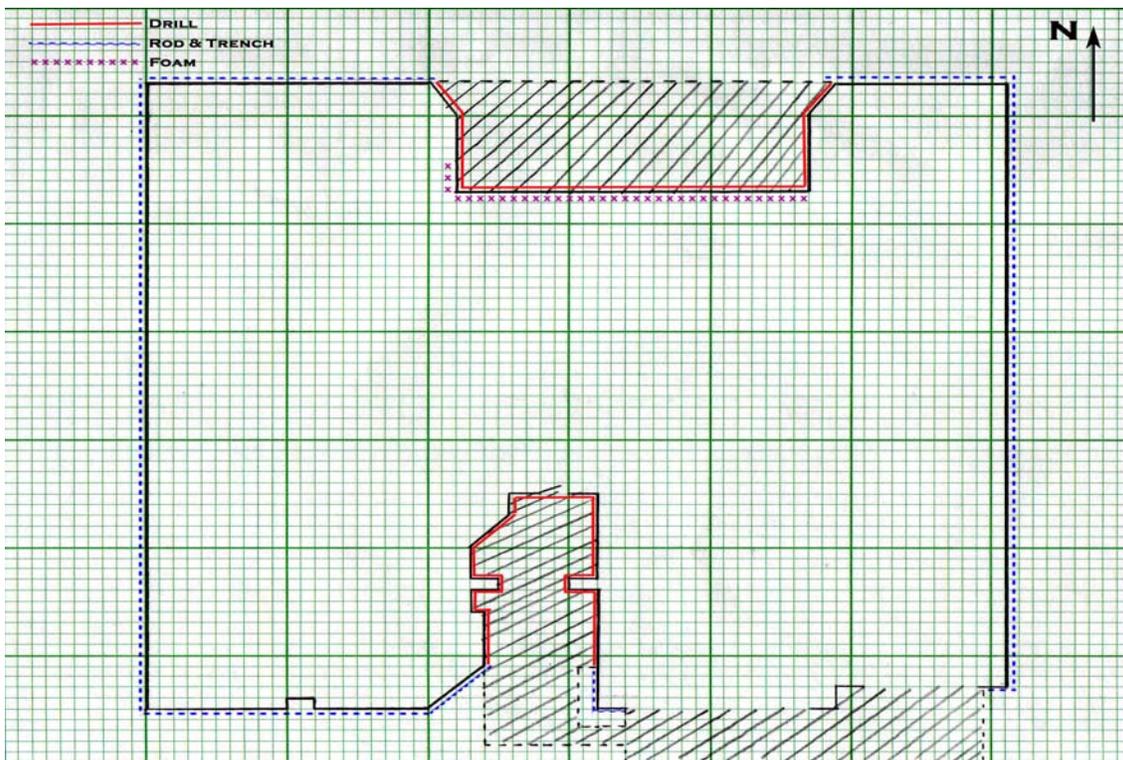
b) Schematic diagram of the application of Transport[®] to Site 3

Site 3 was a structure with a monolithic slab foundation with ten (10) termite entry points both inside and outside the structure. The structure was treated by rod and trench and sub-slab applications of Transport[®]. One gallon of foam was applied to the rear interior wall facing the patio. A total of 109 gallons of finished product was applied to 388 linear feet of the structure. A schematic diagram of the treatment of this structure is represented in Figure 2b. The house quickly cleared of termites. Follow-up inspections revealed no live termites during 2 years of subsequent inspections.

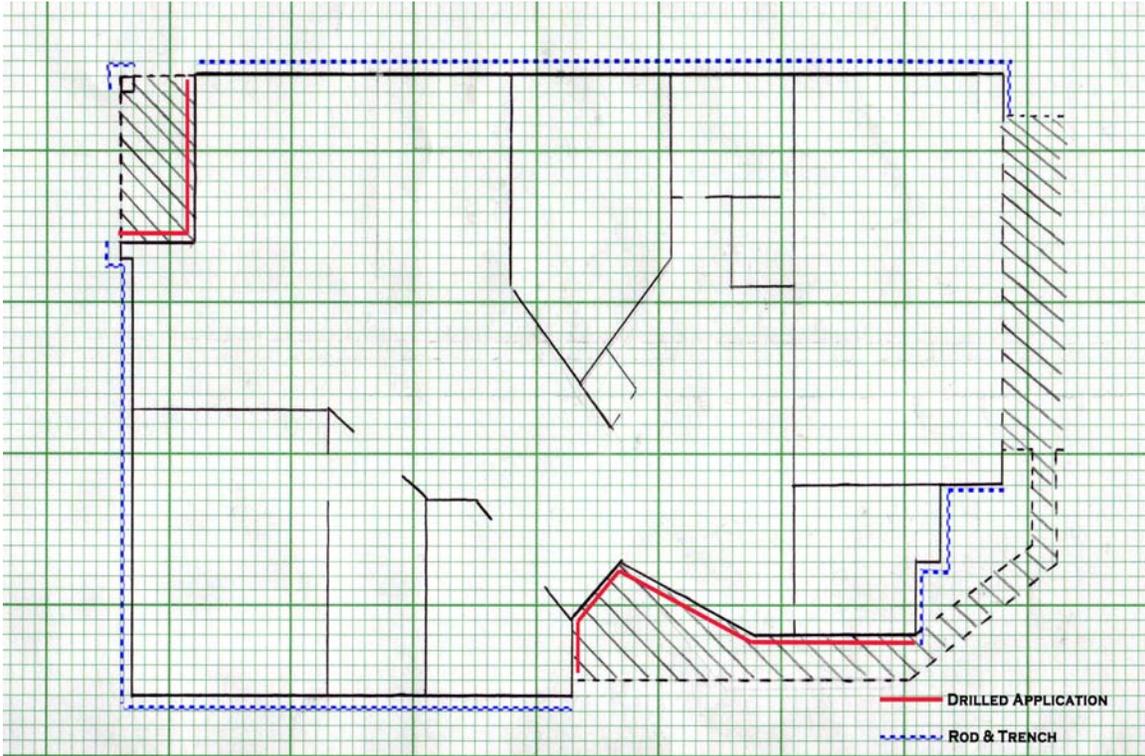
Figure 3

a) Schematic diagram of the application of Transport[®] to Site 4

Site 4 was a small structure with a post-tension foundation with multiple entry points on the outside stem wall and in the garage. A total of 85.2 gallons of finished product of 1% solution were applied to 213 linear feet. A schematic diagram of the treatment of this structure is represented in Figure 3a. A follow-up inspection within 3 weeks revealed the structure was free of live termites. Subsequent inspections over the next two years reported no termite activity and effective protection of the structure.

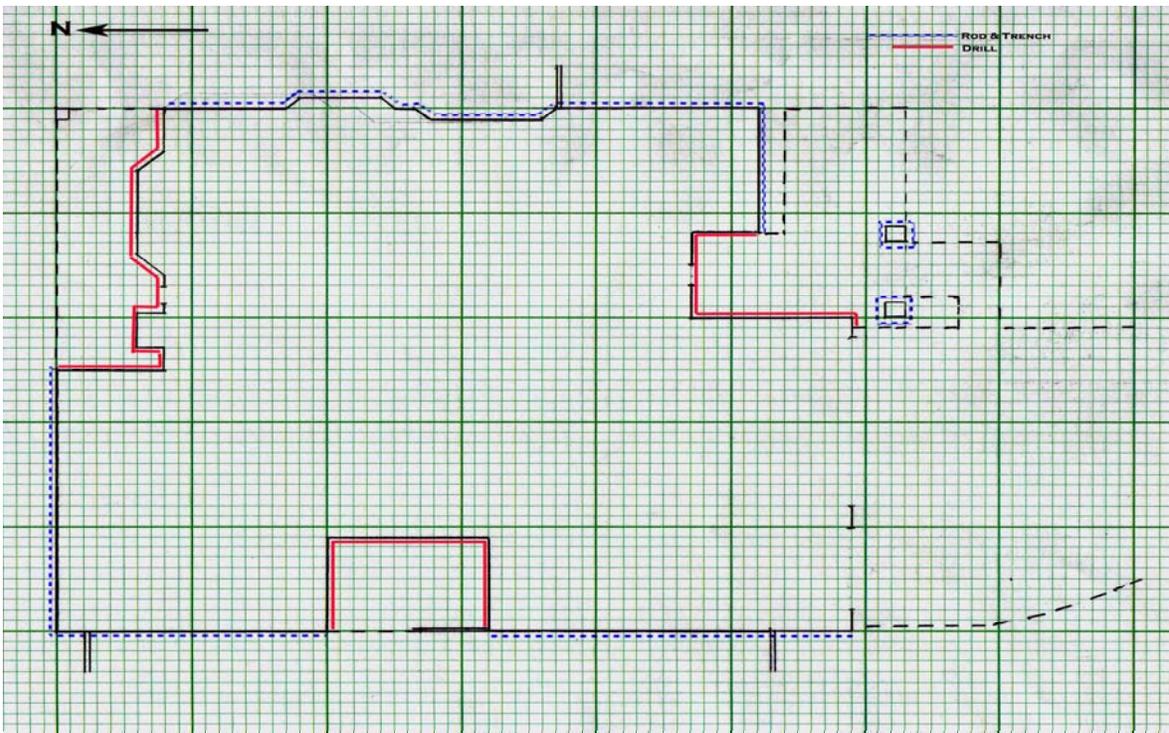
b) Schematic diagram of the application of Transport[®] to Site 5.

Site 5 was structure with a monolithic slab foundation with twenty termite (20) tubes and entry points on the exterior of the house, porch, and the garage. Transport[®] was applied by rod and trench and sub-slab applications. A schematic diagram of the treatment of this structure is represented in Figure 3b. A total of 116.4 gallons of finished product of 1% was applied to 488 linear feet. A follow-up inspection 2 weeks later revealed the house was clear of live termites. No live termites were reported during subsequent inspections over a 2-year period.

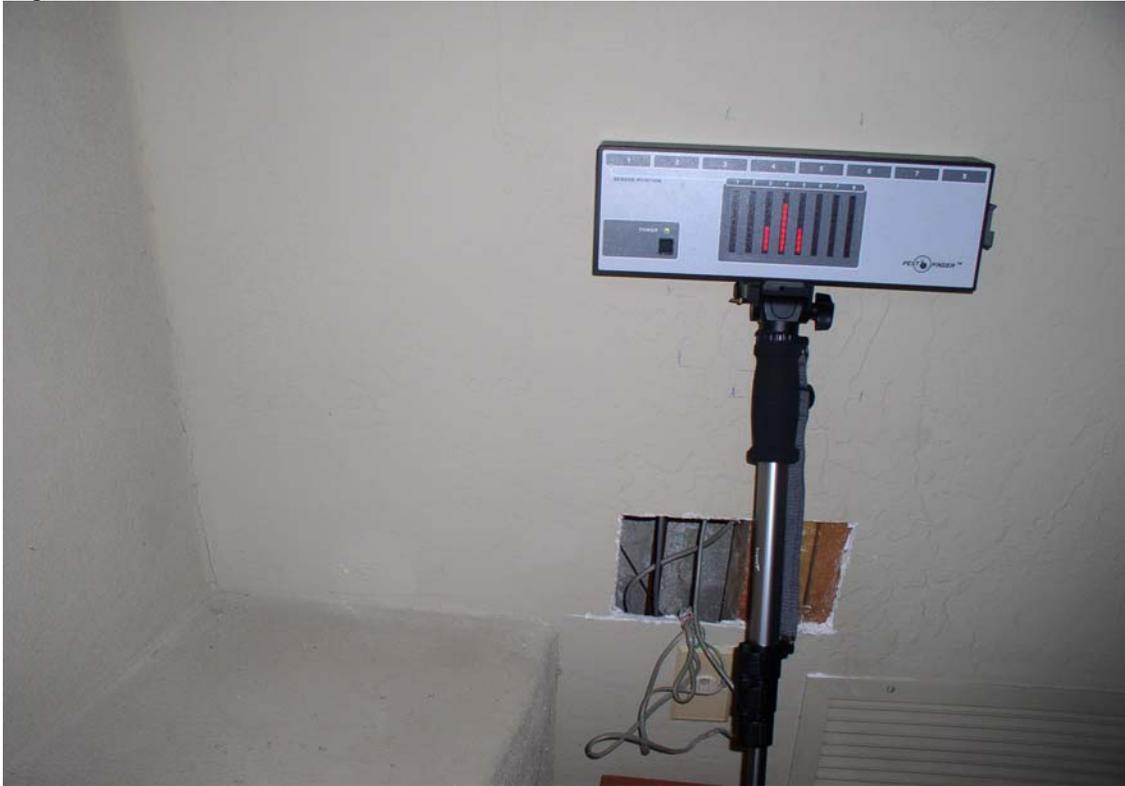
Figure 4

a) Motion detection of termites within a wall by Pestfinder.

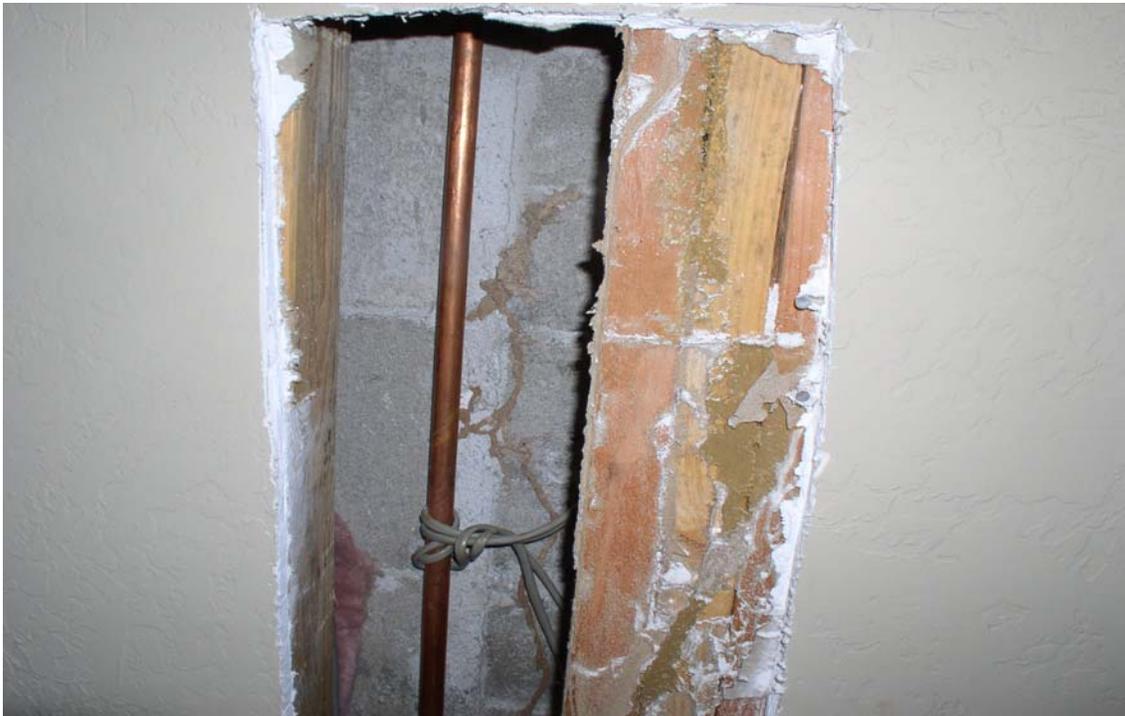
b) Exposed wall showing termite trails where Pestfinder detected motion.
