EXTRACTION OF SURFACE AND SUBSURFACE
GEOLOGIC INFORMATION FROM DIGITAL IMAGES OF THE
PROPOSED ARIZONA SUPERCONDUCTING SUPER COLLIDER SITES

A Thesis Submitted to the Faculty of the
DEPARTMENT OF MINING AND GEOLOGICAL ENGINEERING

MASTER OF SCIENCE
WITH A MAJOR IN GEOLOGICAL ENGINEERING

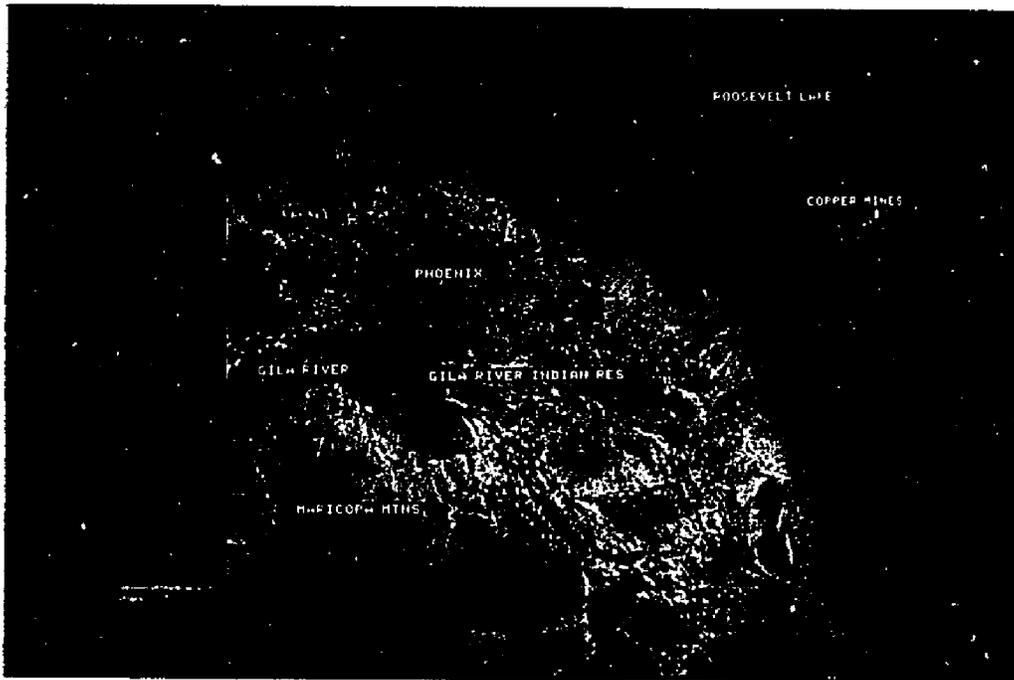
Figure 3. Phoenix Landsat MSS Scene

The Maricopa site for the SSC is in the Maricopa Mountains 30 miles southwest of Phoenix, Arizona (Figure 3). The site is bounded by the Little Rainbow Valley to the east, Interstate 8 to the south, State Route 85 to the west and the Gila River to the north. The site lies within a Bureau of Land Management Wilderness Area.

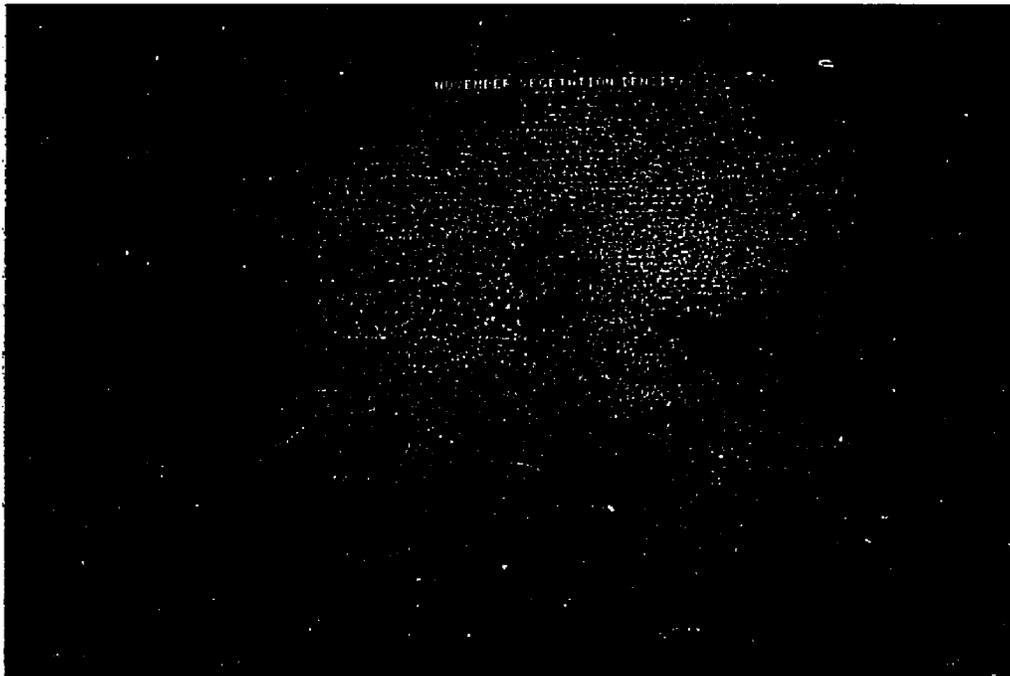
The R75 vegetation densities were classified by pseudocoloring the May and November images (Figure 10). Pseudocoloring assigns a color scale to the gray levels in the image. The number of gray levels assigned to each color can be controlled interactively by adjusting the cursor position in the S570 program PSEUDO-COLOR. A color scale was added to the image to calibrate the pseudocolor coding.

In the absence of field data, the vegetation density was assumed to be linearly related to the gray levels in the ratio image. When the image was pseudocolored, the color assigned to the copper mines was equated to 0% cover and the color assigned to the agricultural fields was equated to 100% cover. The intermediate colors were linearly scaled between these two limits.

Figure 10a. May Vegetation Density for Sierrita Site

Figure 10b. November Vegetation Density for Sierrita Site

The May vegetation density image more clearly defines the riparian vegetation. The riparian trees are in full leaf by May, but the surrounding brush is not growing as vigorously. In November, the riparian trees are senescencing while the surrounding brush is growing more vigorously. The May image was used to define areas of greatest consumptive use. The areal extent of the 80-100% class (black color in Figure 10) and 60-80% class (yellow color in Figure 10) were calculated from histograms of each sector for the May image.

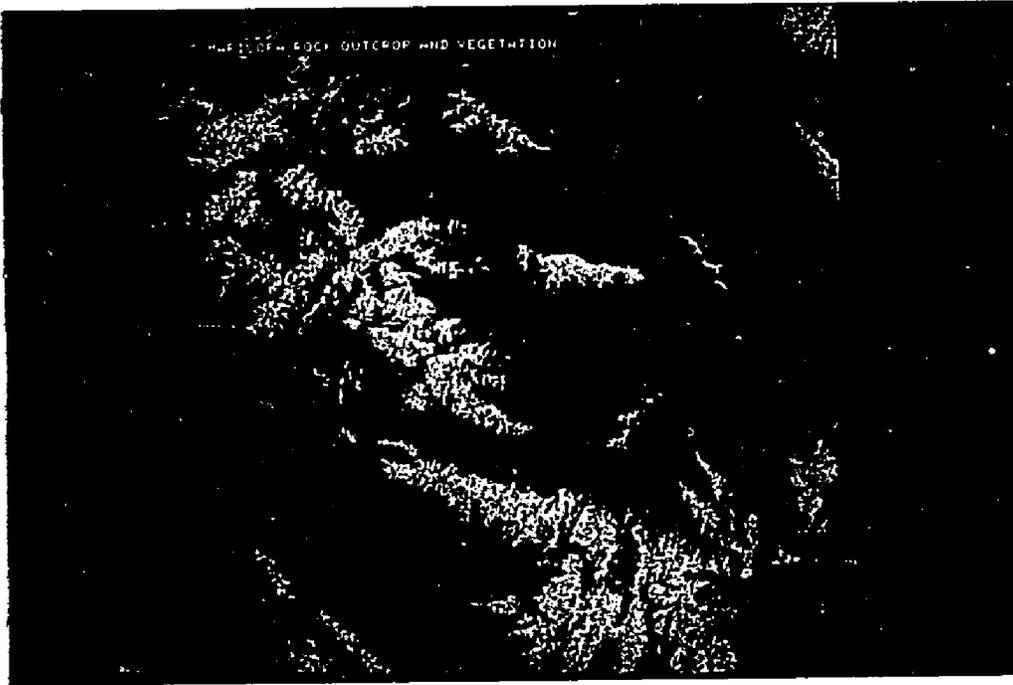
Figure 18. Bedrock Outcrop and Vegetation Density
for Maricopa Site

arid areas. At the Maricopa site, the areas with high drainage densities overlie deep clay-filled basins. These basins can be mapped based on vegetation and drainage density. A density slice of the vegetation density was combined with the density slice of bedrock outcrop to show the location of the basins relative to the bedrock (Figure 18).
