WILSON, Raymond Gale, 1932-
IONIC POLISHING OF FUSED SILICA, 5-15 KEV.

The University of Arizona, Ph.D., 1971
Physics, optics

IONIC POLISHING OF FUSED SILICA

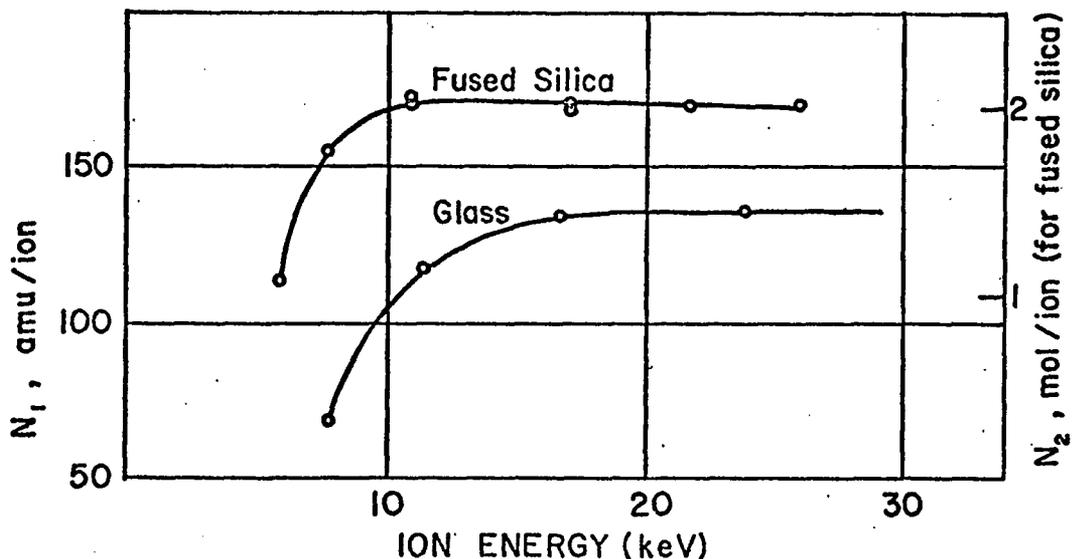
Fig. 1. Erosion Ratio, Kr on Fused Silica and Glass. Variation of cathode erosion ratio N for fused silica and for glass as a function of the Kr ion energy. The N_2 axis, mol/ion, refers to fused silica only. (Akishin et al.¹⁹)

Akishin, Vasil'ev, and Isaev¹⁹ measured erosion ratios for mica, fused silica, and glass using krypton ion beams in the energy range 4 to 30 keV. Apparently the beam they employed was energy analyzed. The beam current density for silica and glass was from

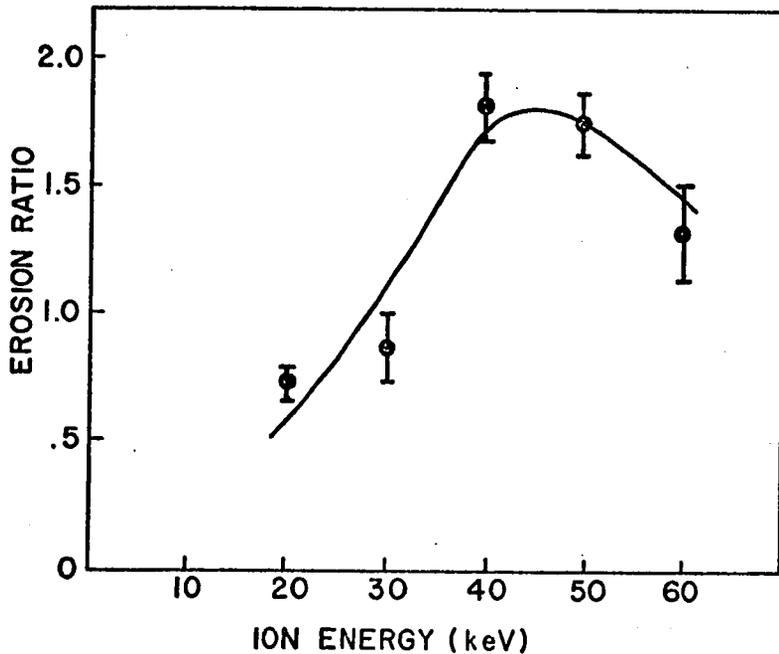
Fig. 2. Erosion Ratio, Xe on Vitreous Silica. Erosion ratio for vitreous silica bombarded by Xe⁺ ions as a function of Xe ion energy. Errors shown are estimated errors made in measuring the volume of the eroded cavity. (Hines and Wallor²⁰)

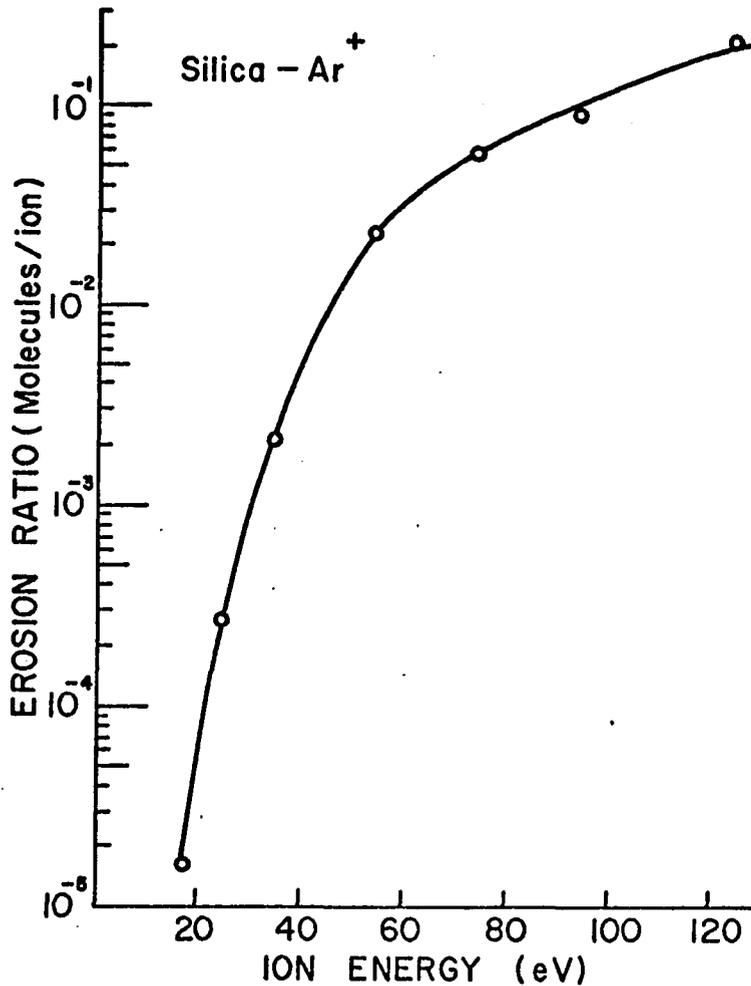
Fig. 3. Erosion Ratio, Ar on Silica.
Erosion ratio vs. bombarding energy.
(Jorgenson and Wehner²³)

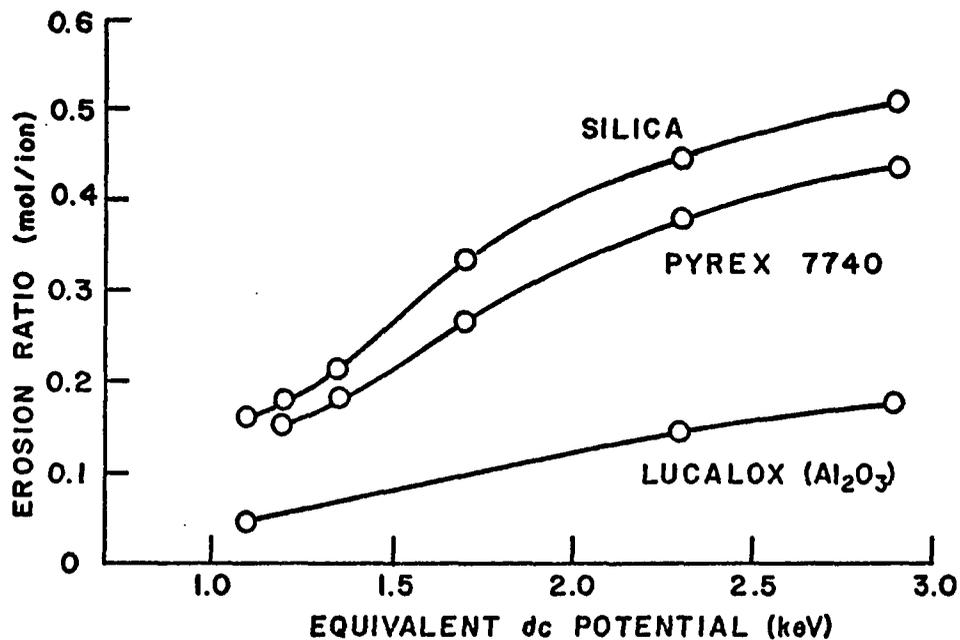
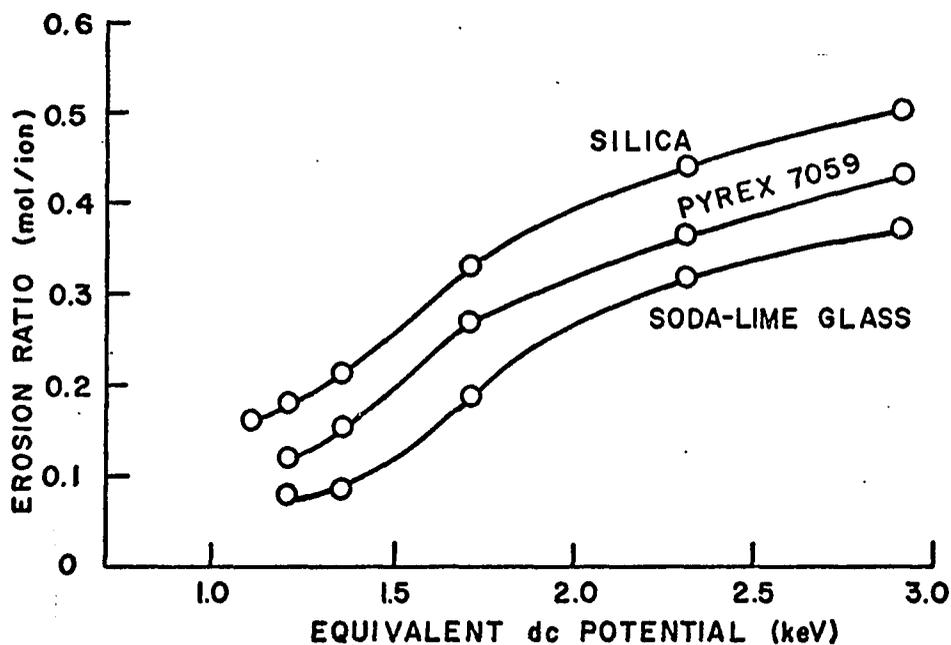
Fig. 4. Equivalent DC Erosion Ratios. (Top) Equivalent dc erosion ratios for fused silica, Pyrex 7740, and Lucalox. (Bottom) Equivalent dc erosion ratios for Pyrex 7059 and soda-lime glass. (The fused silica curve is shown again for reference.) (Davidse and Maissel²⁴)

of this work are presented in Fig. 4. In the term molecule/ion, "mean molecule" was used based upon mean molecular weight and glass composition. Davidse and Maissel compared their work to that of Hines and Wallor²⁰ and that of Jorgenson and Wehner,²³ and this is

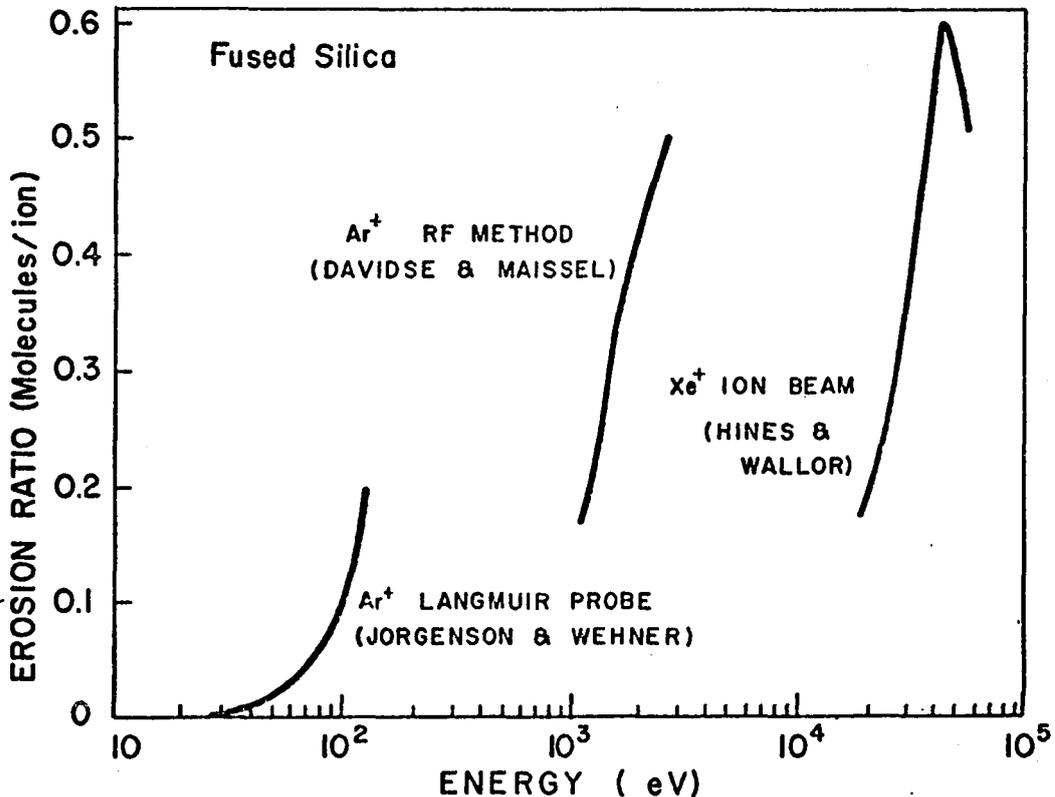
Fig. 5. Comparison of Erosion Ratios. Comparison of erosion ratios obtained by various methods, for fused silica. (Davidse and Maissel²⁴)

shown in Fig. 5. This comparison serves at least one purpose: to point out that bombardment methods and conditions play a decisive role as concerns erosion ratio.

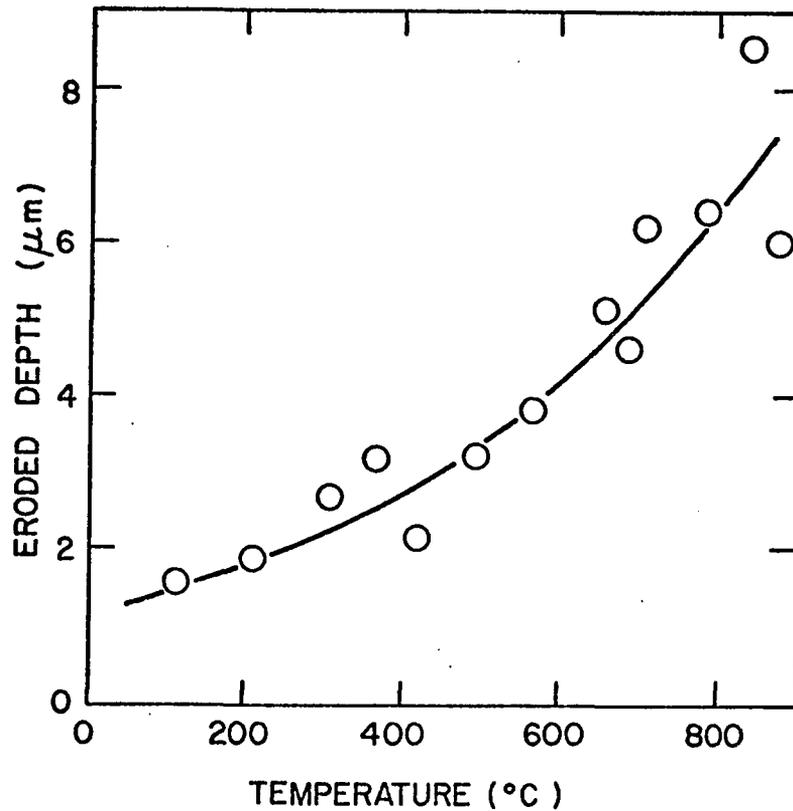
Fig. 6. Eroded Depth as Function of Temperature. Eroded depth due to bombardment of fused silica by argon at 12 keV, as a function of temperature. (Dugdale and Ford²²)

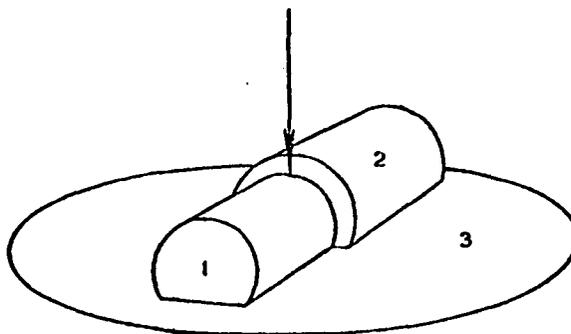
Fig. 7. Eroded Depth Experimental Arrangement. Experimental arrangement to measure erosion of fused silica as a function of angle of incidence: (1) silica rod, (2) close-fitting silica tube, (3) heated stage. (Dugdale and Ford²²)

in the path of the ion beam, which was normal to the rod and tube axis at the tube end (Fig. 7). A step was eroded into the rod and then measured with a microscope. This provided erosion depth data as a function of angle of incidence. These results are shown in Fig. 8 for 12 keV Ar^+ ions and temperatures of 300° , 600° , and 900°C . The temperatures are to be regarded as approximate, and, owing to inhomogeneities of the ion beam, calculated erosion rates at glancing angles would be in error. The results, however, clearly indicate the effect on erosion ratio of temperature and angle of incidence. As a mechanism for sputtering, or erosion,

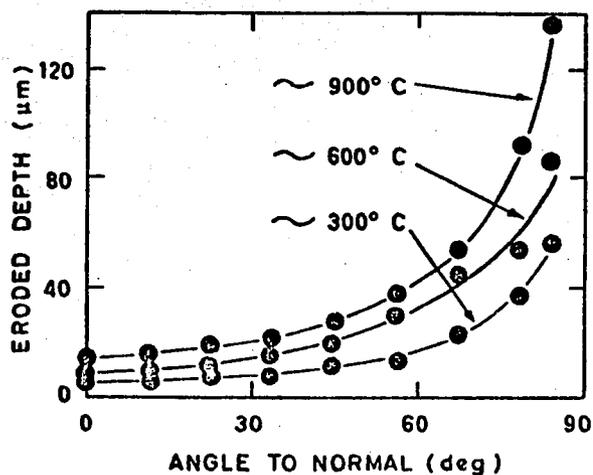
Fig. 8. Eroded Depth as Function of Angle. Eroded depth due to bombardment of fused silica with argon at 12 keV, as a function of angle of incidence. (Dugdale and Ford²²)

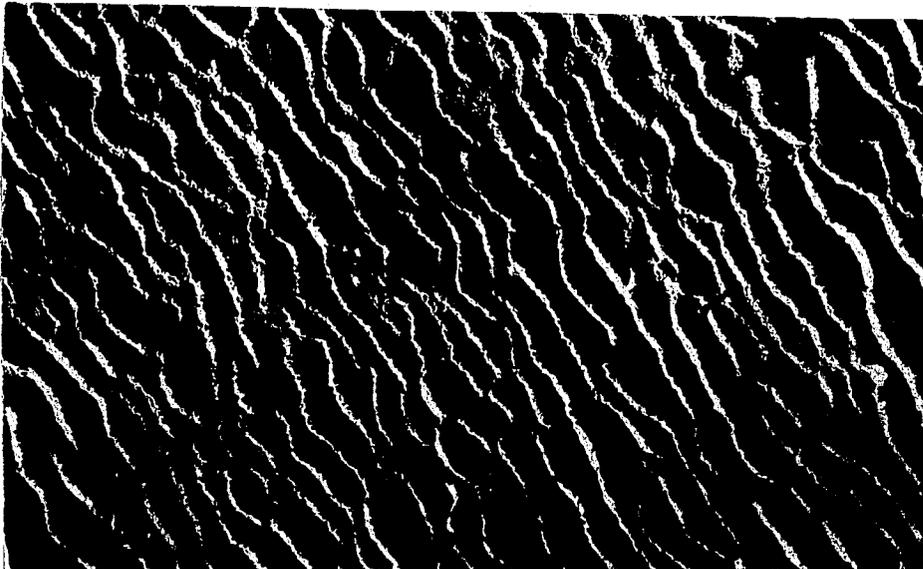
Fig. 10. Glass Polished at 60° . Polished glass surface bombarded for 2 hours at 60° by a 4 keV ion beam, direction of which is indicated by the arrow. Average distance between ridges is 120 nm. (Navez et al.³⁰)

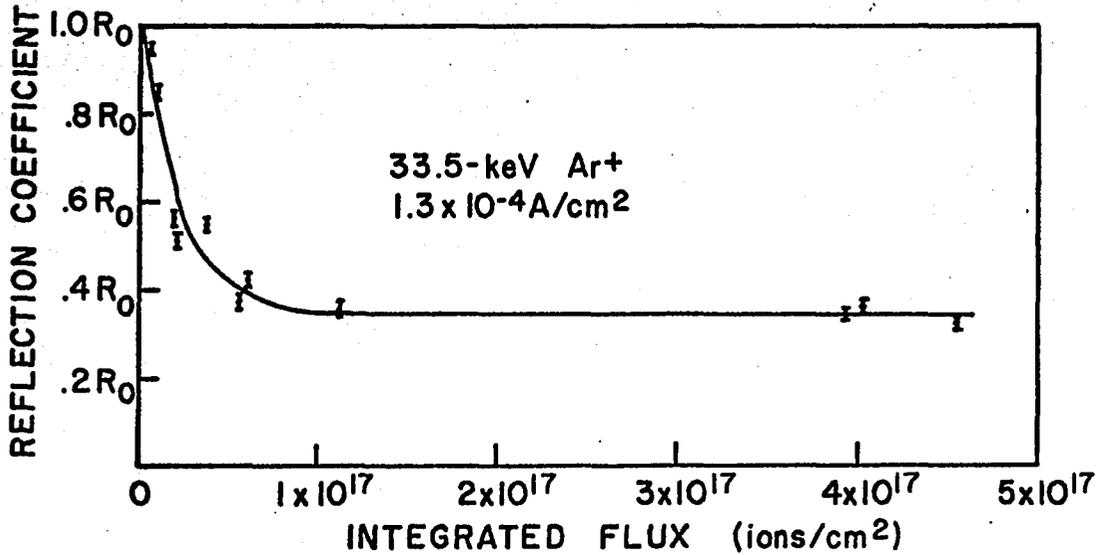
Fig. 15. Reflection Coefficient of Glass.
Reflection coefficient of glass ($n_D = 1.5246$) as a function of integrated flux of positive ions. (Hines²¹)

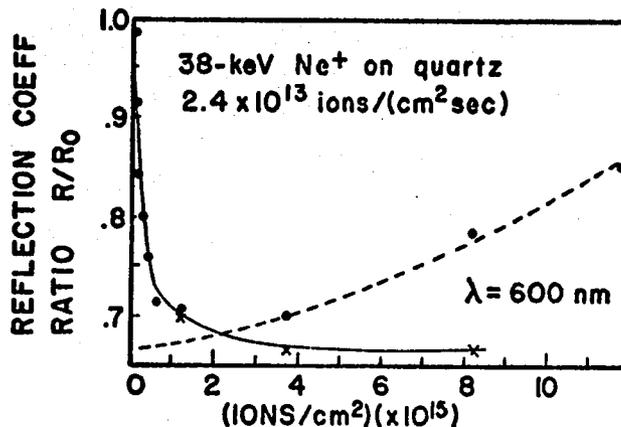
Fig. 16. Reflection Coefficient Ratio of Quartz. Effects of radiation damage as derived from experiment. Experimental points represent combined effect of radiation damage plus effect of the contaminant film on the quartz surface. Dashed line is a theoretical curve for the reflection coefficient ratio of saturation bombarded quartz with contaminant film (see text). Crosses are experimental points corrected for contaminant film. Solid curve gives effect of radiation damage alone. (Hines and Arndt¹⁸)

film whose thickness is a linear function of the integrated flux. Extrapolating this curve to zero flux gives the saturation value R/R_0 due to the radiation damage alone, and the difference between the dashed curve and the saturation value R/R_0 gives the correction for the presence of the contaminant film. The crosses are the experimental points corrected for the contaminant film, and the solid curve gives the effect of the radiation damage alone.

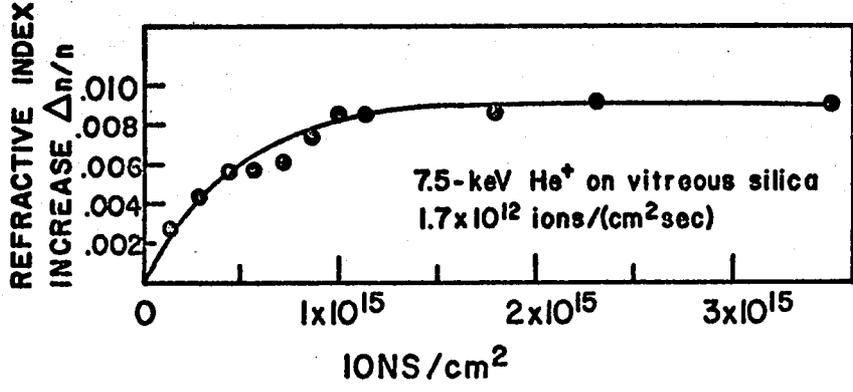
Fig. 17. Refractive Index Increase of Vitreous Silica. Increase in refractive index of vitreous silica as a function of integrated flux of 7.5 keV He⁺ ions. (Hines and Arndt¹⁸)

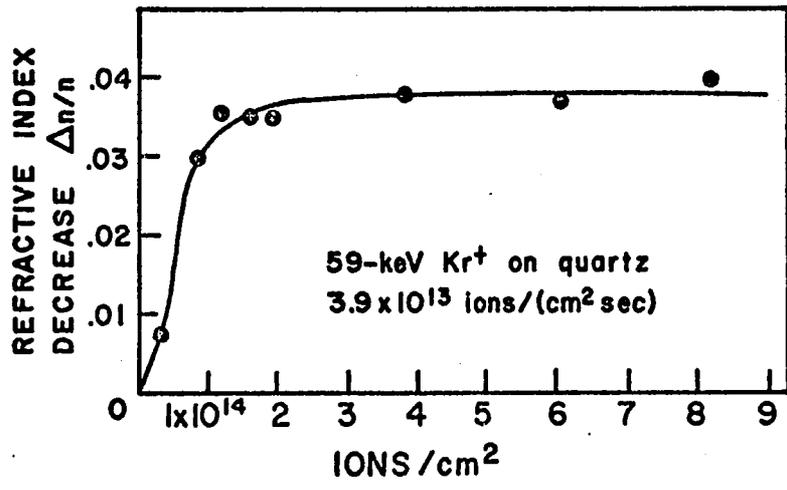
Fig. 18. Refractive Index Decrease of Quartz. Decrease in ordinary refractive index of quartz bombarded by 59 keV Kr⁺ ions. Experimental points are obtained by fitting theoretical curves to the data shown in Fig. 20. (Hines and Arndt¹⁸)

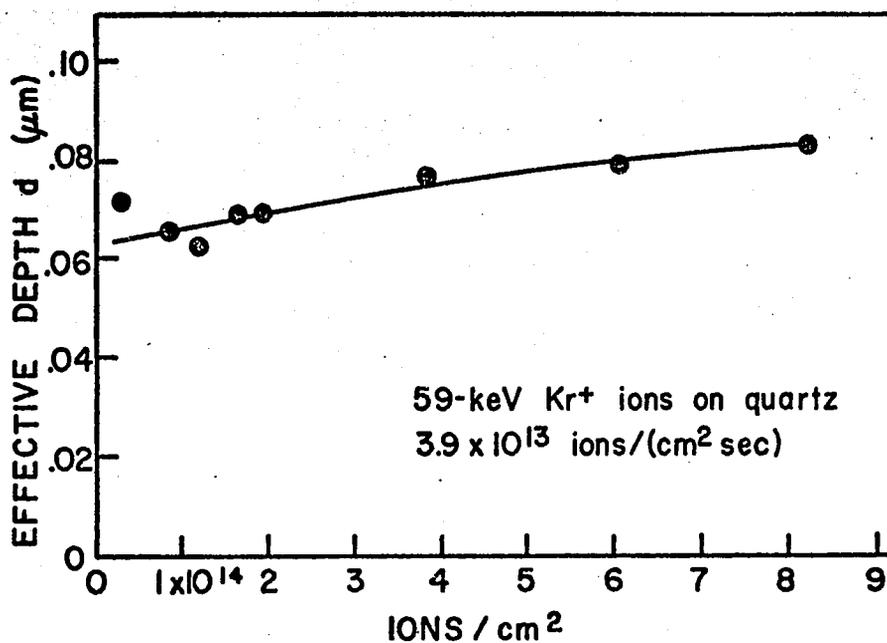
Fig. 19. Effective Depth of Bombarded Layer.
Effective depth of the layer produced when quartz is bombarded by 59-keV Kr⁺ ions. The increase in depth for fluxes larger than that required for saturation (see Fig. 18) is attributed to the penetration of the high-energy knock-ons produced by the Kr⁺ ions. (Hines and Arndt¹⁸)

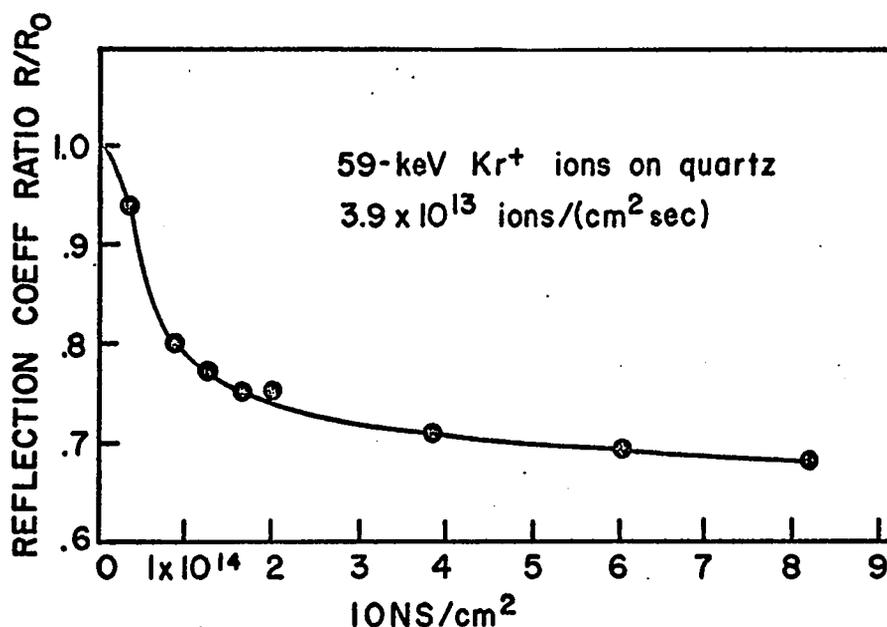
Fig. 20. Reflection Coefficient Ratio vs. Integrated Flux.
Reflection coefficient ratios ($\lambda = 550$ nm) vs. integrated flux for quartz bombarded by 59-keV Kr⁺ ions. (Hines and Arndt¹⁸)

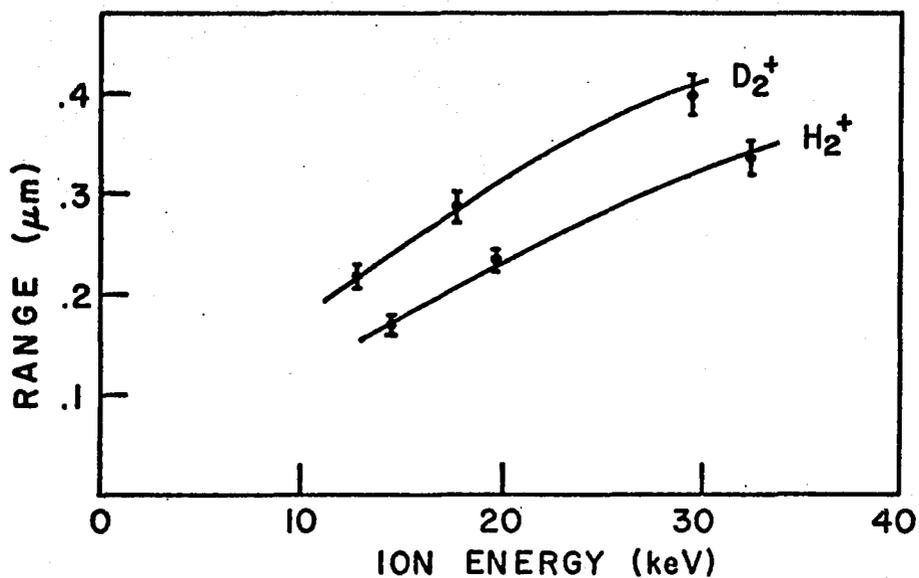
Fig. 21. H_2^+ and D_2^+ Range in Quartz.
Range in quartz of H_2^+ and D_2^+ ions as a function of ion energy. The molecular ions split into atomic particles as they enter the solid so that the range for atomic ions of a given energy will be equal to the range of molecular ions of twice the energy. (Hines³⁵)

Schroeder, Bashkin, and Nester⁸ observed similar changes in index in their work with BK-7 glass. Hines³⁵ then used the altered layers of quartz to determine ranges of 7.5 to 52 keV H_2^+ , D_2^+ , He^+ , and Ne^+ ions in quartz. Under certain assumptions his results agree well with theoretical predictions. Typical results are shown in Figs. 21 and 22.

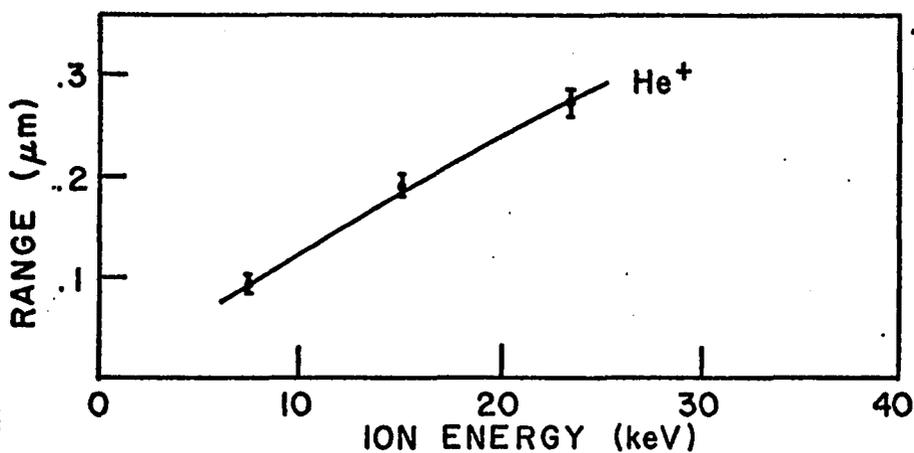
Fig. 22. He^+ Range in Quartz.
Range in quartz of He^+ ions as a function of ion energy. (Hines³⁵)

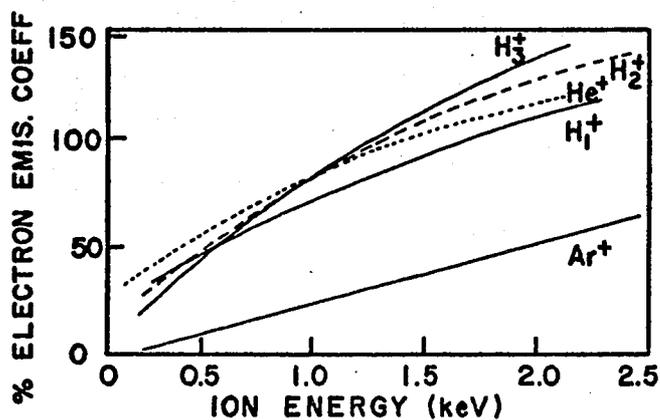
Fig. 23. Secondary Electron Emission, 0 - 2.5 keV. Secondary electron emission coefficient for glass as a function of incident ion energy: Ar^+ , H_1^+ , H_2^+ , H_3^+ , and He^+ . (Batanov³⁶)

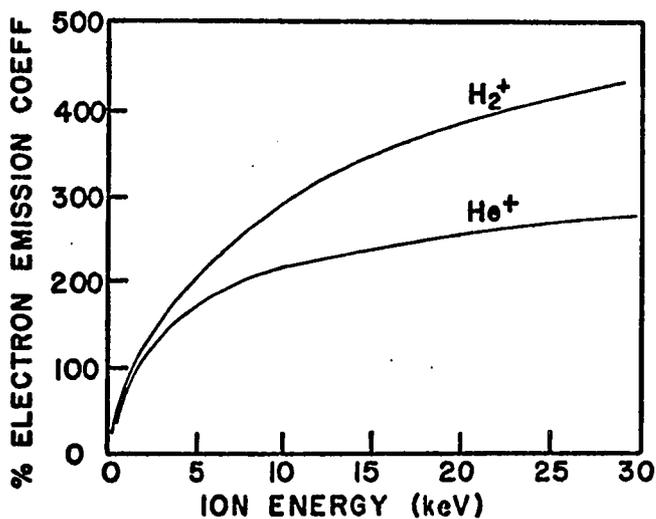
Fig. 24. Secondary Electron Emission, 0 - 30 keV. Secondary electron emission coefficient for glass as a function of incident ion energy: H_2^+ and He^+ . (Batanov³⁶)

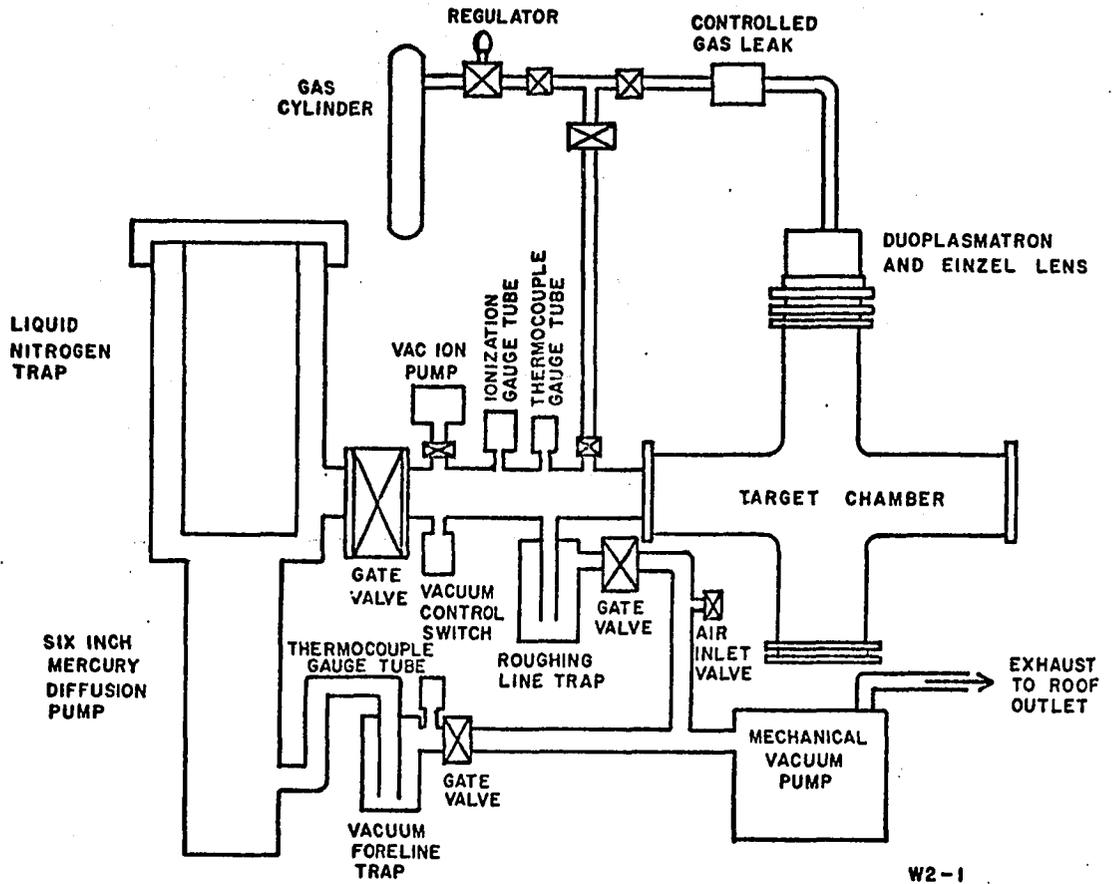
Fig. 25. Schematic Diagram of the Ionic Polishing Vacuum System.

The 6-inch diffusion pump was baffled at its input to impede the movement of mercury vapor toward the vacuum chamber. This particular pump was chosen for two reasons. Hydrocarbon contamination had been a problem in previous experiments; with mercury as the pumping fluid we hoped to avoid that problem. The leak rate into the vacuum system of gas fed to the duoplasmatron was about 10^{-4} cc/sec at standard pressure and temperature. Calculation shows that this is about 10 l/sec at 10^{-5} Torr. The mercury pump was rated to have a pumping speed of about 460 l/sec at 10^{-5} Torr; thus, it had the gas-handling ability sought and in addition provided a reasonable pumpdown time. Pumping on the Pyrex cross, the duoplasmatron, and the instrumentation flange, the system pressure readily went to the 10^{-7} Torr scale in about 8 hours, the duoplasmatron filament requiring a few hours bakeout time. This was a satisfactory vacuum for duoplasmatron operation.

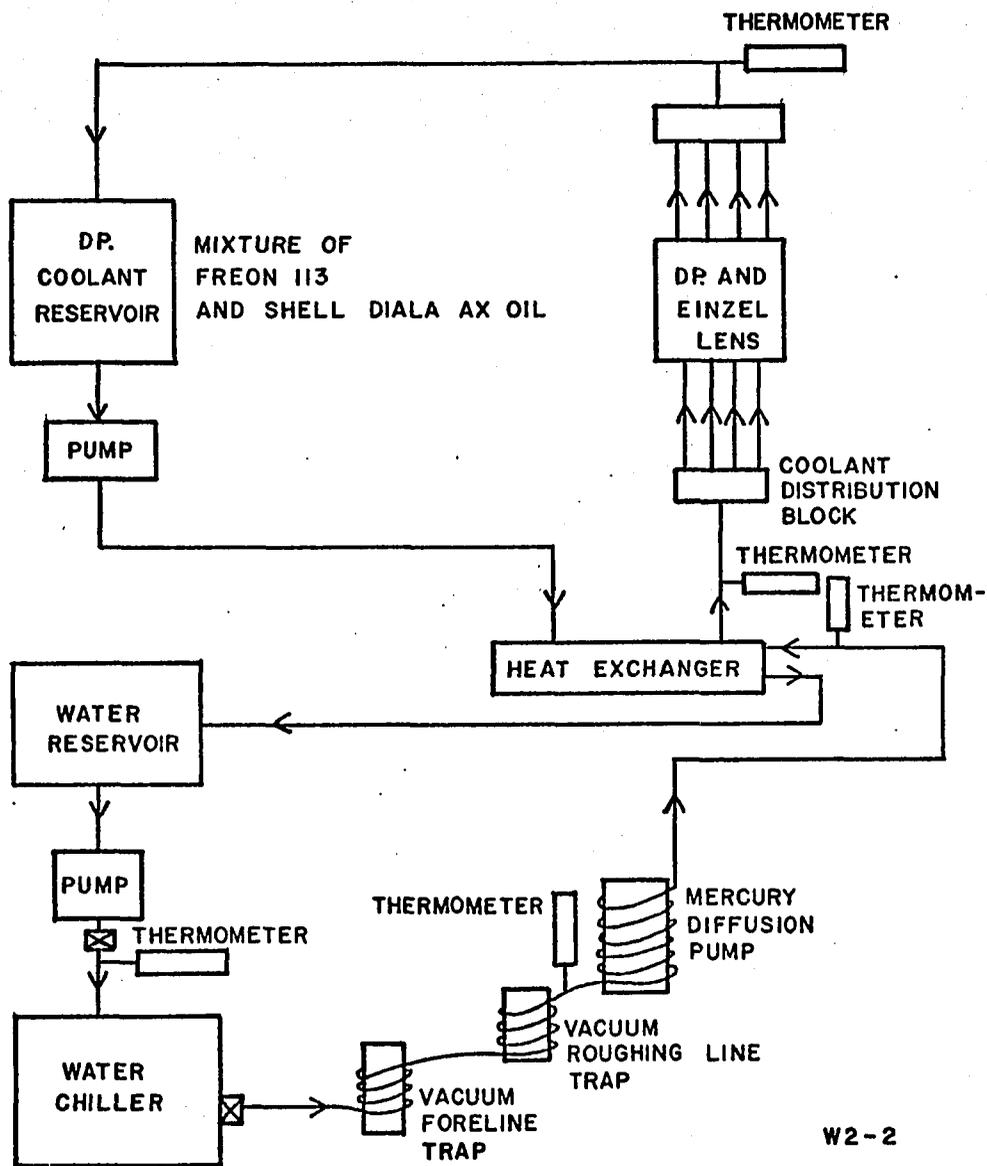
Fig. 27. Schematic Diagram of the Ionic Polishing Cooling Systems.

The diffusion pump required cooling with water to about 6°C. The duoplasmatron needed cooling to near room temperature with an insulating fluid. A water reservoir tank was built of stainless steel to supply water to a water Chiller by means of a standard well pump. It was this water that cooled the diffusion pump and the roughing line and fore line traps. The water then proceeded to a heat exchanger and cooled an insulating fluid being pumped through the exchanger and into the duoplasmatron and then into a reservoir. Freon 113 was the coolant originally recommended, and a Jabsco pump was supplied with this cooling system. Pumping Freon 113 we found the Jabsco pump to have far too much capacity, building up enough fore pressure to stop the driving motor. The impeller squeezing cam was replaced by a thinner one, but pressure still built up, and the noise was just bearable. It is this writer's understanding that Freon 113 is one of the most difficult substances

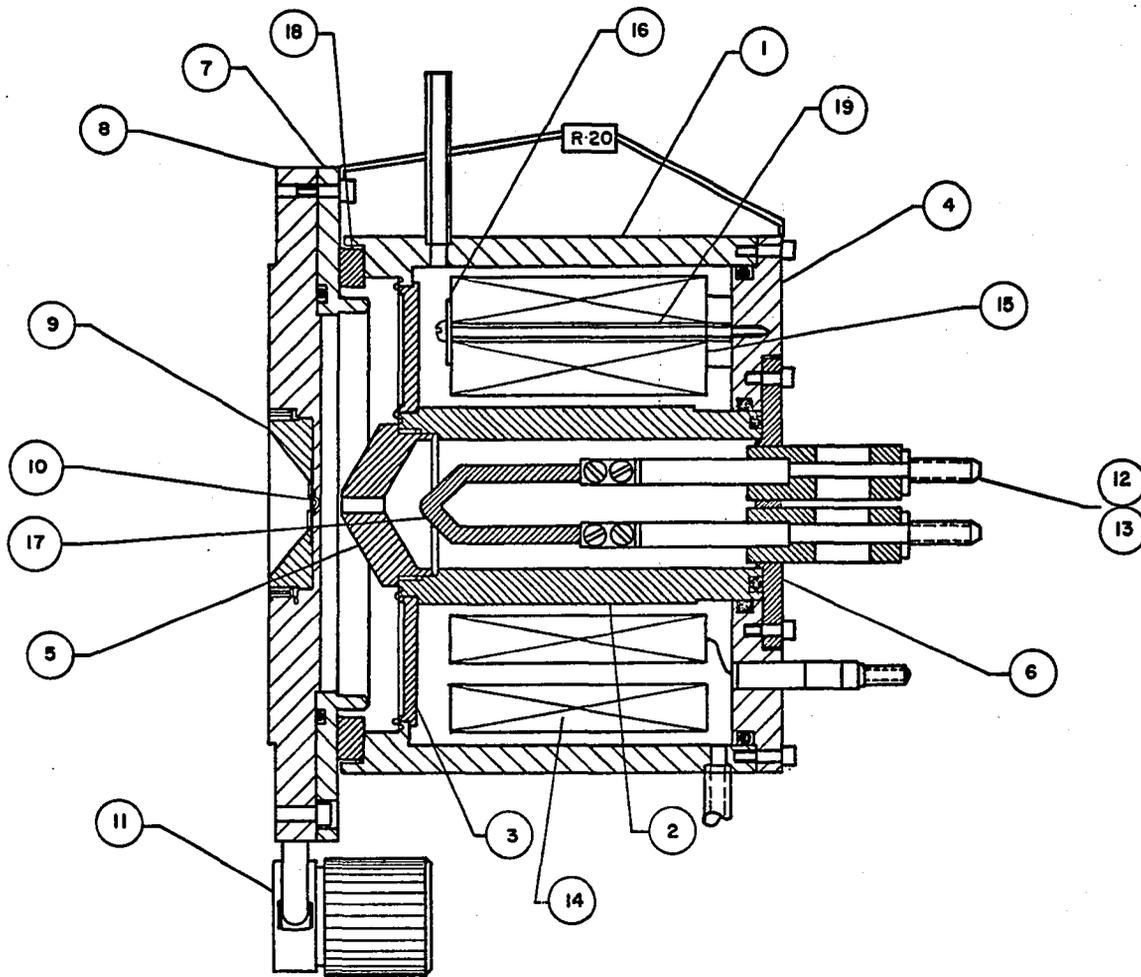
Fig. 28. Duoplasmatron Schematic Diagram.

The ion source and control element for this research was a Texas Nuclear Model 9406 duoplasmatron and associated Gap and Einzel lens (electrostatic), see Figs. 28 and 29. The duoplasmatron received research grade gases by way of a single - stage regulator and an Andonian Adjustable Leak. The output pressure on the regulator was adjustable from 0 to 60 psi, and it supplied gas to the controlled leak. The leak could supply gas at rates of about 10^{-4} to 10^{-2} cc/sec. The leak rate depended on how much twist was put onto a fine metal tube inside the leak, and a micrometer dial and lever arrangement supplied the twisting torque; this was a fine adjustment. A coarse adjustment could be made by twisting, through a degree or two, the 1/4-inch tube on the input side of the leak.

In the duoplasmatron itself, see Fig. 28, there was an axial electron beam, originating at the filament cathode and accelerated through an intermediate electrode toward the anode plate. The intermediate electrode, constructed of magnetic material, provided electrostatic and magnetic focusing from which the source derived its name. It was biased at a voltage between the cathode and the anode and thus produced some electrostatic focusing of the electron beam. A solenoid developed a magnetic field between the intermediate electrode and the anode plate, thus magnetically focusing the electron beam. The magnetic field return path was through the anode plate, then through the small air gap near the intermediate electrode insulator.

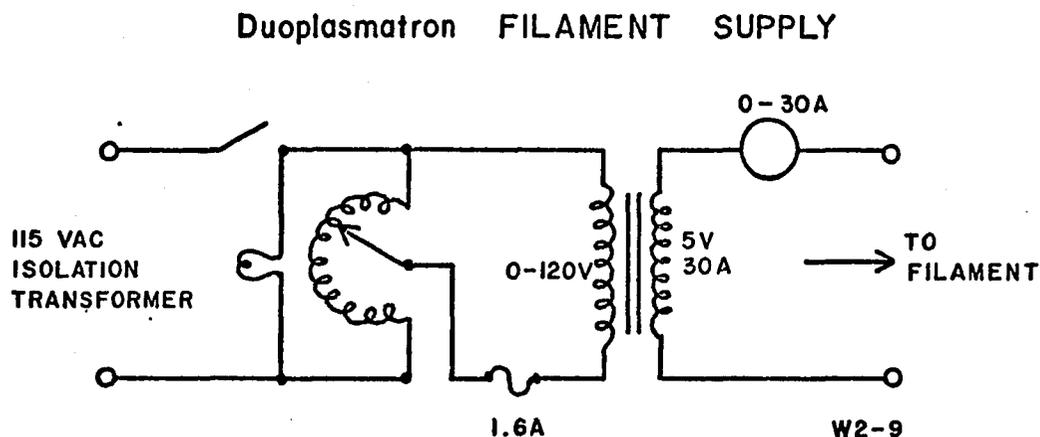
Fig. 30. Power Supply for Duoplasmatron Filament.

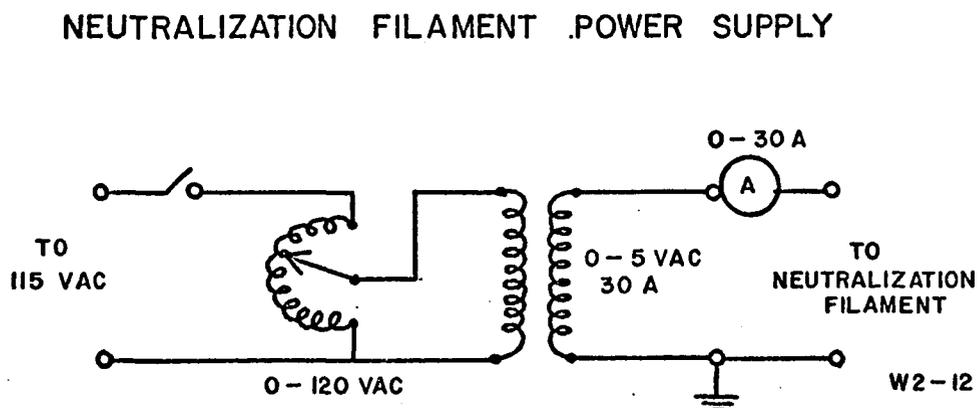
Fig. 36. Power Supply for the Neutralization Filament.

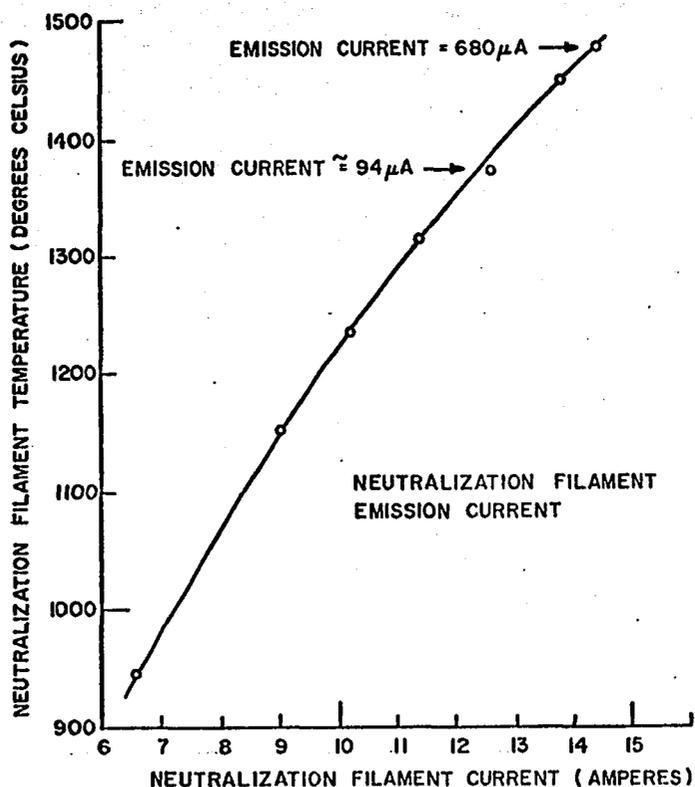
Fig. 37. Temperature and Electron Emission Characteristics of the Neutralization Filament.

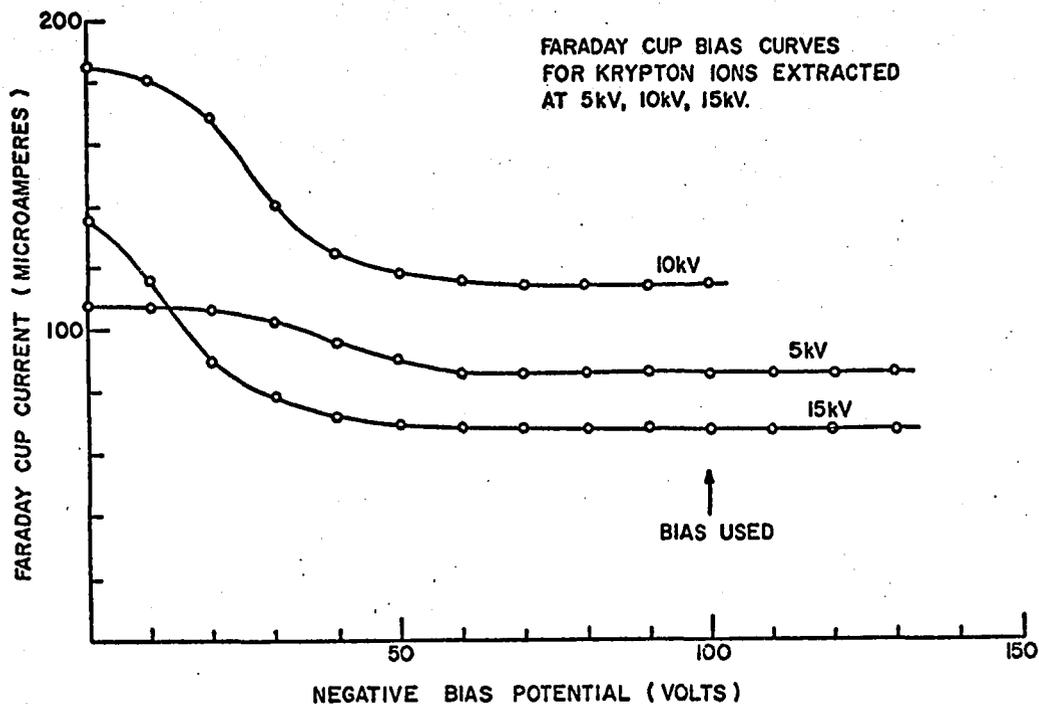
Fig. 38. Typical Faraday Cup Bias Curves.

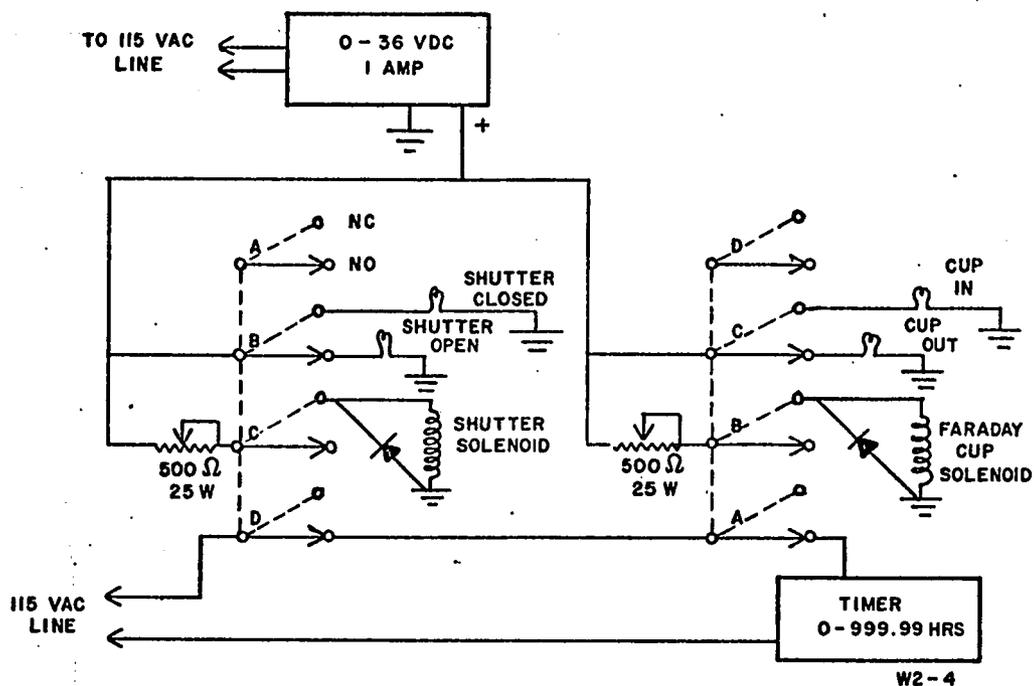
Fig. 40. Shutter and Faraday Cup Control Circuit.

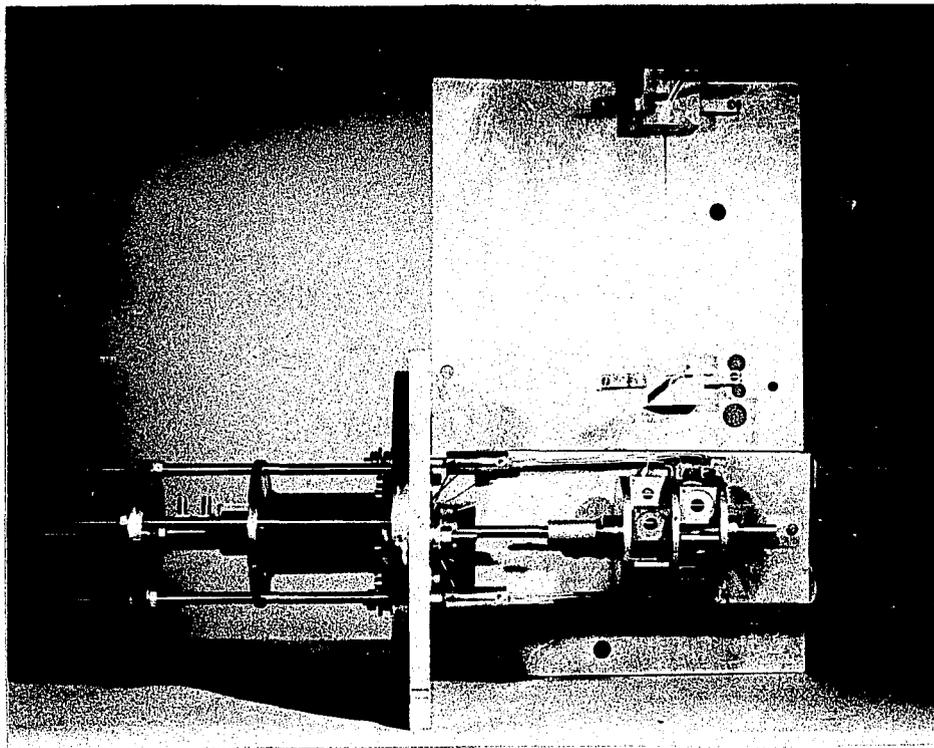
Fig. 41. Target Assembly Flange on Analog Fixture.
Target assembly flange on analog fixture, showing
laser beam pinholes aligned in ion beam direction.

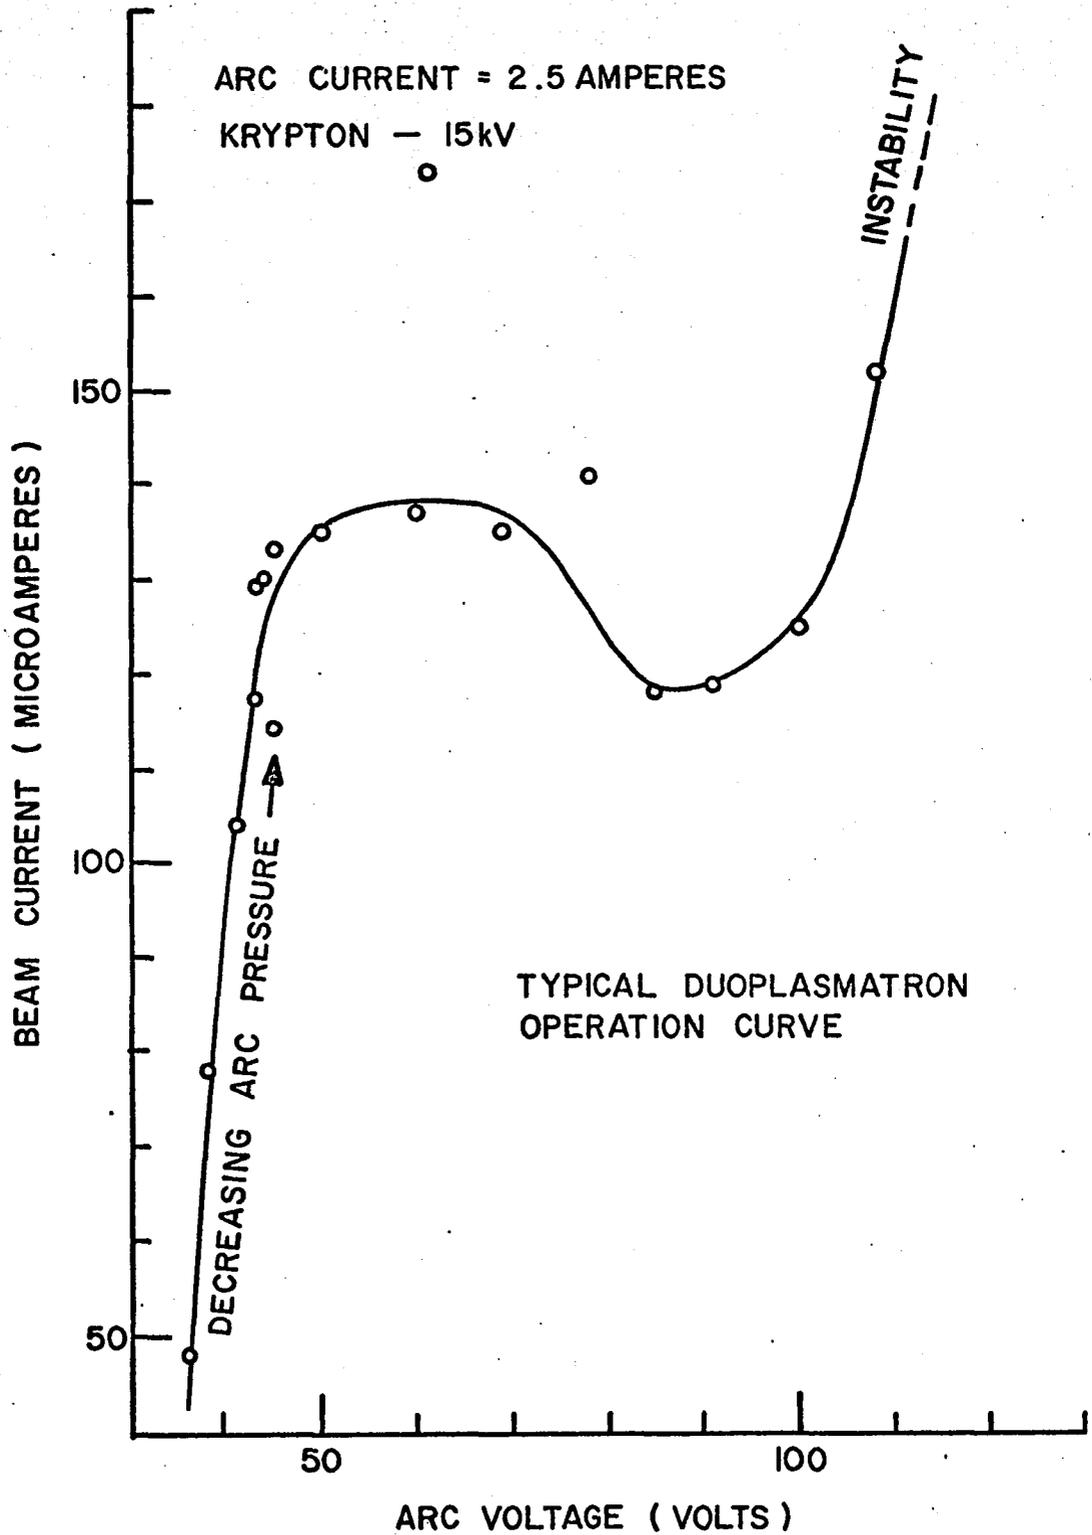
Fig. 43. Typical Duoplasmatron Operation Curve.

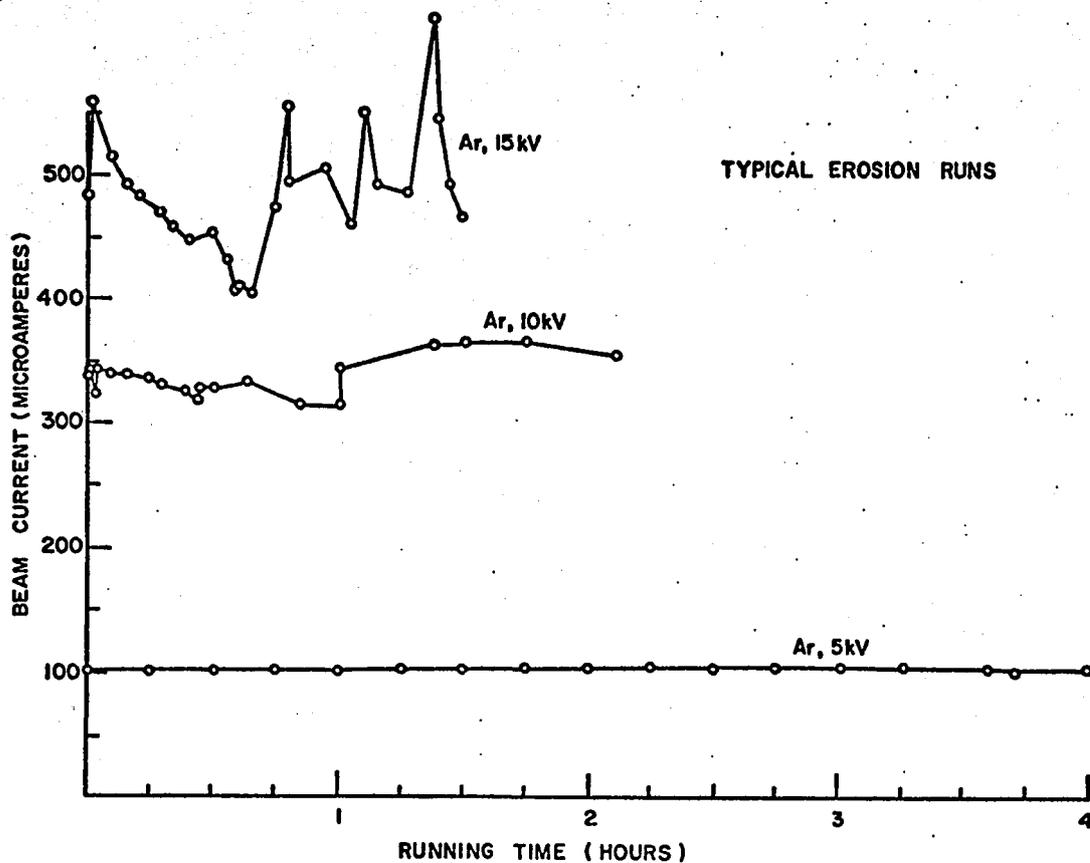
Fig. 45. Typical Erosion Runs.
Ion beam current versus running time for three typical runs, giving some indication of beam current stability.

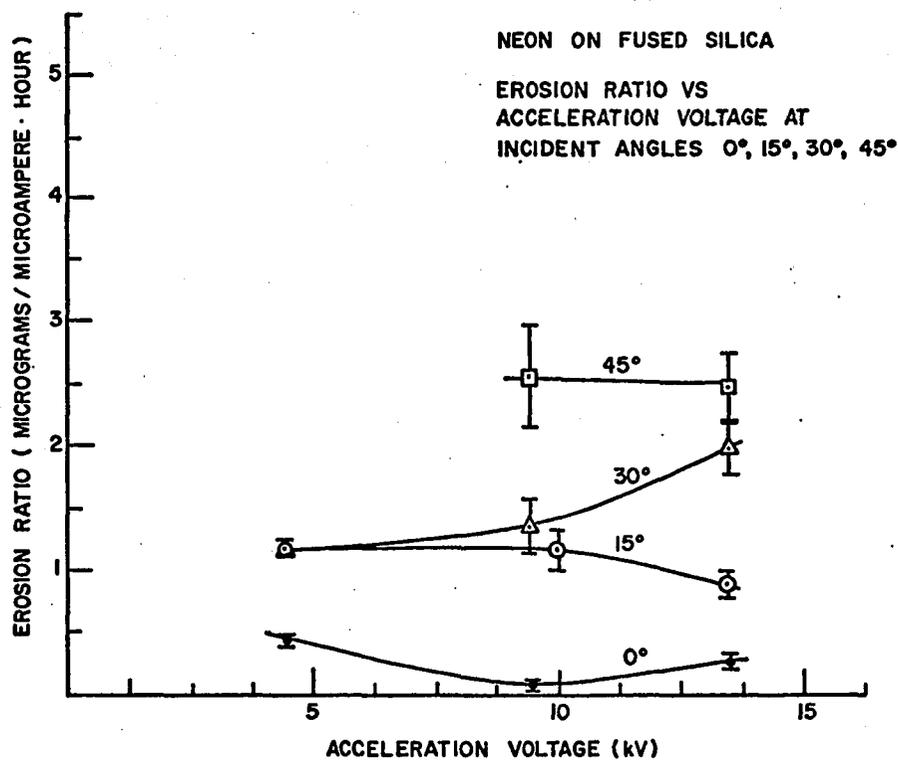
Fig. 48. Erosion Ratio Versus Acceleration Voltage, Neon on Fused Silica.
