WILSON, Raymond Gale, 1932-
IONIC POLISHING OF FUSED SILICA, 5-15 KEV.

The University of Arizona, Ph.D., 1971
Physics, optics

IONIC POLISHING OF FUSED SILICA

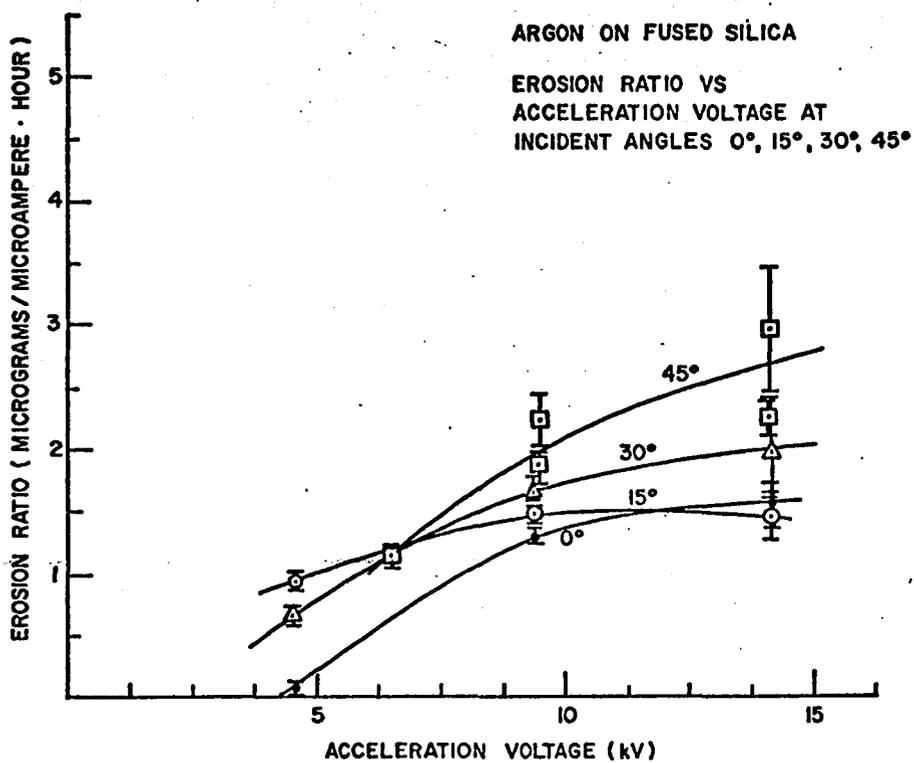
Fig. 49. Erosion Ratio Versus Acceleration Voltage, Argon on Fused Silica.

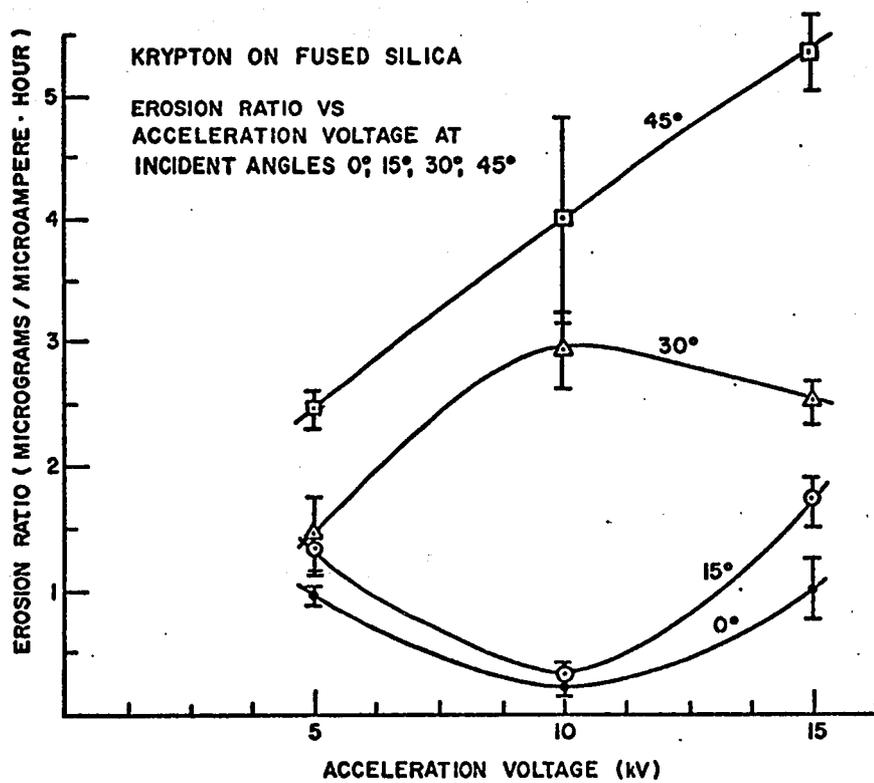
Fig. 50. Erosion Ratio Versus Acceleration Voltage, Krypton on Fused Silica.

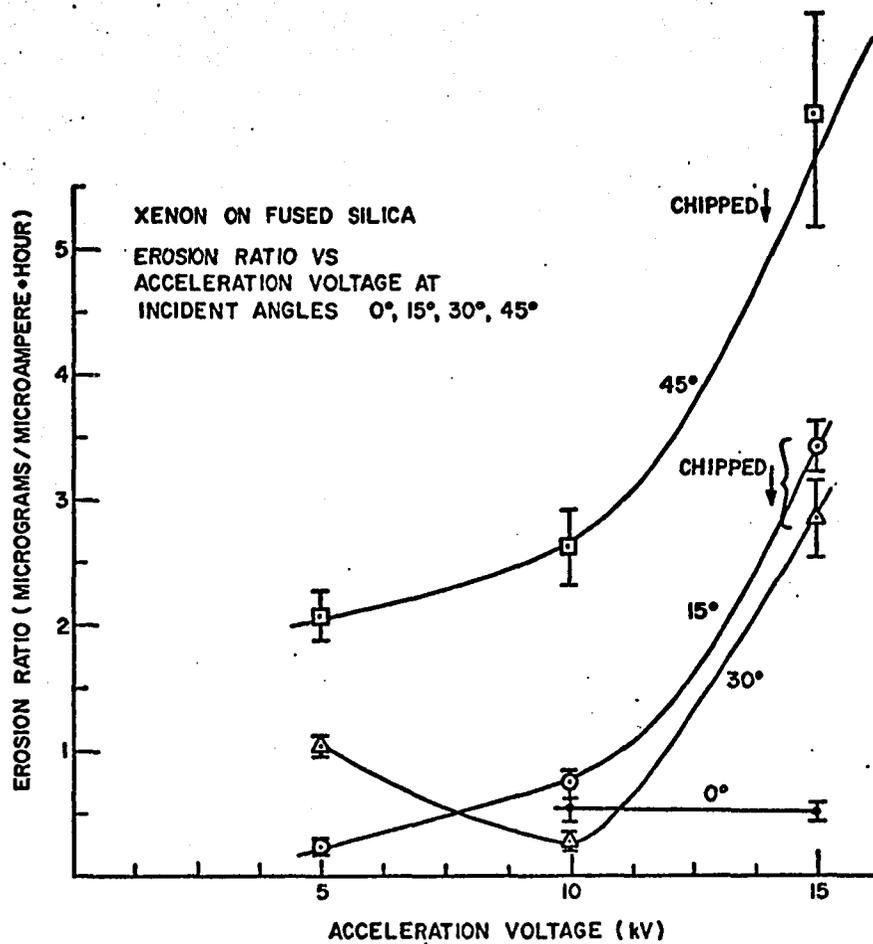
Fig. 51. Erosion Ratio Versus Acceleration Voltage, Xenon on Fused Silica.

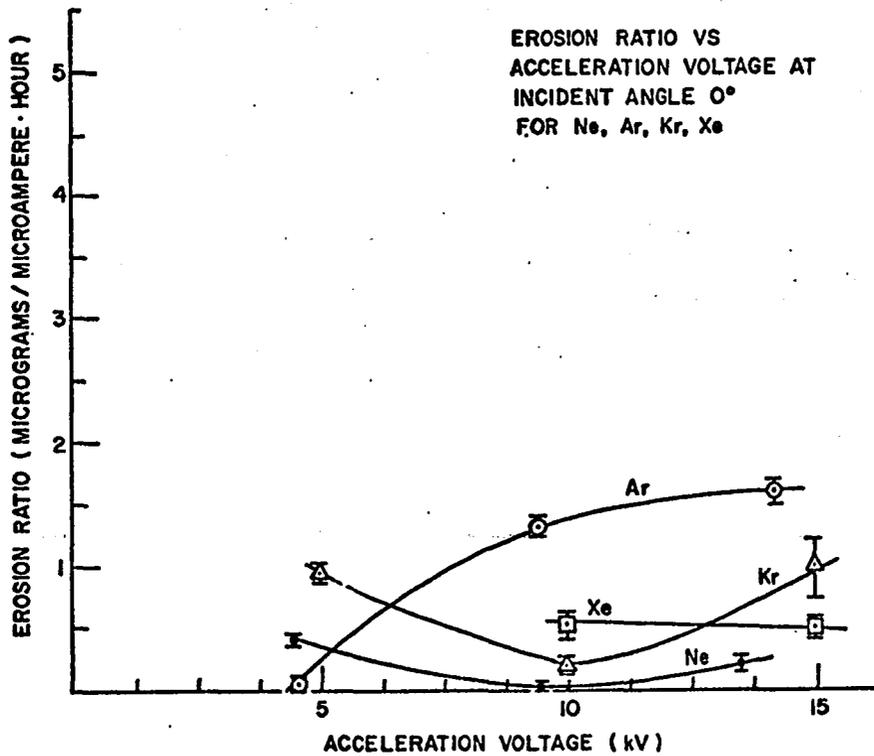
Fig. 52. Erosion Ratio Versus Acceleration Voltage, Angle of Incidence, 0°.

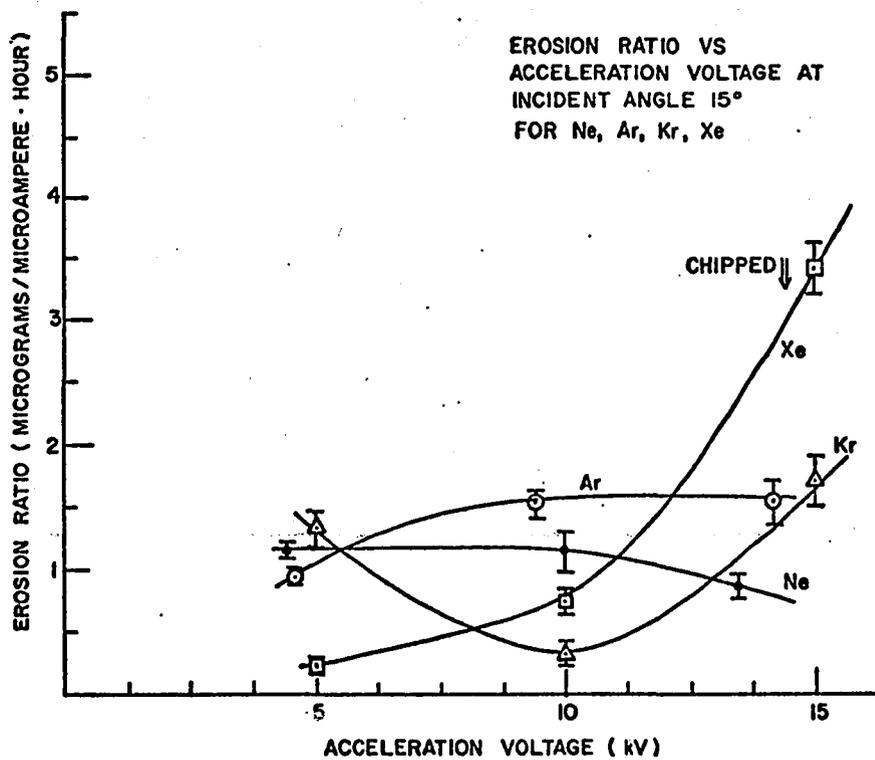
Fig. 53. Erosion Ratio Versus Acceleration Voltage, Angle of Incidence, 15°.

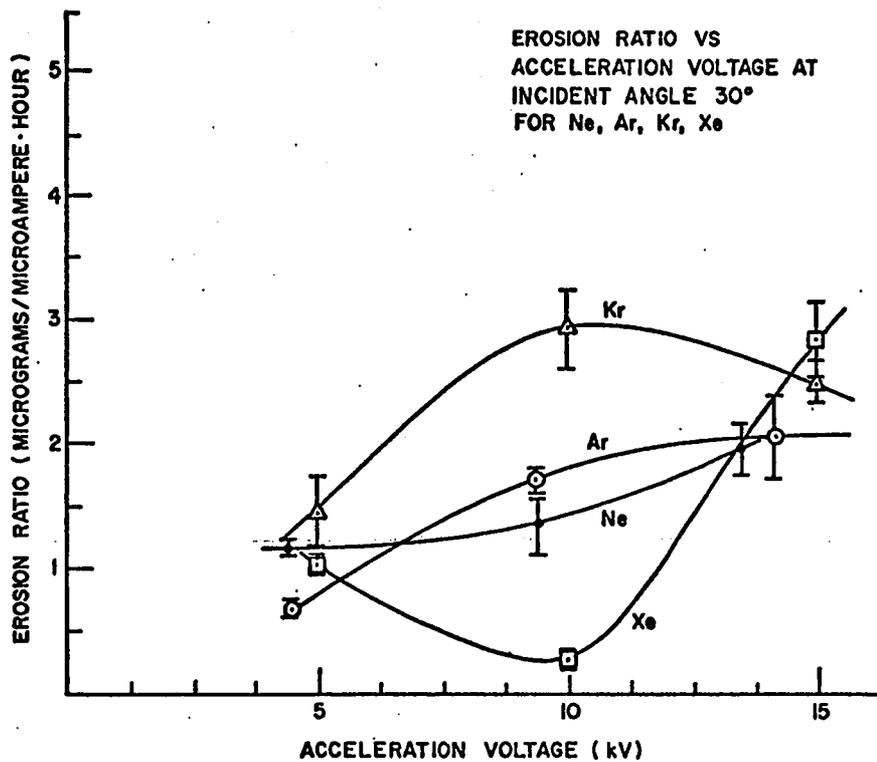
Fig. 54. Erosion Ratio Versus Acceleration Voltage, Angle of Incidence, 30°.

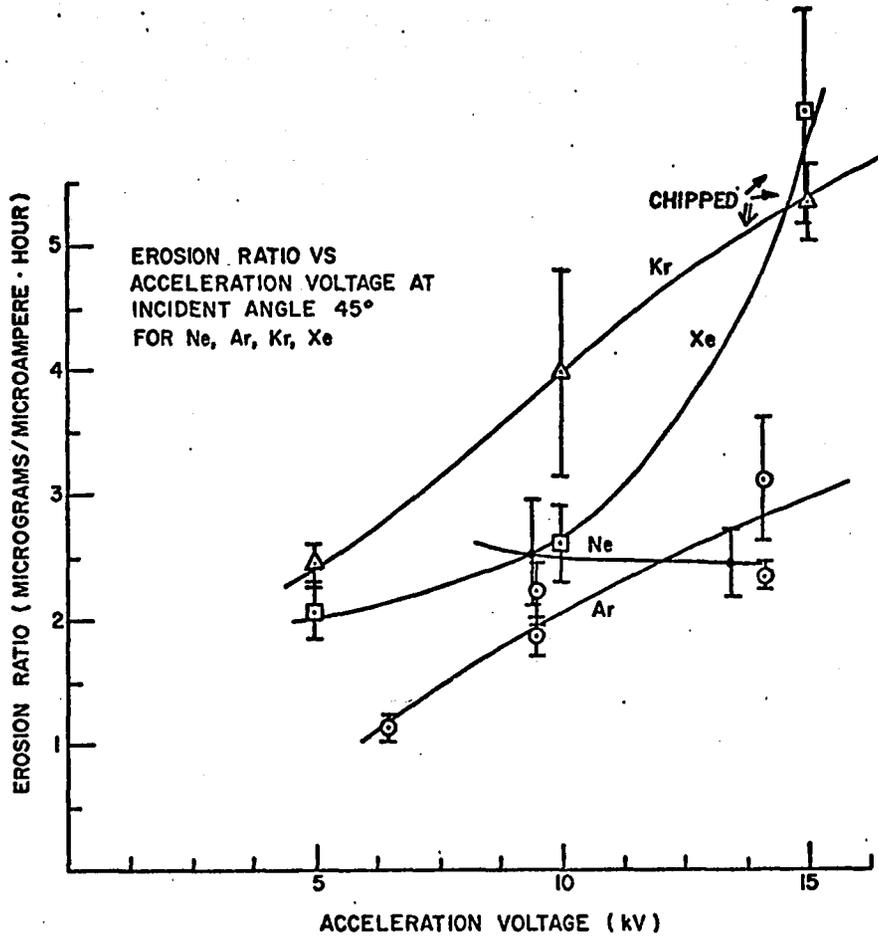
Fig. 55. Erosion Ratio Versus Acceleration Voltage, Angle of Incidence, 45°.

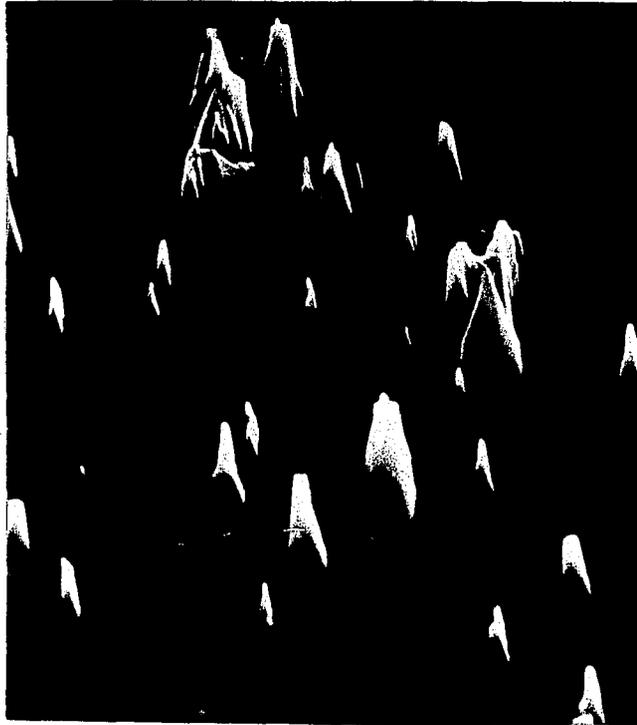
Fig. 64. SEM Micrograph, Fused Silica, 5 KeV, Xenon at 45°, Magnification 3,000X.
