WATER HARVESTING PLAN FOR LIVESTOCK OR HOME

By C. Brent Cluff

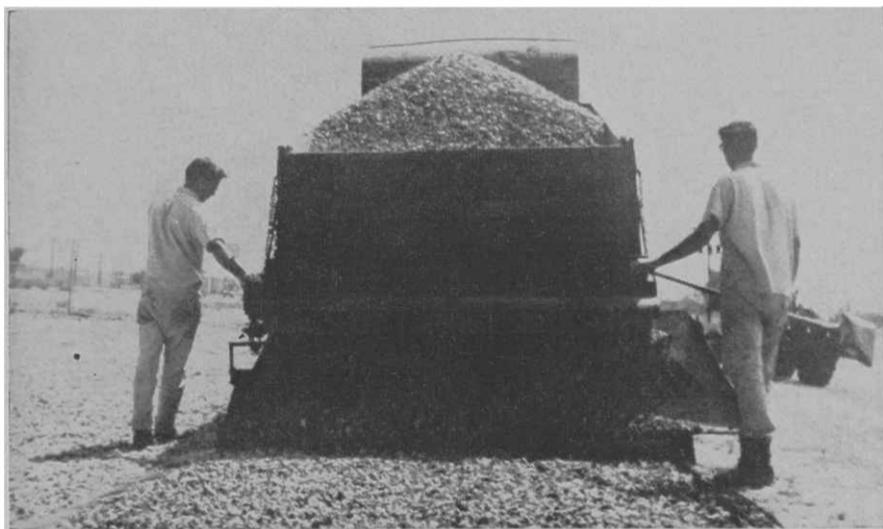
LAYING PLASTIC and covering it with gravel in one operation.

In April, 1965 a plastic-laying gravel spreader was

developed. It was first tested by installing a half acre gravel-covered plastic catchment at the Water Resources Research Center Field Laboratory. The imported gravel was dispensed from a dump truck into a standard spreader box before dropping onto a slide.

Plastic was dispensed under a roller on the lower part of the slide. Four-mil black polyethylene was used with no significant damage to the plastic. Side slopes on the catchment were five percent. Integration of the plastic was accomplished with a six-inch overlap. The estimated cost of the catchment was \$500. The completed catchment is shown in the photo, at bottom of Page 6, following a one-fourth inch rainstorm.

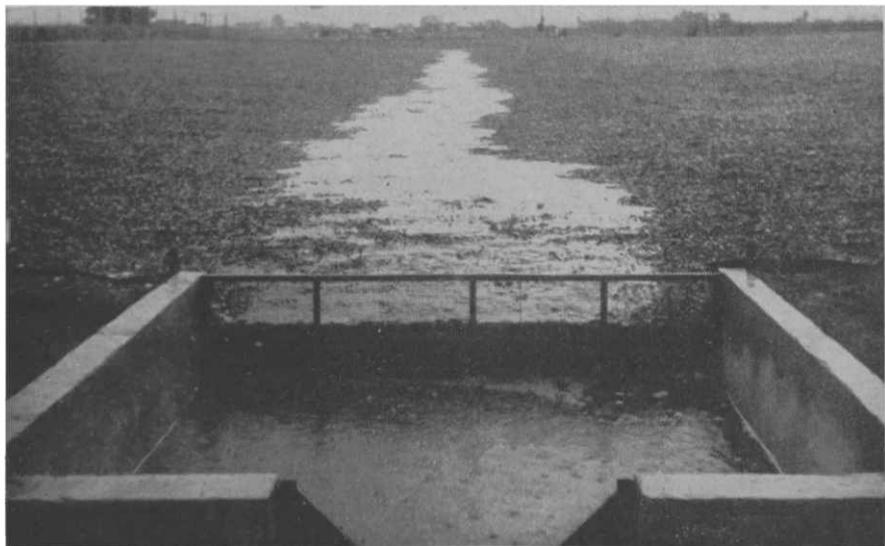
COMPLETED HALF ACRE gravel covered plastic catchment following a quarter inch rainfall.

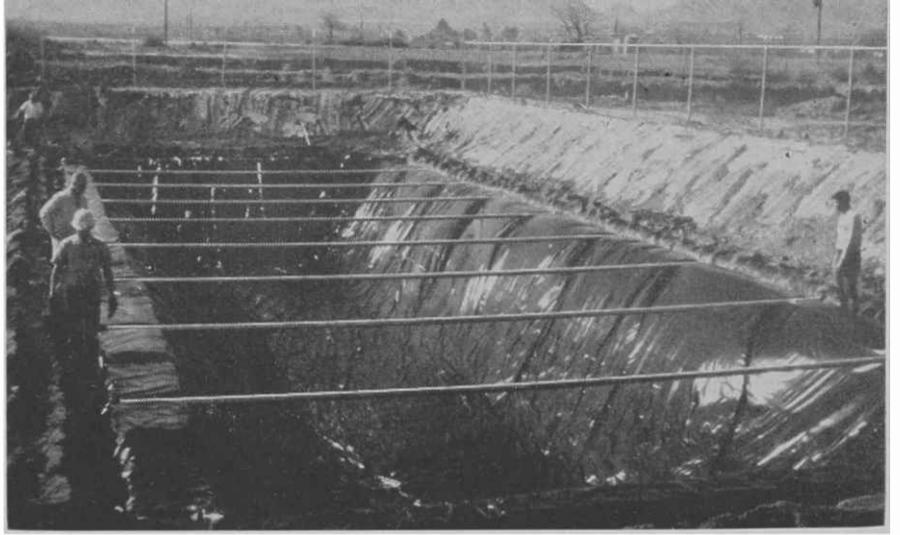
TANK WITH LINER in place, ready for the cover.

Water from the half-acre catchment flows through a 12-inch butyl rubber tube into a 100,000-gallon storage tank. The tank was excavated by using a gradall. Surface dimensions of the tank are 26.5 x 86.0 feet. The tank is eight feet deep, with side slopes of 1:1, making the bottom dimension 10.5 x 70.0 feet. Dimensions of the tank are such that a single 40 x 100 foot sheet of inexpensive six-mil black polyethylene can be used as a liner. This liner is covered with a single sheet of butyl rubber. The rubber cover, which is supported by five-inch aluminum irrigation tubing, prevents evaporation losses and also protects the plastic liner from sunlight. The edges of the cover and liner are secured in a trench around the edge of the tank.

The butyl rubber is equipped with inlet valves so that rain falling on the cover can flow into the tank.

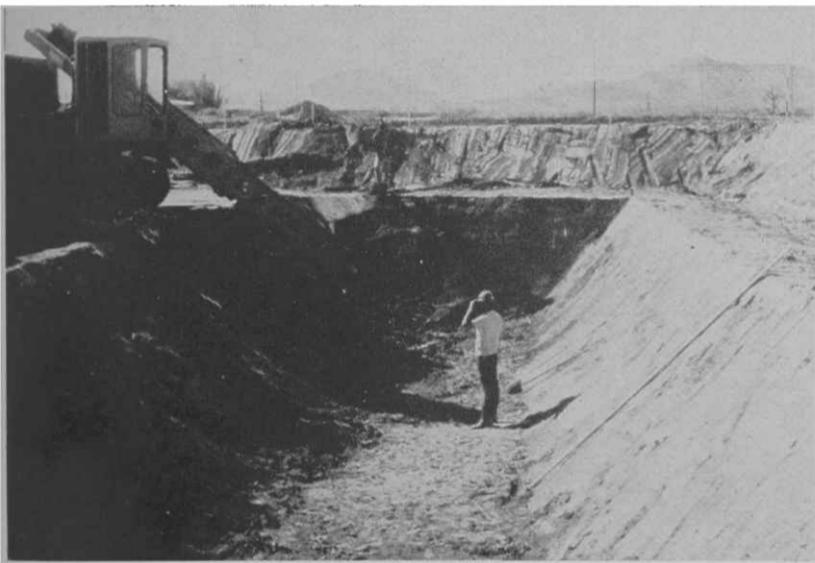
EXCAVATING STORAGE tank with Gradall.

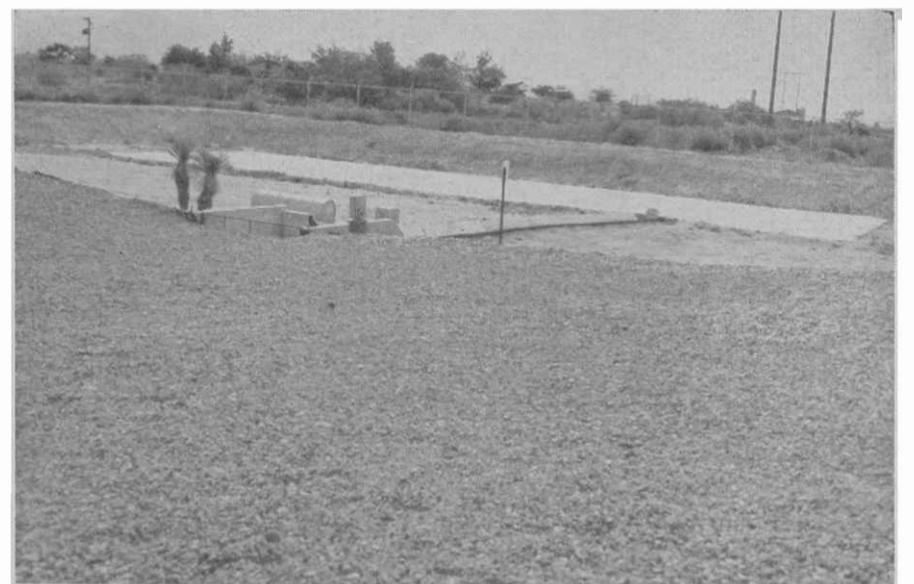
GRAVEL-COVERED plastic catchment in foreground, with completed rubber-covered storage tank in the background.

Thus the tank also serves as part of the catchment. The completed tank was constructed within a period of three working days. A cost analysis of the tank installation is given in the table on Page 7.
