EARTH FISSURING IN THE PICACHO AREA
PINAL COUNTY, ARIZONA

A Thesis Submitted to the Faculty of the
Department of Geology
In Partial Fulfillment of the Requirements
For the Degree of
MASTER OF SCIENCE
In the Graduate College
THE UNIVERSITY OF ARIZONA

1962

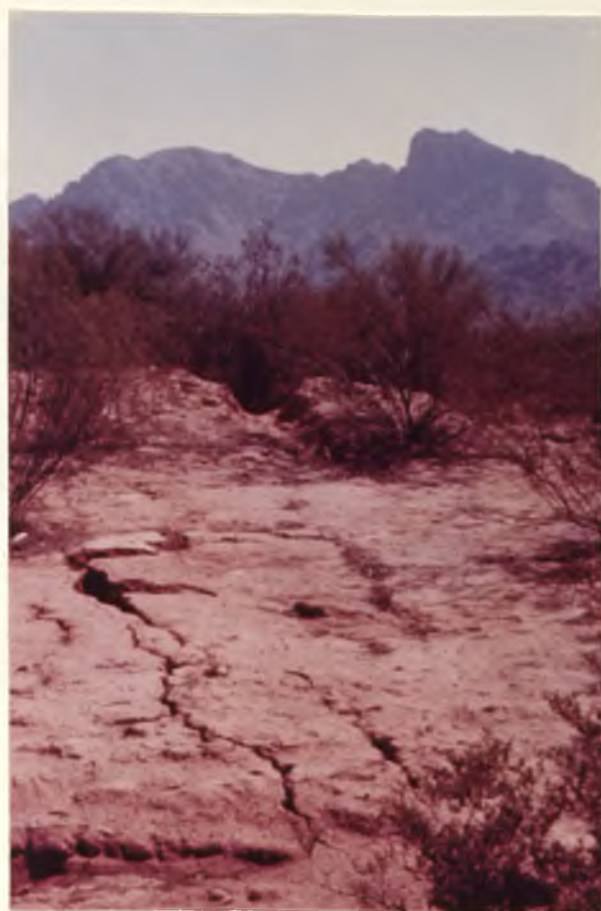
PLATE 1
OLD FISSURE SCARS

Old scars in earth embankment in the background appear
in the same zone with those developed in 1961.

The author first examined the old fissure scars, which were located 3 miles southeast of Picacho, during the fall of 1959 (see Plate 1). At that time the fissure had an inactive, weathered appearance. From 1959 until the latter part of May 1961 there was no new evidence of a break near the old scars; during the last week in May 1961

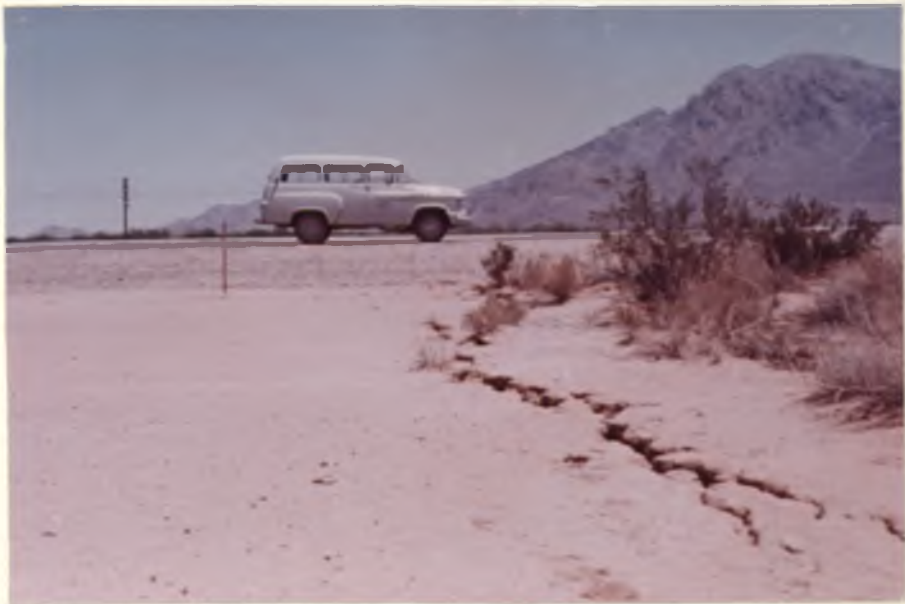
PLATE 2
ELEVATION CHANGE

Careful scrutiny will reveal an abrupt elevation change
near the front wheels of the truck.

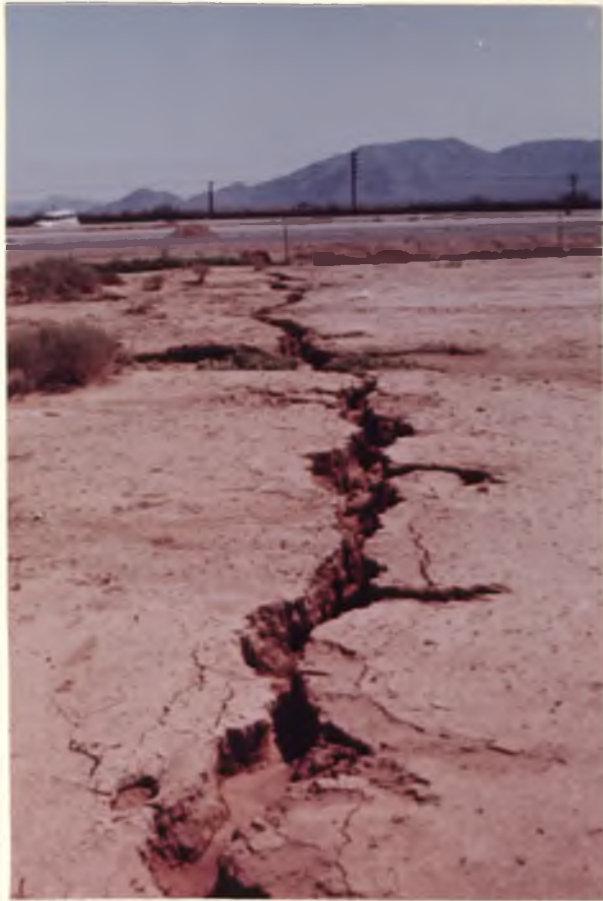
PLATE 3

A fissure located 1 mile SW of Picacho on Highway 84.

This zone may have been active as early as 1949.

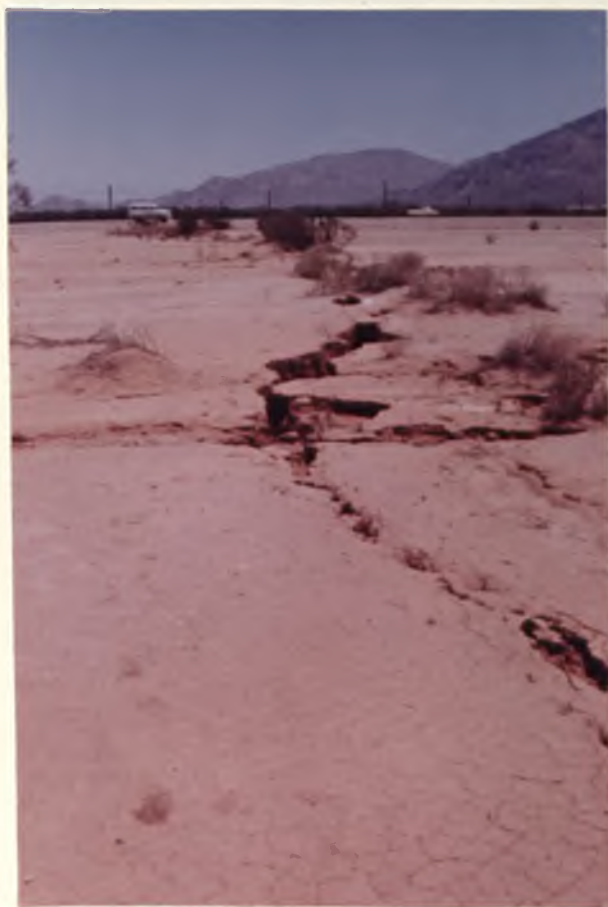
PLATE 4
LARGE OPENING

Large opening along old fissure zone revealed by linear growth of vegetation. Before a torrential rain flooded the area on August 4, 1961, the crack(s) were less than $\frac{1}{2}$ inch wide.

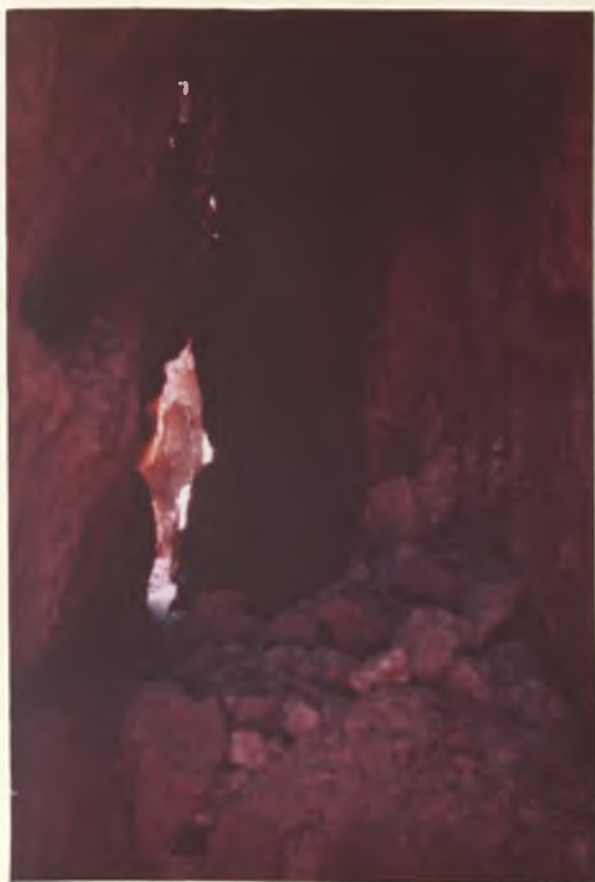
PLATE 5

Photograph taken 10 feet below the surface at the large opening shown in Plate 4. The light area in the background is approximately 4 feet high.

hairline cracks began to appear and by the end of June a narrow ($\frac{1}{4}$ inch average) fissure was visible along the entire length of the old breaks. This fissure had increased from the 1000 feet observed in 1927 to almost 8 miles by 1961. By July 1, 1961 a bump was noticeable on the highway where the fissure intersected it. The highway, now designated as Interstate 10, had been completed in April 1961; the elevation change causing the bump occurred largely during the month of June. A level line run by the author on August 20, 1961 showed that there was an elevation drop of 0.10 foot in a distance of 2.00 feet where the bump was located; this contrasted with a normal gradient of 1 per cent (0.01 foot per foot) at that point. Plate 2, taken on August 5, 1961, visibly illustrates the elevation change described above. On the morning of August 4, the author again examined the fissure 3 miles southeast of Picacho. The earth crack by this time had widened to slightly less than $\frac{1}{2}$ inch in width. On the afternoon of August 4, a torrential rainstorm occurred in the area, causing ponding of water along the highway and railroad southeast of Picacho. Large quantities of water were noted by observers to have entered fissures at two locations, one 3 miles southeast of Picacho and the other 1 mile southeast. On August 5, the breaks as illustrated in Plates 3 and 4 were from a few inches to several feet in width. Plate 5, which was taken about 10 feet below the ground surface at the large opening shown in the foreground of Plate 4, illustrates the magnitude that the breaks may attain; the opening in the background (overexposed area in photograph) was approximately 4 feet in height.

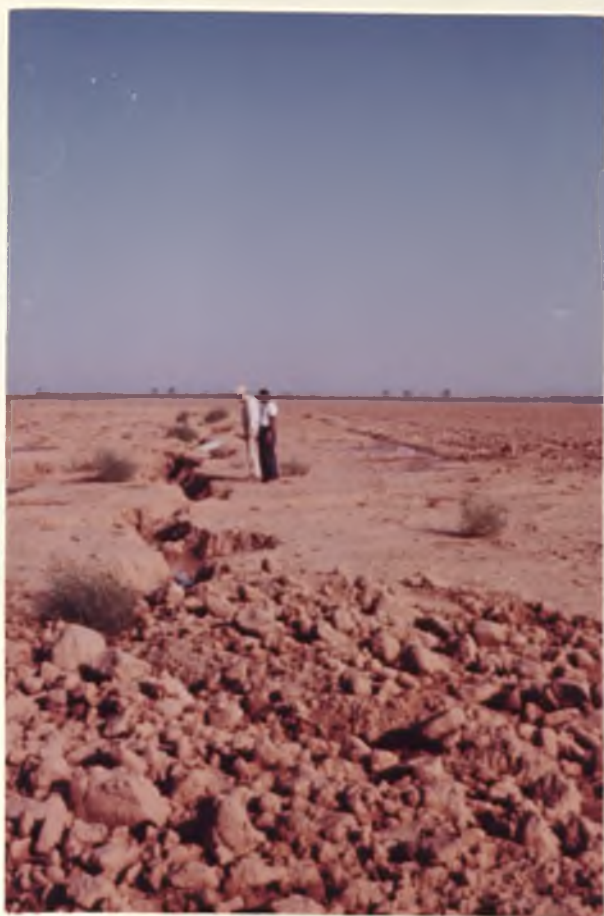
PLATE 6

A fissure which appeared in a cotton field in the late
1950's. Attempts to reclaim the land have failed to date.

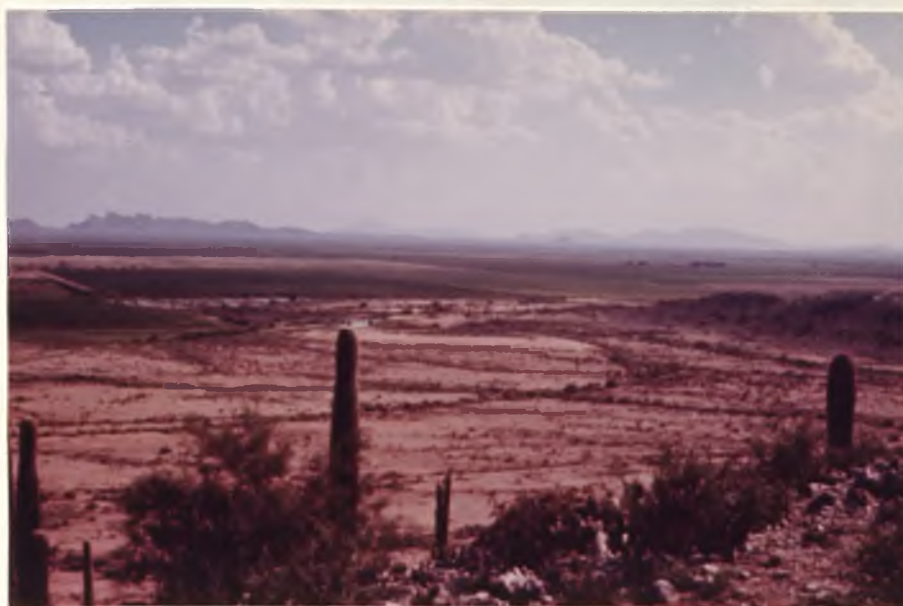
PLATE 8

View from a prominence on the southeast part of the Casa Grande Mountains. Note the close conformity of the fissures to the mountain front. Gravity anomalies indicate that the basement rock has a shallower slope on this side of the basin.

Plate 8 was taken from a prominence on the southeast side of the Casa Grande Mountains. These fissures were studied by Pashley (1961).
