SLOPE STABILITY OF THE TRIPP PIT NEAR ELY, NEVADA

A Thesis Submitted to the Faculty of the  
DEPARTMENT OF MINING AND GEOLOGICAL ENGINEERING  
In Partial Fulfillment of the Requirements  
For the Degree of  
MASTER OF SCIENCE  
WITH A MAJOR IN MINING ENGINEERING  
In the Graduate College  
THE UNIVERSITY OF ARIZONA

1 9 7 8

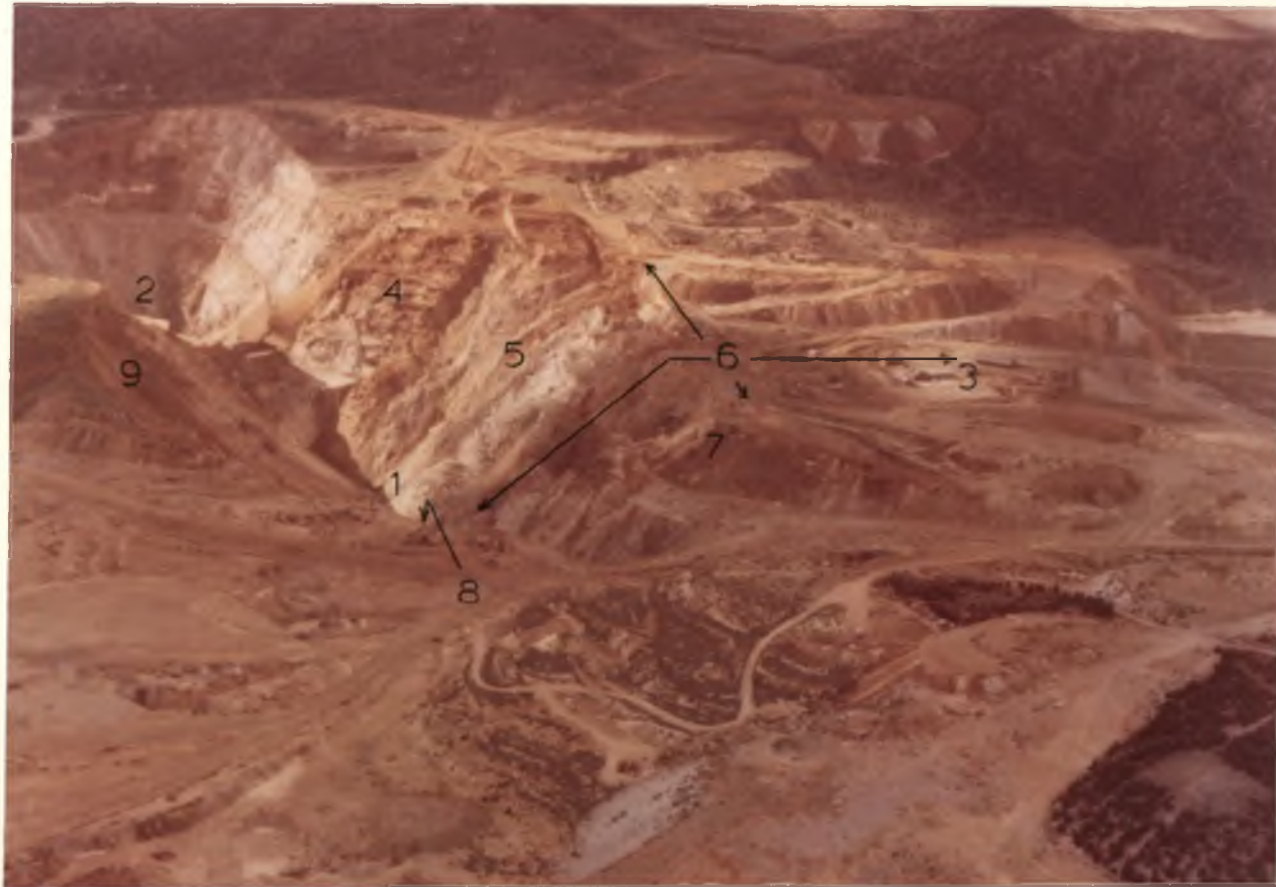
Figure 2. Aerial photograph of the Tripp Pit area

**Figure 2. Aerial photograph of the Tripp Pit area**

**Key to location of features:**

1. Tripp Pit
2. Veteran Pit
3. Shop area
4. Northwest Tripp slide
5. Transition zone
6. Northeast Tripp slide
7. Morris slide
8. Richards slide (below pit rim, not in photograph)
9. Southwest Tripp slide

The eastern corner of the pit has been backfilled and has no failures in it. The south side has two distinguishable failures. On the far eastern side just before the backfilled material is the Richards slide, and on the western portion of the south side is the Southwest Tripp slide (SWTS), which has involved about 800 feet of the pit rim. Between these two slides is a relatively stable section of pit wall that has a few small (less than 50,000 tons) failures, which involve only a few benches. Table 9 lists the important features of each of the main identifiable failures, and the failures are shown on Figure 2.

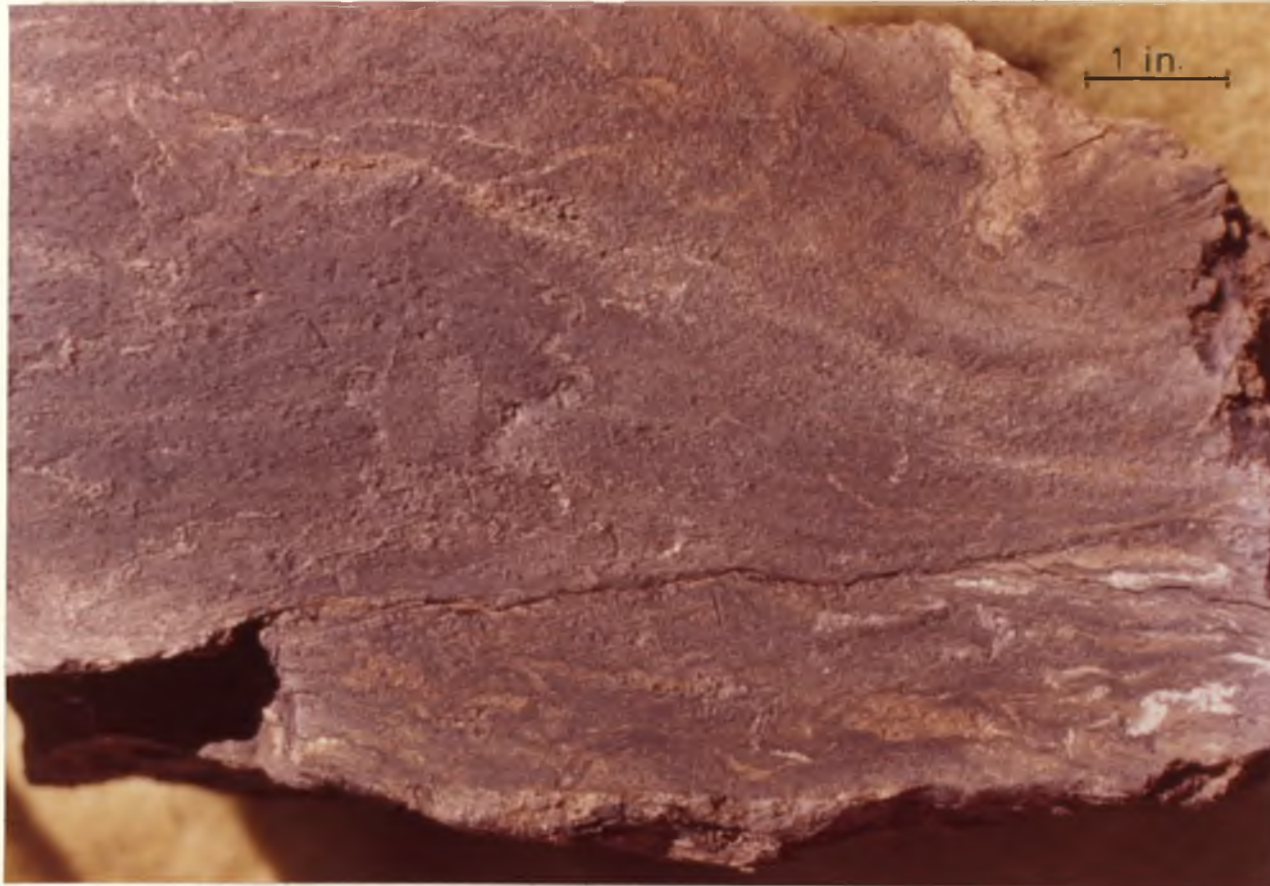
Figure 5. Fault gouge

gouge are usually not in contact with each other. This texture is here described as "floating." The matrix is generally a black to grayish-black clay. Where sulfides have been oxidized, this clay has been observed to have a tan-brown appearance probably due to limonites within it. Figure 5 is a photograph of some typical Tripp Pit gouge used for the shear tests.

An interesting phenomenon was observed in the small-scale laboratory direct shear test of this fault gouge. For one test a core sample 1.3 in. in diameter was precut along the shearing surface. The shearing did not occur along this prepared surface. Instead, the sliding occurred along a weaker cup-shaped zone existing approximately 0.1 in. below this cut surface. This occurred several times on different specimens. At confining pressures between 250 and 450 psi, the precut zone usually rehealed, and only the sliding surface, which may or may not have been the precut surface, could be identified. Expanding this concept to a large 20-foot gouge-filled fault, the shearing will occur along the weakest zone within the fault. There is no reason why shearing would not occur along many of these weaker zones within a fault with the differences in movement between these zones being taken up by the multitude of smaller crosscutting subfaults with the main zone and the plastic flow within the gouge. If the zone could be extensively sampled and these samples subjected to shearing tests, the average shear strength of all samples may not be that of the zone itself for this reason. The actual strength could conceivably be close to the strength exhibited by only the weakest samples. This may be one explanation why the

tested shear strength of the fault gouge in the Tripp Pit was slightly higher than the back-calculated strength from the actual failures.

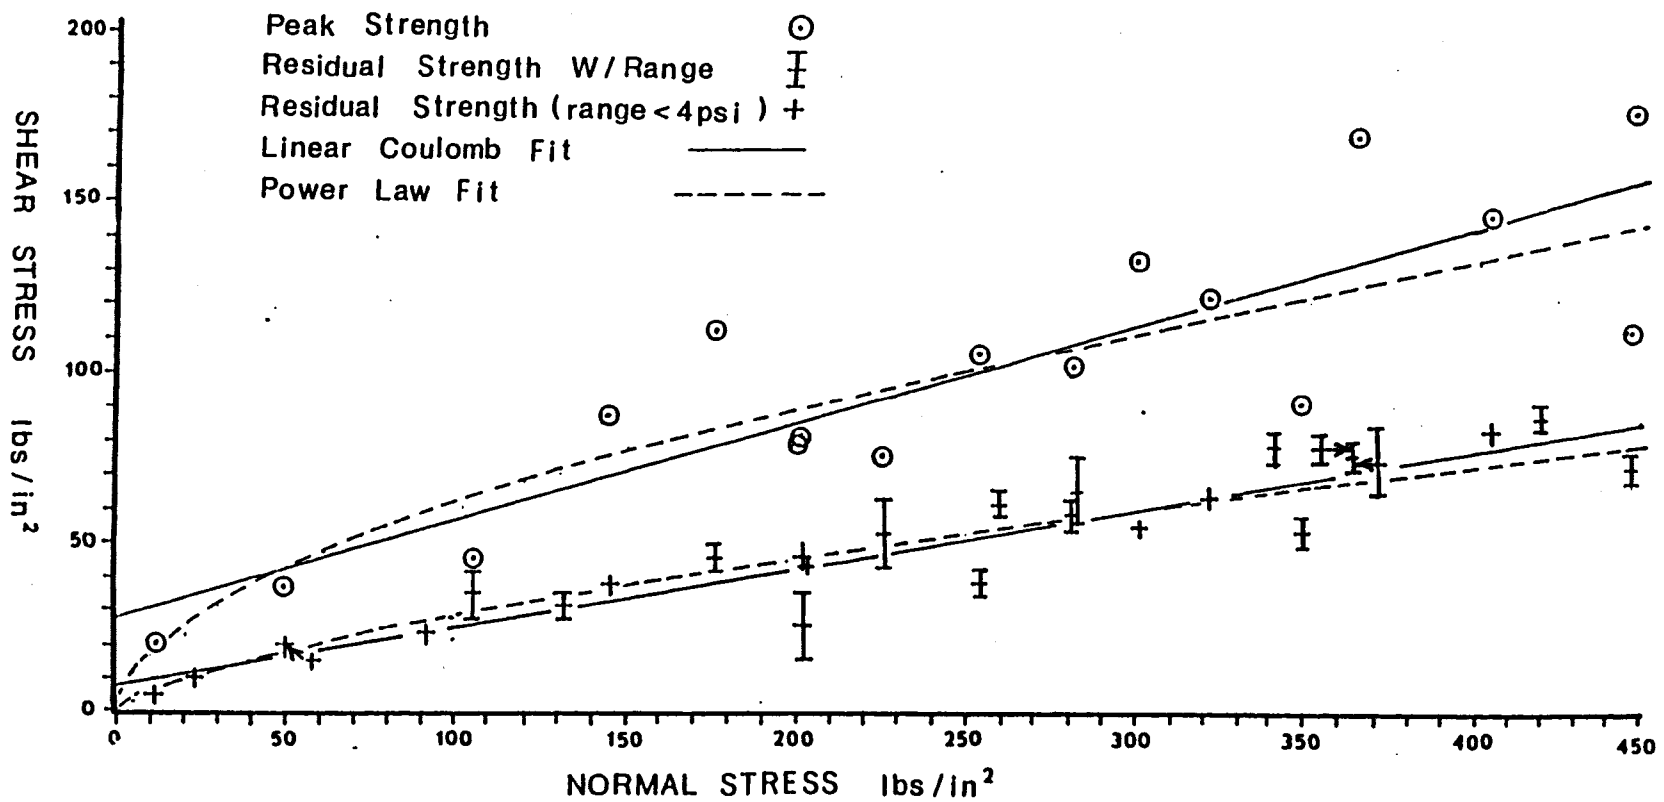
Figure 7. Tested and predicted strengths of Tripp fault gouge

The results of all the tests can be analyzed by plotting the normal stress versus the shearing stress as was done in Figure 7. As can be seen, the peak strength of the gouge was roughly twice the residual strength. Using Coulomb failure criteria to evaluate the data, a linear regression on the peak and residual shear strengths yielded the results shown in Table 6.

Coulomb failure criteria may not be the best way to represent the shear strength of the gouge. Jaeger (1971) noted that the power law tends to fit data that turn down at the lower normal stresses. As can be seen in Table 7, the power equation does fit the data slightly better than a linear equation.

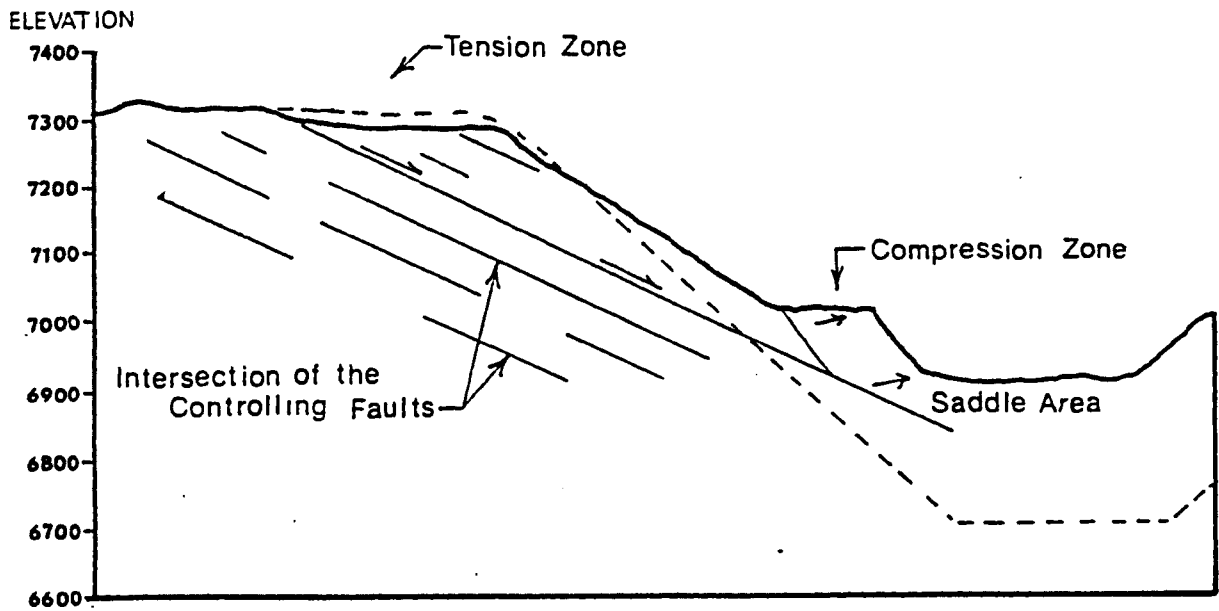
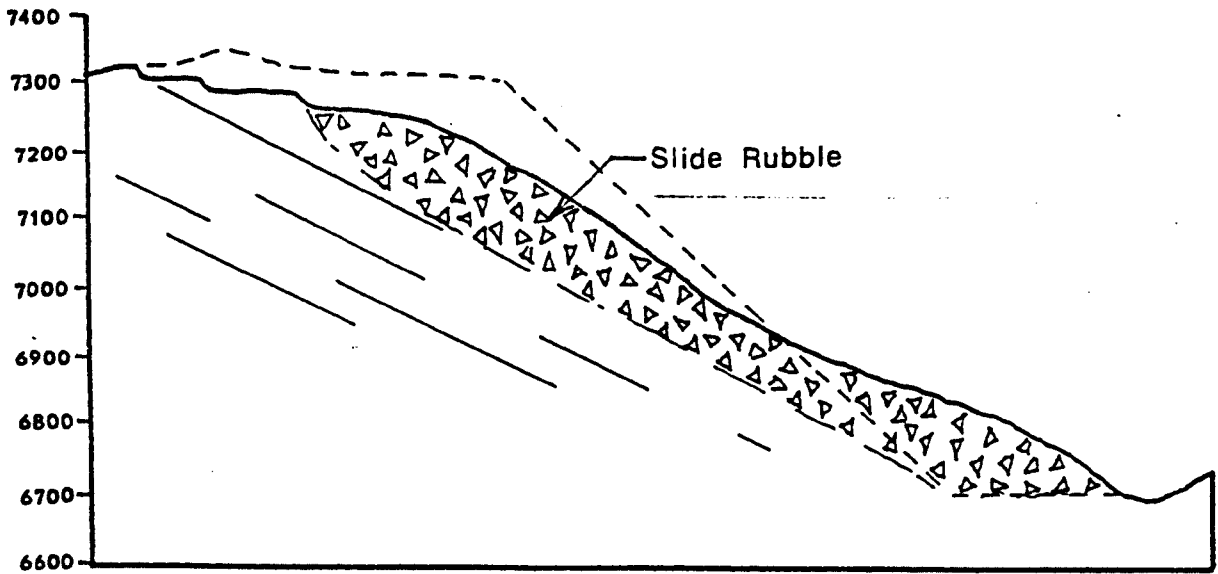
Figure 10. Schematic cross section of the Northwest Tripp slide illustrating slide development

INITIAL STAGE , 400 ft VERTICAL RELIEF

SECOND STAGE , 600 ft VERTICAL RELIEF

CROSS SECTIONS LOOKING EAST , SCALE 1 in. = 300 ft

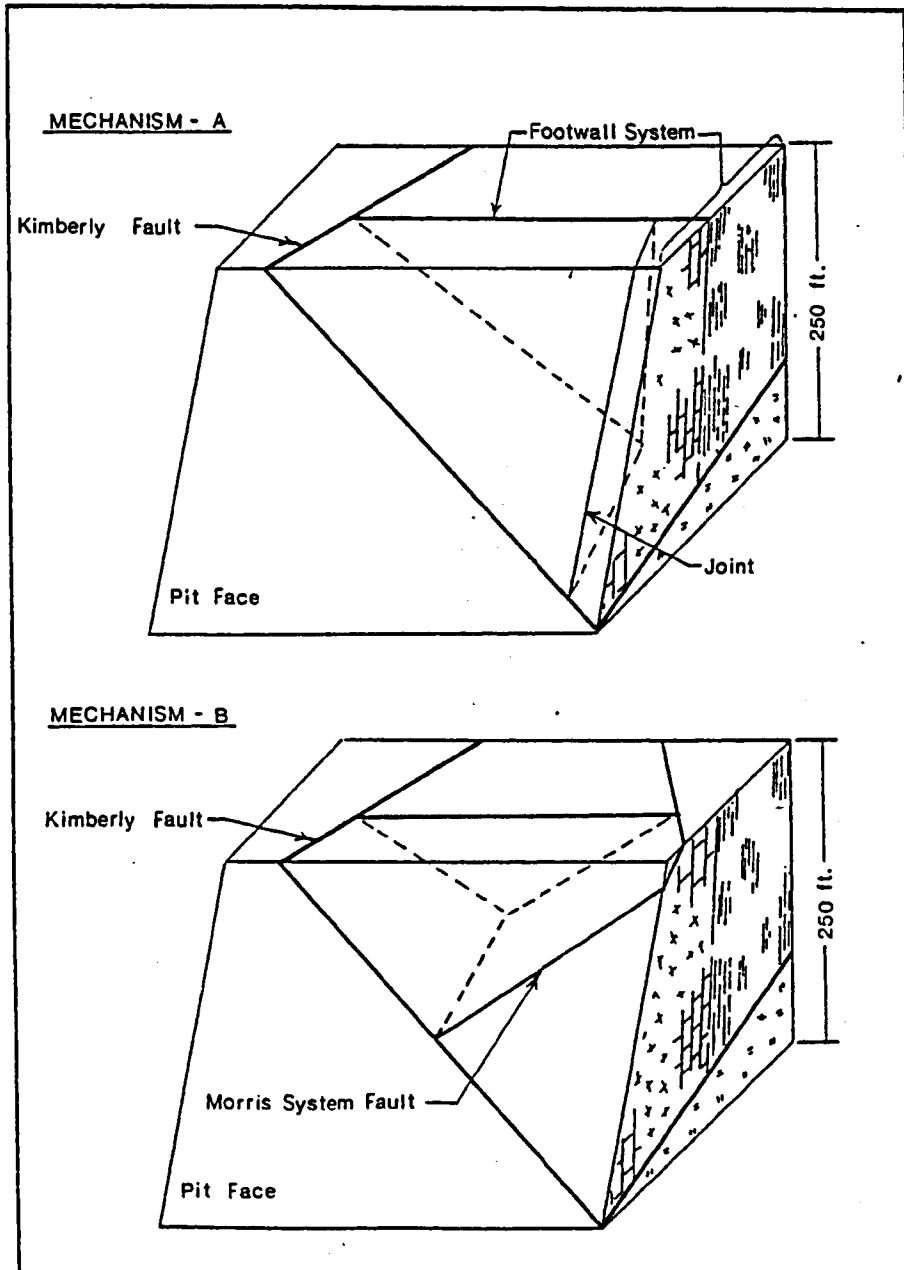
Figure 11. Block diagrams showing possible failure mechanisms for the transition zone.

The area just west of 95,000 E., which has been very active in the last 7 years, has a very complex failure mechanism. The two block diagrams in Figure 11 illustrate two possible mechanisms.

Mechanism A is the intersection of the Kimberly fault and the Footwall fault system, which plunges S.  $15^{\circ}$  E. at  $32^{\circ}$  but does not

intersect the pit face. To fail, one of the many steeply dipping, northeast-striking joint sets needs to be included in the mechanics. In the Tripp Pit the failure that is believed to be caused by this mechanism resembles a toppling failure. As the block started to move a graben formed behind it on the footwall system. This graben, acting as a nearly vertical, gravity-driven wedge, would force the upper portion of the block to move faster than the lower portion. Another explanation could be that as the block moved past the pit face its leading edge became supported by only the rubble material already on the face. The tension caused by this broke off the leading edge, which was rotated forward by additional rubbleized rock falling in behind the break. This is similar to the overturning failure of a retaining wall.

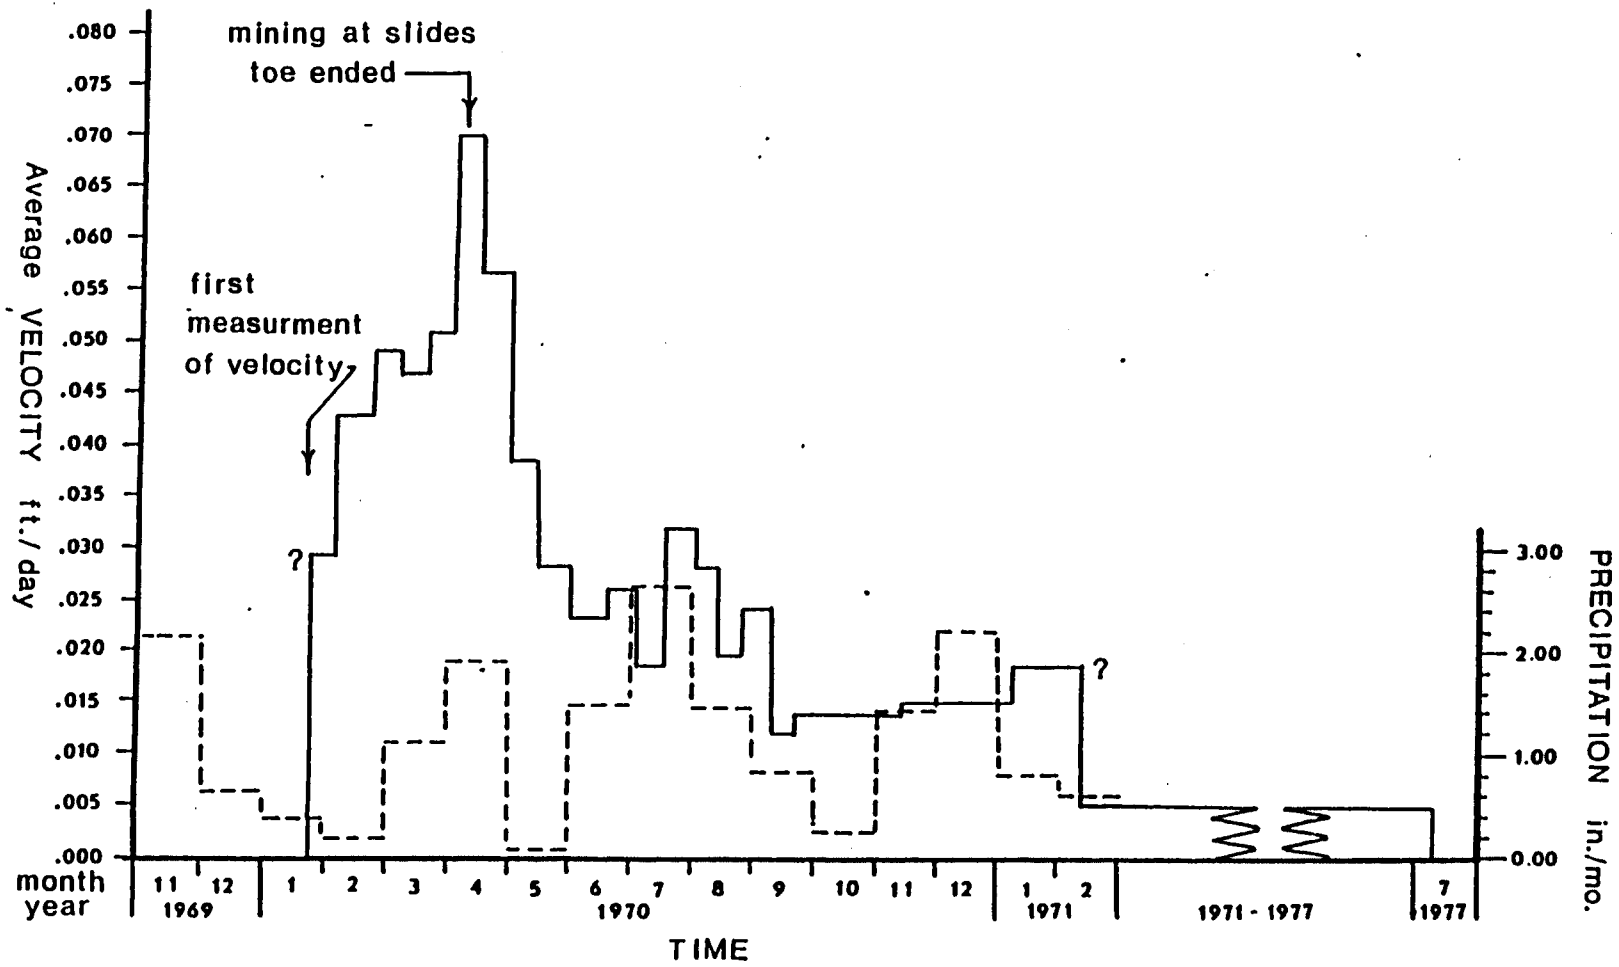
Figure 12. Precipitation and wedge velocity of the Northeast Tripp slide over time

During the failure's most active period (first half of 1970), the Bureau of Mines initiated a microseismic investigation (Merrill and Stateham, 1970). The highest seismic noise rate was recorded in April 1970, which corresponded to the failure's highest velocity. After May 1970, both the noise rate and the velocity decreased rapidly (Fig. 12).

The overall movement of the NETS and the differential movement within the slide can be better understood than movement in other failures in the Tripp Pit because a survey net consisting of 27 stations was established. These points were monitored bimonthly from February 1970 to February 1971 during the slide's most active period. For my study, the survey net was resurveyed in July 1977 and the total movement to date determined. The data have been presented in vector form on Figure 3 for the first year (February 1970 to February 1971) and on Figure 8 for the accumulated movement to date (February 1970 to July 1977).

For the poorly drained north side of the Tripp Pit, the maximum amount of water over a period of a year may also be important. During 1969, 16.35 inches of precipitation were recorded. Then in 1970 the largest of the north-wall slides became noticeably active (Dimock, 1970). Although many other factors, such as mining activity around the toe of the slide, may have been the main cause for this failure's occurring at this time, the large amount of precipitation the previous year cannot be ignored.

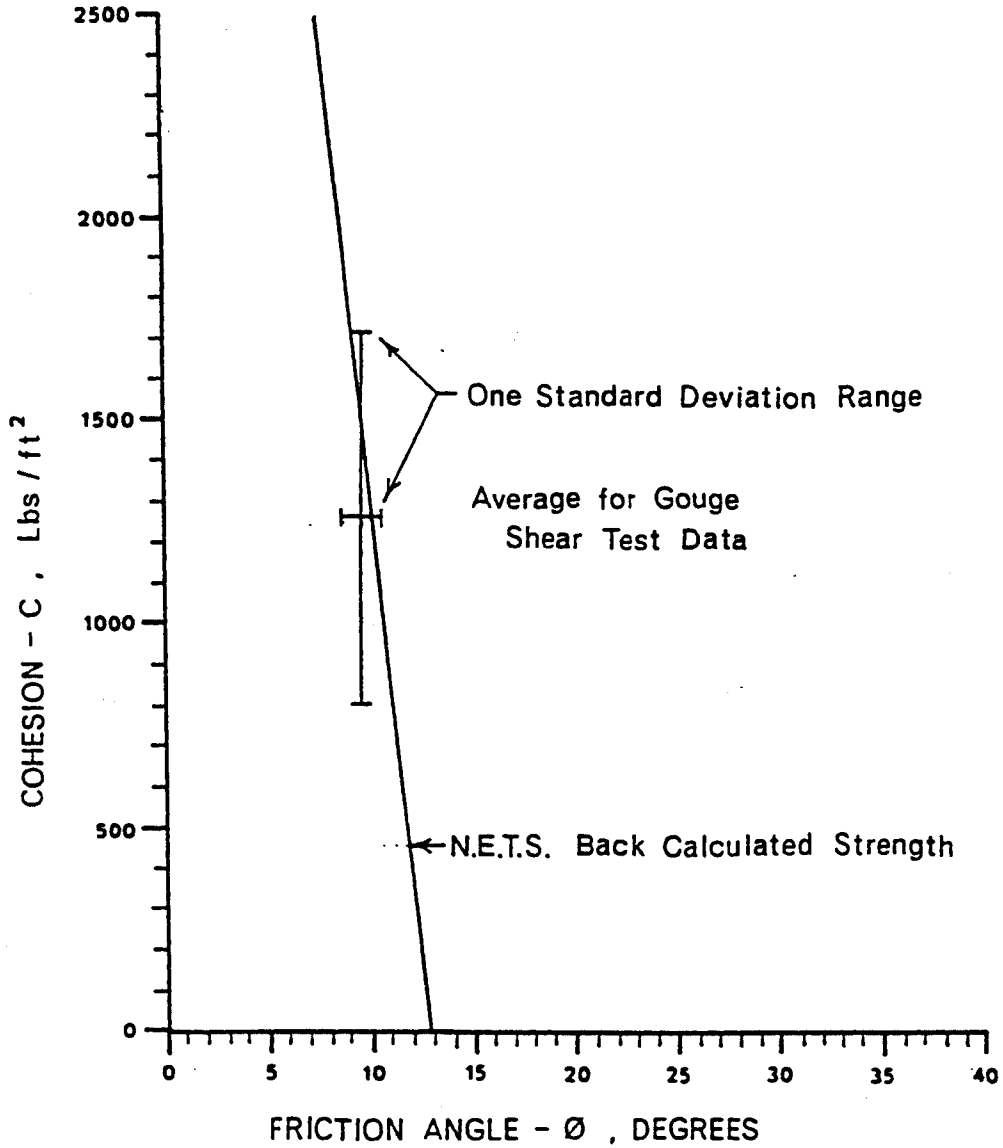
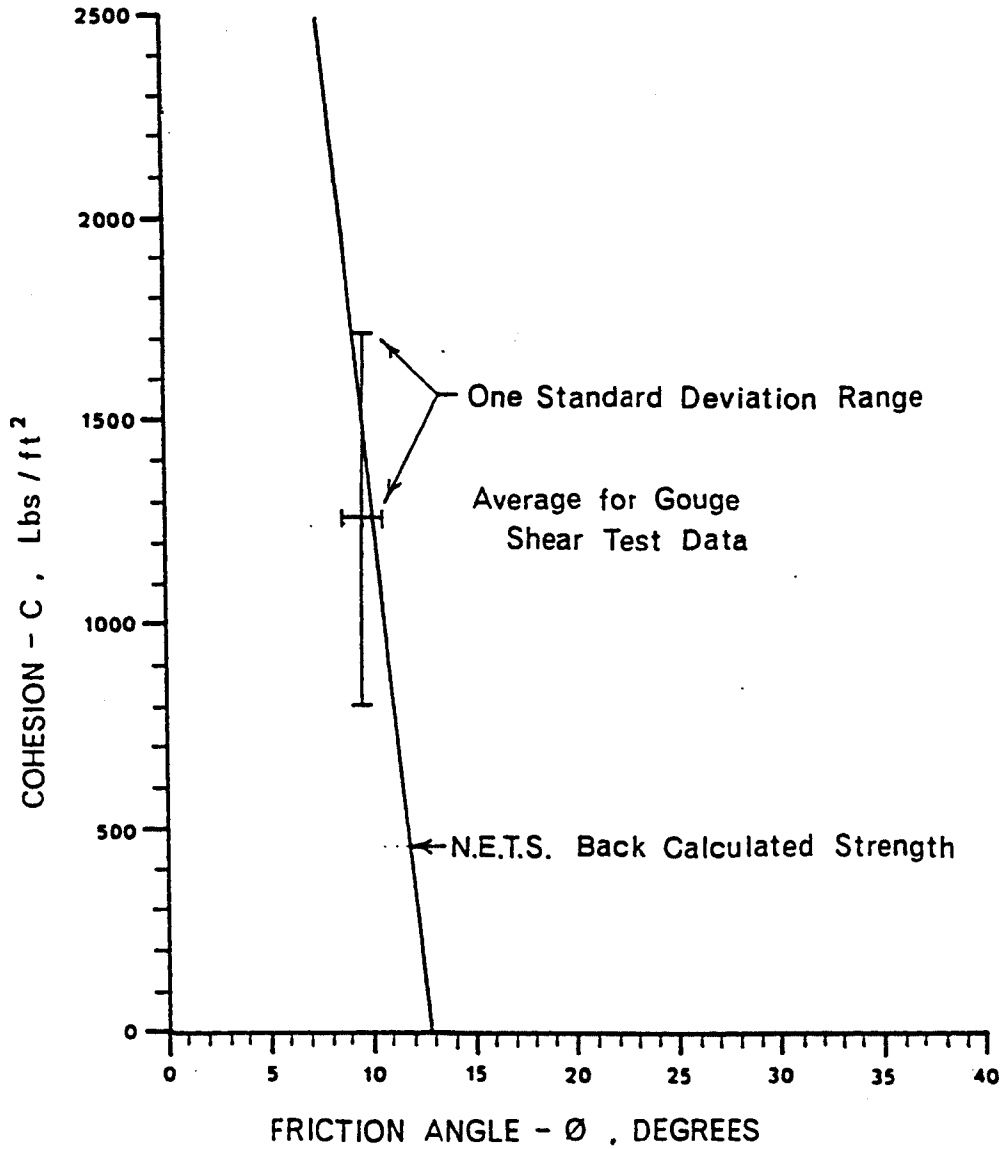
Figure 13. Back-calculated and tested shear strength for the Northeast Tripp slide

Back-calculated vs. Tested Strength. On Figure 13 both the back-calculated strength (assuming equal friction angles and cohesion for the two controlling faults) and the average strength calculated from the direct shear testing of the clay fault gouge are plotted. As can be seen, both strengths compare very favorably, especially when the standard deviation statistics of the shear data is considered. In addition, the back-calculated strength is very sensitive to the orientations of the two controlling structures. Changes in the strike or dip of either fault could change the back-calculated friction angle. The accuracy of the structural interpretation for the Kimberly and Morris faults is believed to be good but not to within one or two degrees of either strike or dip.

The question arises as to why the tested residual strength of a thick fault zone should be more representative of that zone's effective strength than the tested peak strength of the fault gouge. As shown in Figure 5, the gouge is far from homogeneous. Within the zone there can be expected to be subzones in which the gouge is weaker. This could be where movement last occurred on the fault. For most of the test samples, the peak shear force was roughly twice the residual strength. The exception was sample 2-6 (tested at 227 psi normal pressure, see Appendix A). The peak and residual strengths of this sample were almost equal, suggesting that subzones existed within the tested samples where this was true. Skempton (1964) came to a similar conclusion.

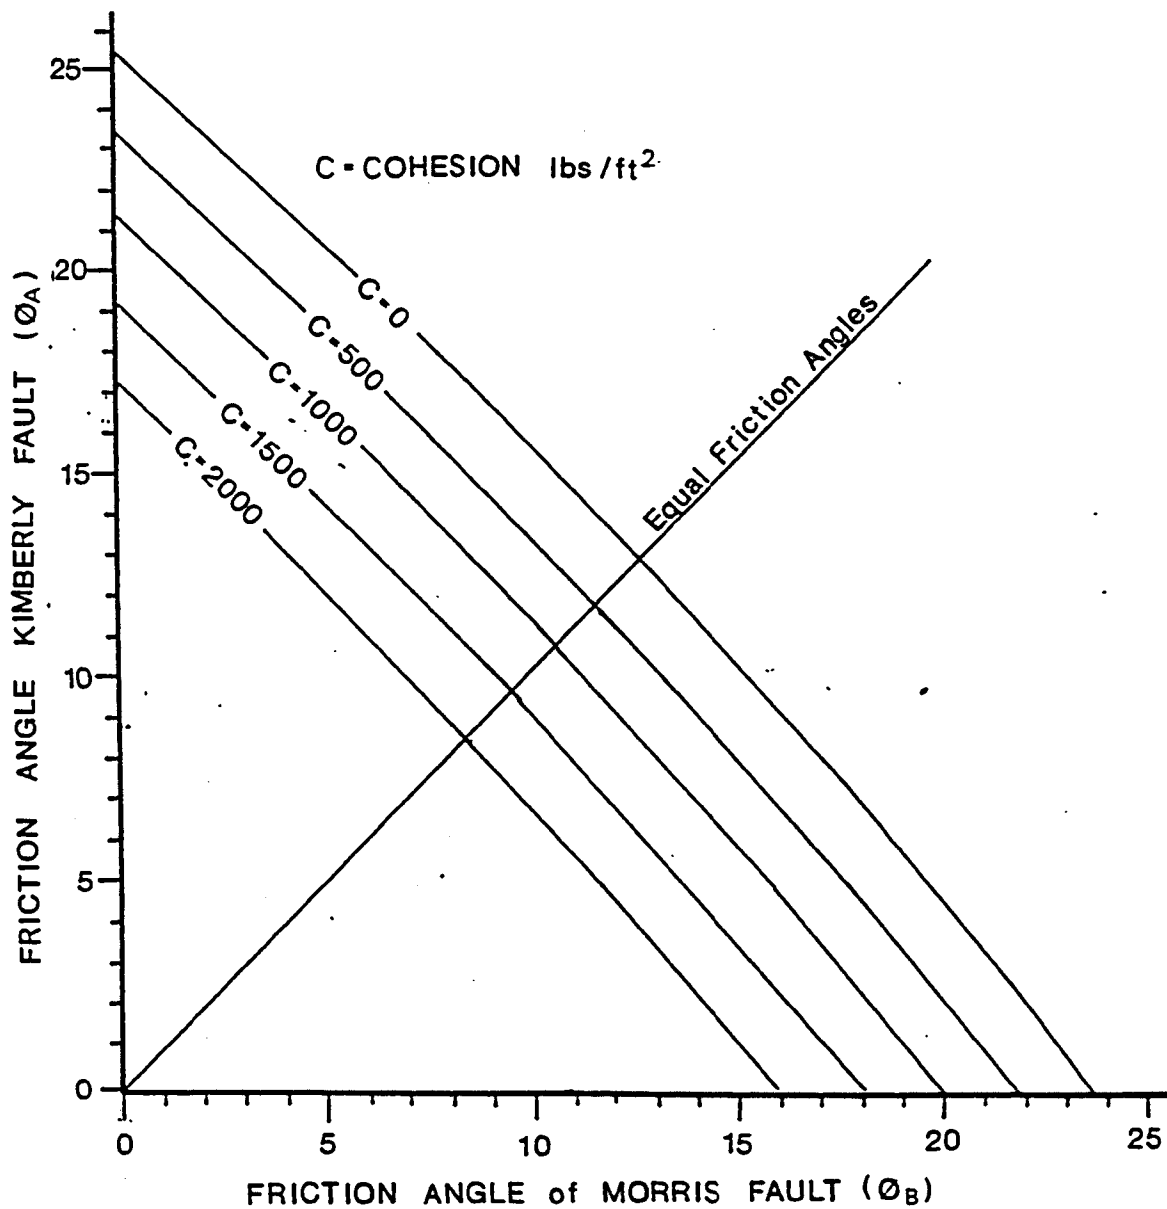
Figure 14. Effective strength of faults controlling the faults for the Northeast Tripp slide

$$2.10 \tan \phi_A + 2.28 \tan \phi_B = 1.00$$

From this, if plane A (Kimberly fault) was found to have a friction angle  $\phi_A = 14.5^\circ$ , plane B (Morris fault) would have to have a friction angle of  $11.3^\circ$  to keep the safety factor equal to one. This analysis was

repeated for various cohesions between zero and 2,000 lb/ft<sup>2</sup> and the results plotted in Figure 14.

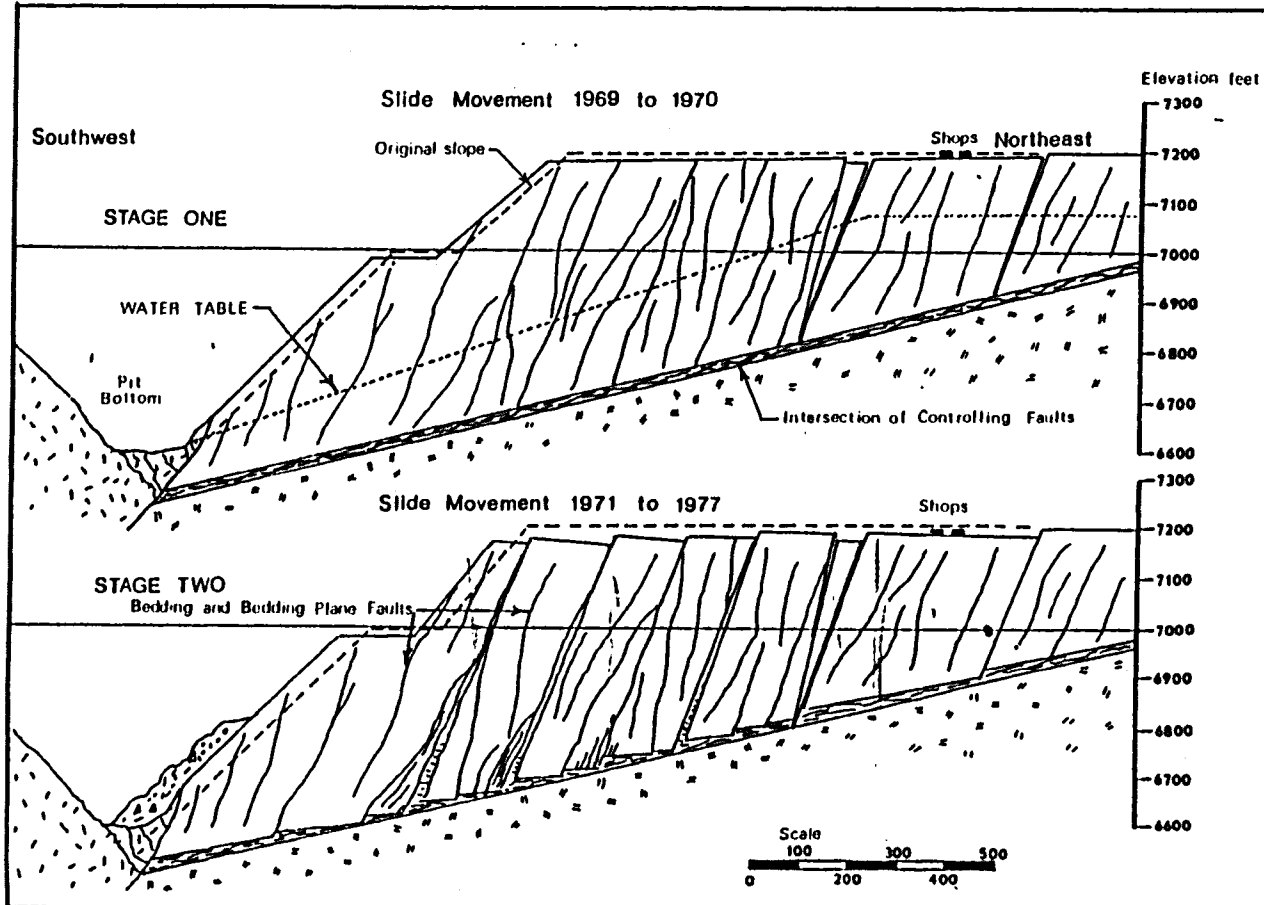
Figure 15. Cross section of the Northeast Tripp slide illustrating its failure mechanism

Based on the nature of the tension cracks and the vector movement data, the mechanics within the slide has been divided into two stages, which are illustrated on Figure 15. The change from the first stage to the second stage was gradational and probably occurred in the 1st half of 1970. The first stage can be characterized by limited differential movement within the Footwall system and by the displacement vectors' paralleling the intersection of controlling structures. The failing wedge was basically behaving as a single mass.

The second stage can be characterized by the breakup of the wedge. Dip-slip movement along the Footwall structure began as the bottom of the blocks within the wedge moved further toward the pit than the top portions. This rotation would explain why the vertical components of the movement vectors greatly increased during this period and also the dip-slip movement on the pit side of most of the tension cracks. During the second stage, the rotation of the blocks could have been aided by plastic flow within the fault zones. There exists the possibility that the gouge has been totally squeezed out in places but to prove such a theory

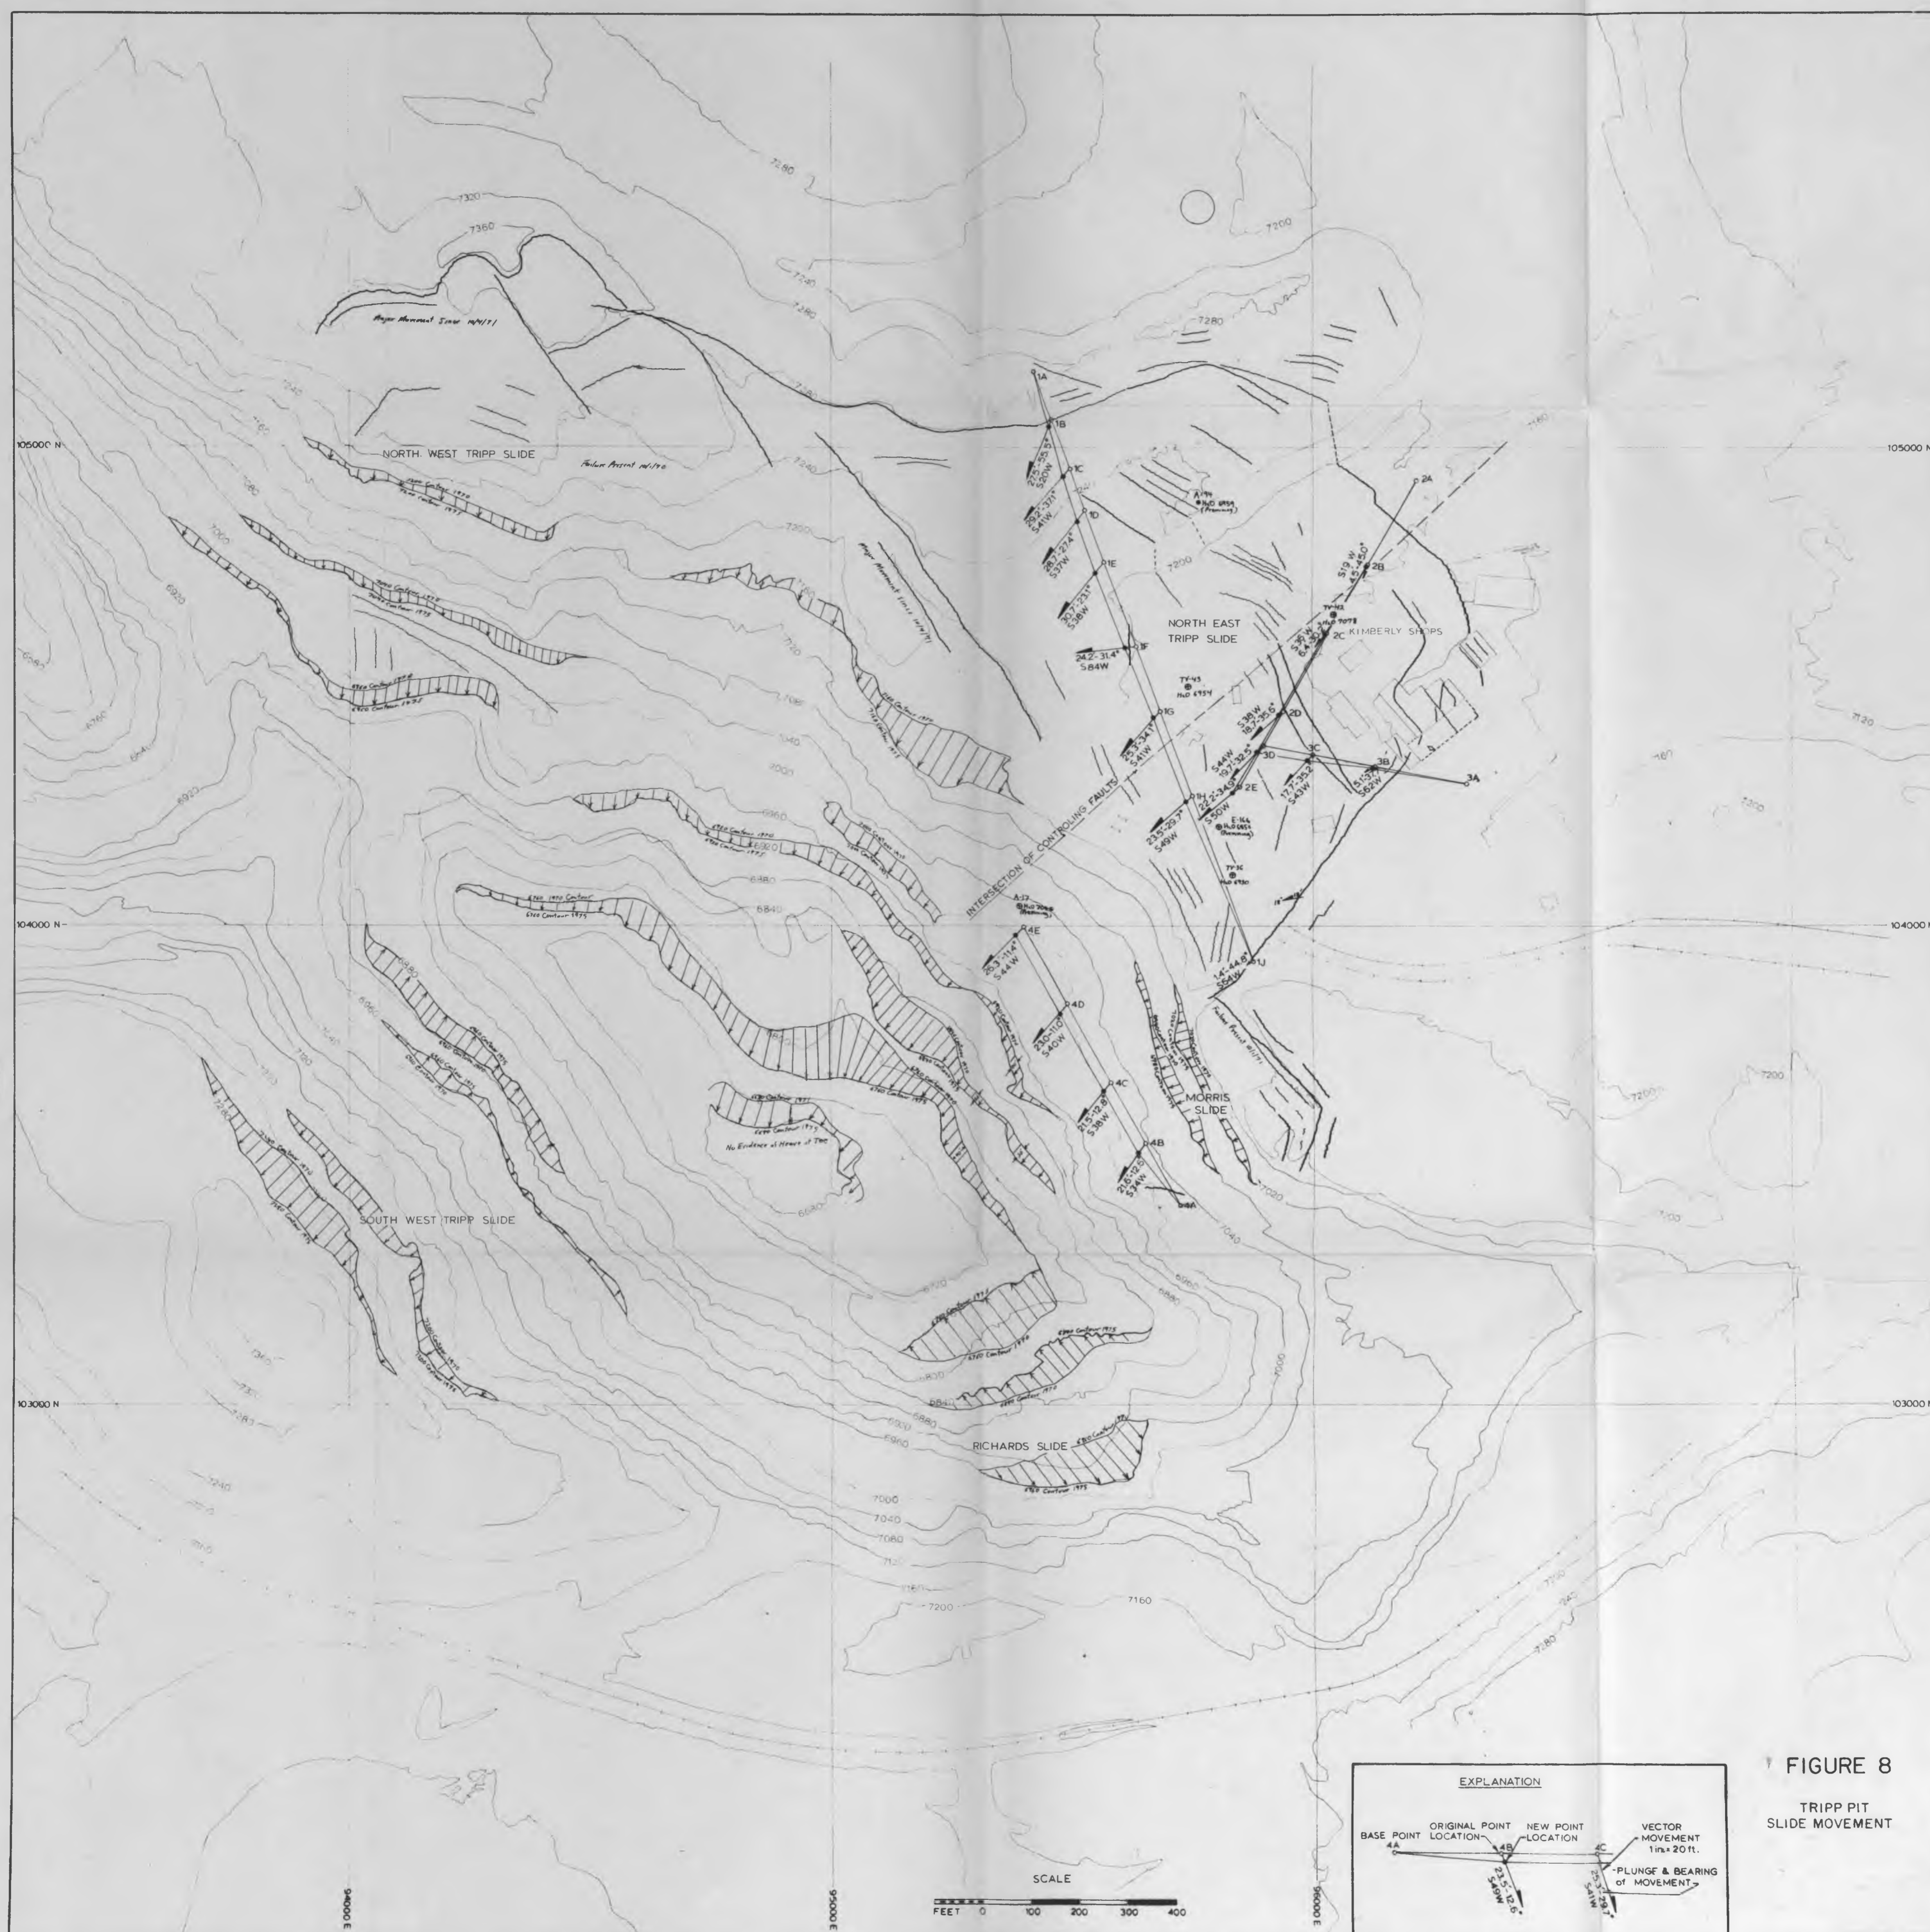
FIGURE 8  
TRIPP PIT  
SLIDE MOVEMENT

Before discussing each of the slides individually, a brief review of the slides with respect to each other and the Tripp Pit in general will be made. Figure 8 shows the location of the slides. Almost the entire north wall of the pit is involved in some sort of slope failure. These failures have been divided into two main slides: the Northwest Tripp slide (NWTS) on the west and the Northeast Tripp slide (NETS) on the east. The area between the two main slides is a transition zone, which runs

roughly between 95,000 E. and 94,700 E. One small slide, the Morris, exists on the extreme eastern end of the north side. It was the Morris failure that finally forced the mining in the Tripp Pit to be abandoned.

An interesting historical note should be mentioned before ending this chapter. The large 33-million-ton Northeast Tripp slide (NETS) had the pit repair shops above it (Fig. 8). These shops included a wash rack for cleaning the pit trucks. The waste water from the wash rack was conveniently disposed of by dumping it down one of the tension cracks that had developed behind the slide (Smith, 1977). The shops were abandoned in 1970 when movement from the slide made them unsafe.
