A Comprehensive Analysis of a Major Storm and Associated Flooding in Arizona

Technical Bulletin 202

May 1973

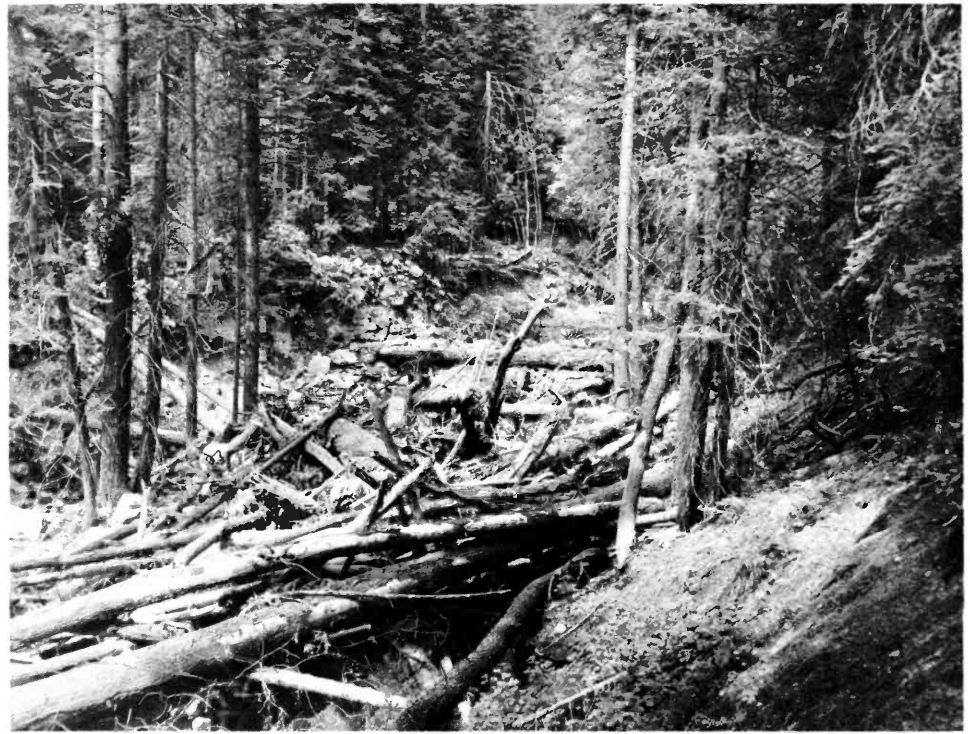
FIGURE 5. DEBRIS JAM ON TONTO CREEK (COURTESY USDA FOREST SERVICE).

Debris jams resulted from high flows which uprooted live trees and carried them downstream along with other vegetative debris and rocks. At restriction points in channels, the churning mass of whole trees, parts of trees, and rocks tended to lodge and form the jams (Figure 5). Debris was deposited in narrow places, on sharp curves, in stands of trees, and around bridges and culverts (Arnolt, 1972). Evidently, debris jams caused at least two types of damage during the flooding. In some cases, channel diversion resulted as a head of water built up behind the debris; elsewhere, and more seriously, debris jams breached, sending a surge of destructive water, timber, and rock materials downstream in flood waves to the next restriction point where the process may have been repeated (Elson, 1971). Apparently, this sequential process led to larger debris jams with increasingly destructive potential upon release, which in turn, resulted in scoured channels to bedrock in some reaches and deposits of debris of all sizes at other locations (Arnolt, 1972).

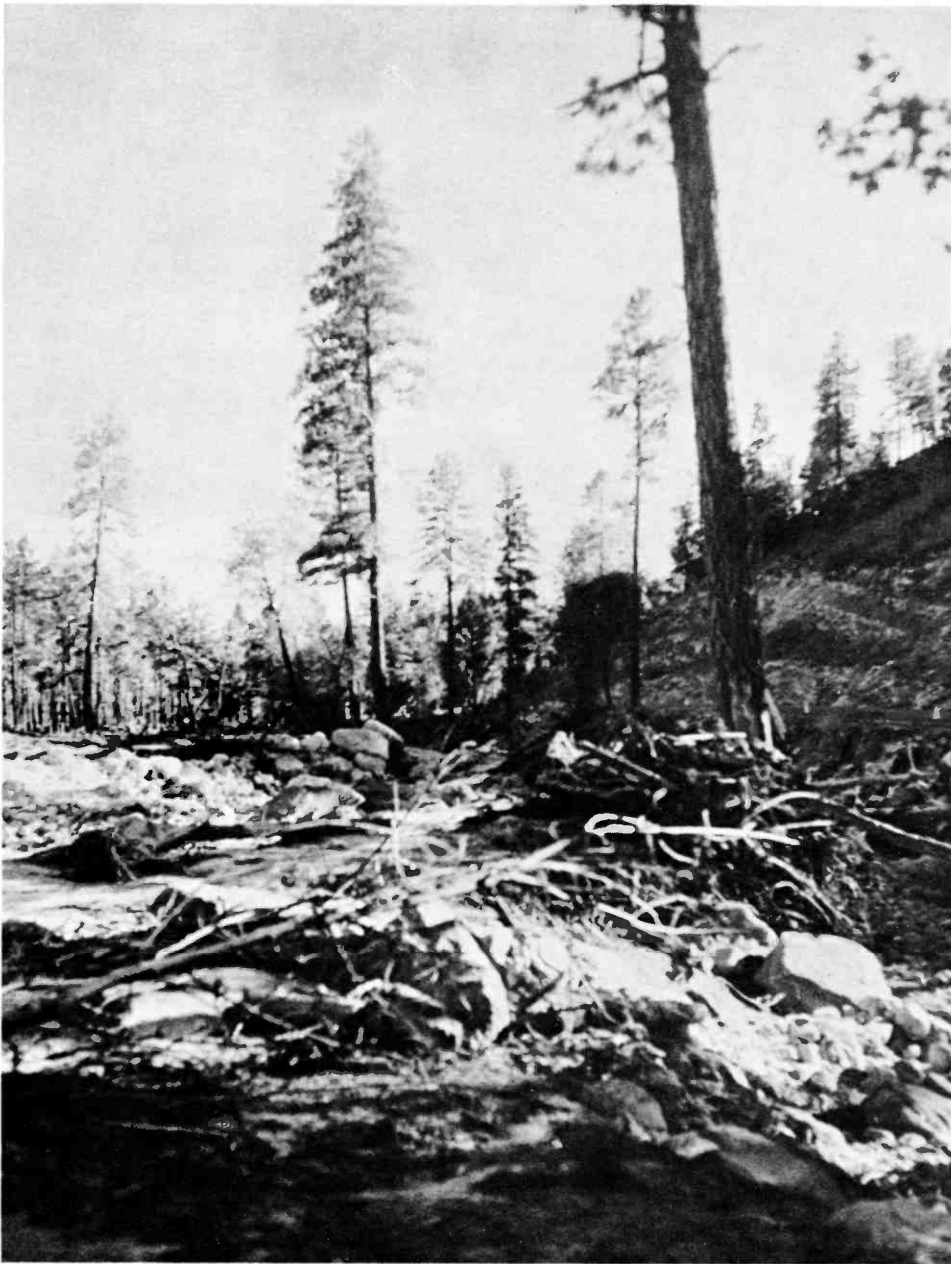
FIGURE 6. TREE IN LEFT CENTER OF PHOTO SHOWING WHERE BRANCHES WERE SHEARED FROM THE RIGHT SIDE OF THE CROWN FOR APPROXIMATELY ONE-HALF THE CROWN LENGTH (COURTESY USDA FOREST SERVICE).

ing more-or-less upright in deep water during flooding (Elson, 1971). Trees left standing on the channel banks after the Storm were scarred and had sheared branches far above the high water mark (Figure 6). Damage to standing trees was evidently the result of contact from trees falling into the water and from trees and trash being carried along in the flow. Most of the trees in the debris were debarked, and branches and roots were abraded and broken almost flush with the trunks. In some cases, large trees were deposited on stream banks as high as 20 to 30 feet above the streambed (Elson, 1971). One report indicated that several large uprooted Douglas-fir trees were deposited on a bridge five miles downstream from the nearest known source of Douglas-fir trees (Williams and Russell, 1970).

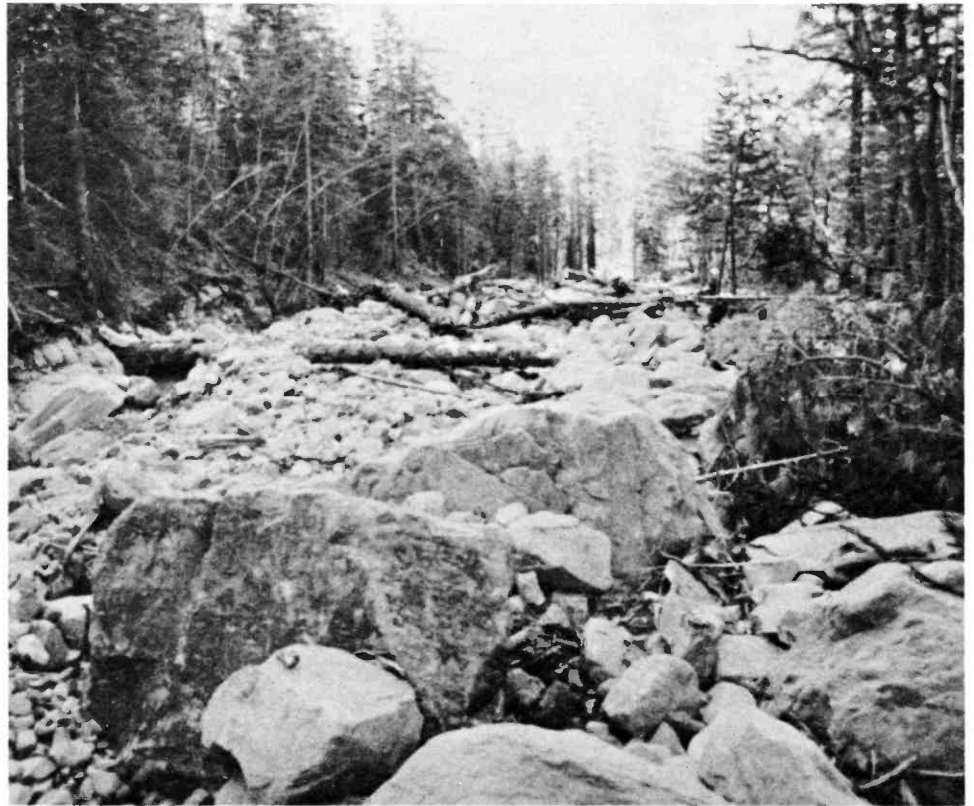
FIGURE 7. BOULDER DEPOSITS ALONG TONTO CREEK (COURTESY USDA FOREST SERVICE).

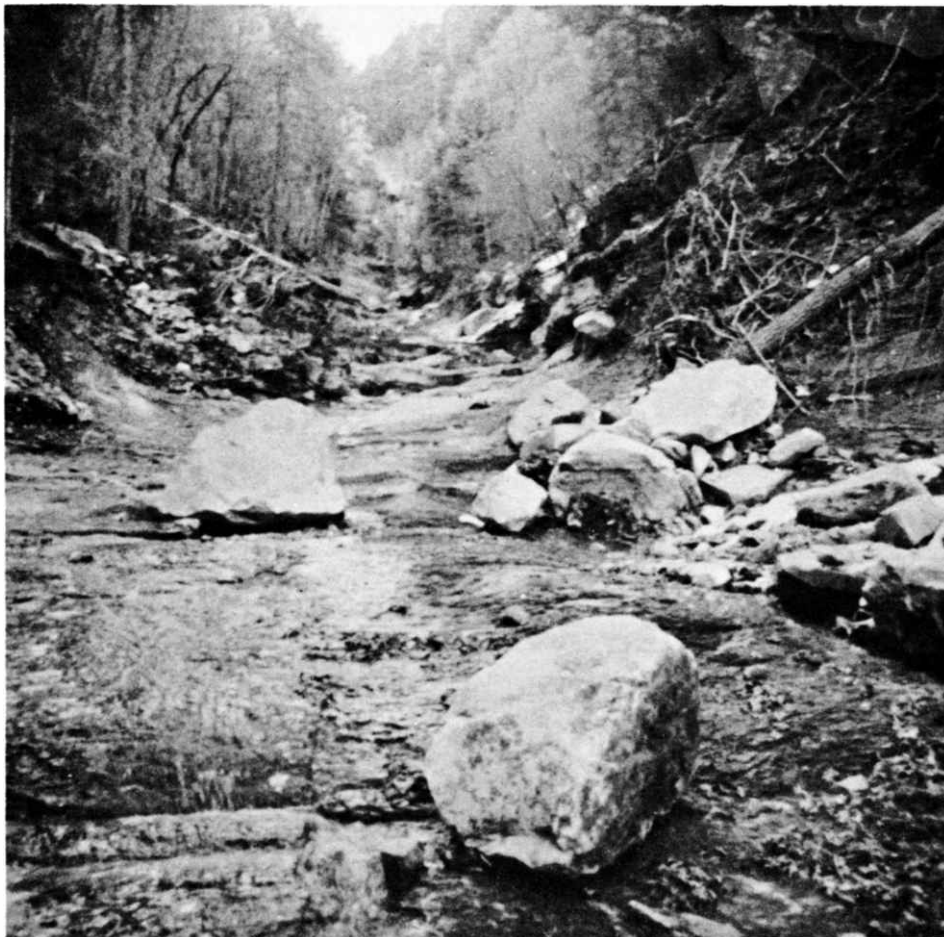
FIGURE 8. CHANNEL SCOUR IN TONTO CREEK DRAINAGE (COURTESY USDA FOREST SERVICE).

Tonto Creek) which was virtually swept clear of material above bedrock for much of its length (Elson, 1971). The scoured channel bottom of Dick Williams Creek was 50 feet below the high water mark and up to 100 feet in width in places. Elson (1971) remarked that the channel appeared "as if it had been scooped clean by some huge behemoth machine." Extensive channel scour was also observed on the Coconino National Forest (Morrison, 1970).

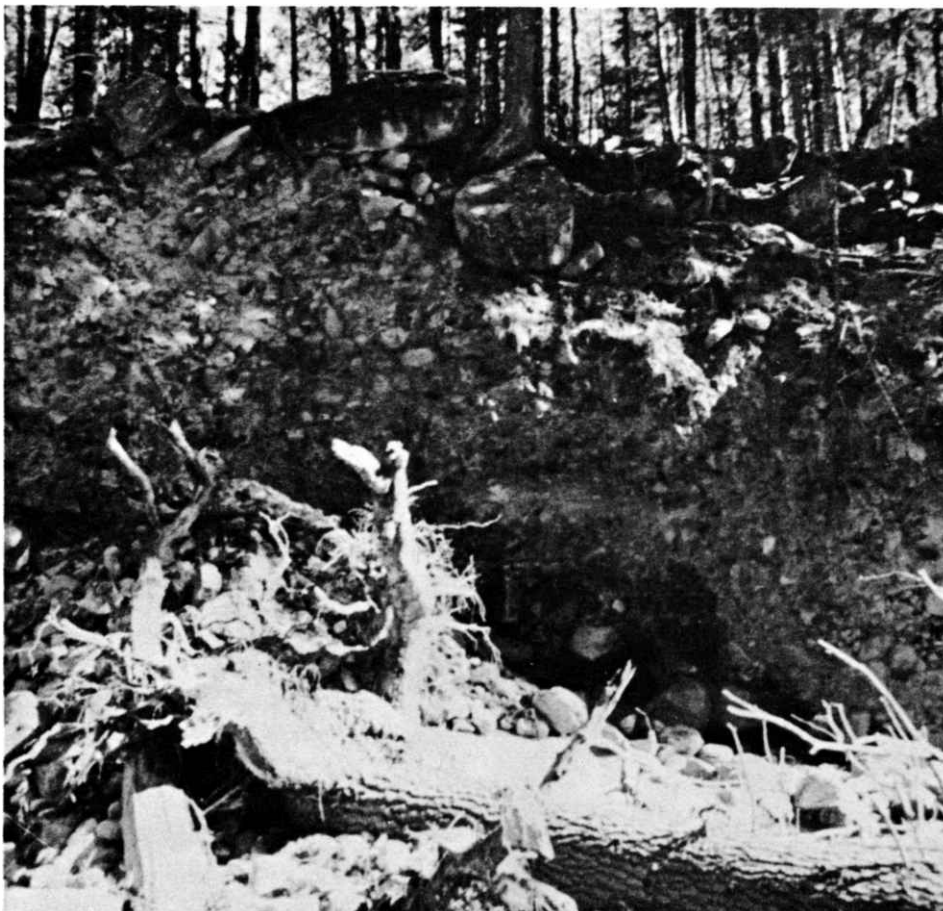
FIGURE 9. VERTICAL STREAM BANK ALONG CHRISTOPHER CREEK (COURTESY USDA FOREST SERVICE).

Vertical stream banks were another result of flood flows (Figure 9), particularly where debris deposits caused streamflow to be diverted against banks, at curves in channels, and where channel scouring was deep (Arnolt, 1972). Some vertical banks were unstable and constituted a potential source of sediment and timber debris if sloughing occurred during subsequent flooding. In addition, unstable banks were considered hazardous for recreation visitors. This hazard was accentuated where trees and large boulders were precariously suspended at high locations on or near the vertical face.

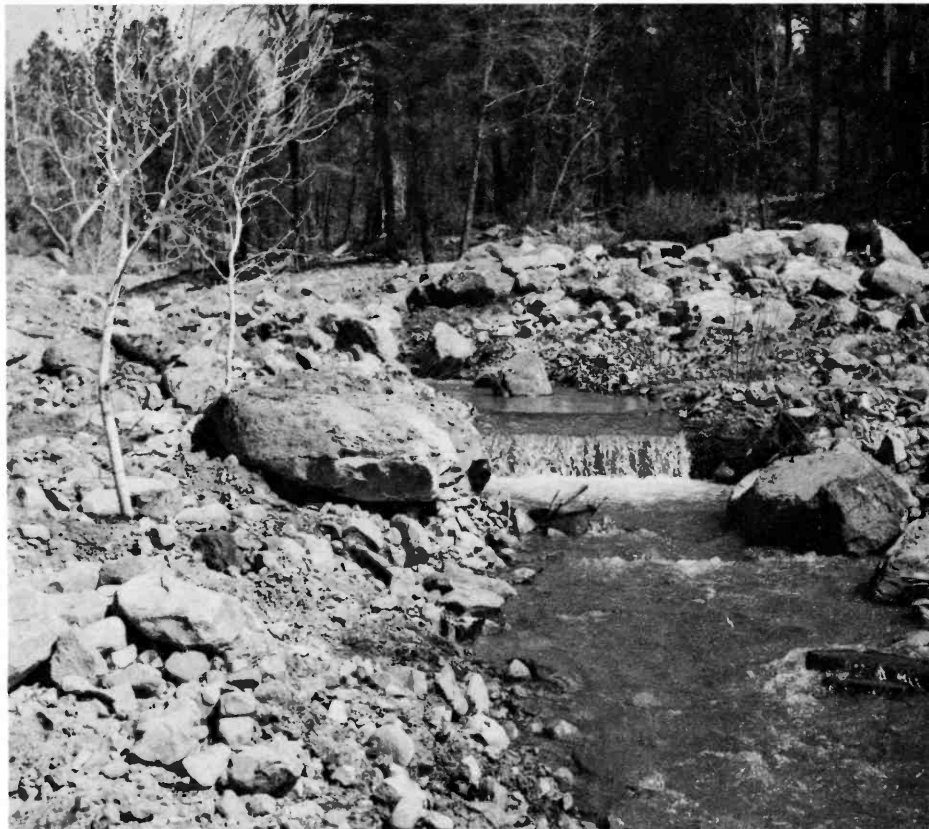
FIGURE 11. A REACH ALONG TONTO CREEK AFTER CLEAN-UP SHOWING PLANTED COTTONWOODS AND ARTIFICIAL POOL (COURTESY USDA FOREST SERVICE).

The large amount of channel and related damage that occurred on upland watersheds above the Kohl's Ranch area on Tonto Creek during the Storm received prompt attention from the USDA Forest Service (Arnolt, 1972) and the U.S. Army Corps of Engineers. Corrective measures undertaken included removal and disposal of timber debris, channel straightening, shaping of boulder fields to facilitate streamflow, shaping of cut banks, revegetation, and

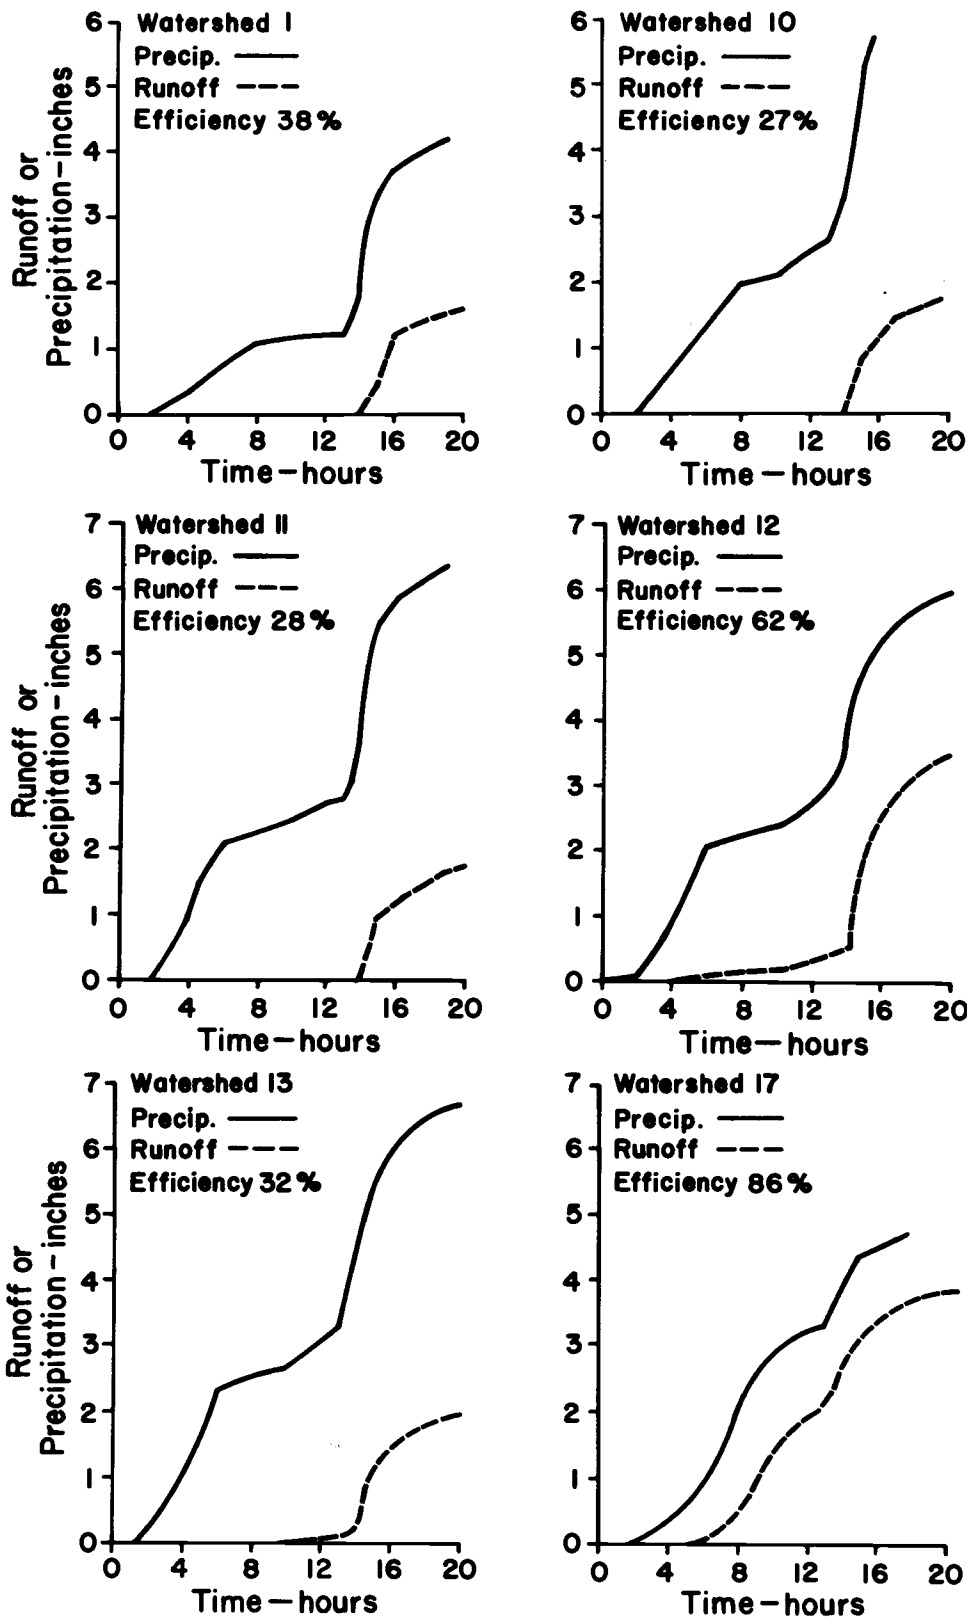
FIGURE 13. RUNOFF EFFICIENCY FOR SELECTED BEAVER CREEK EXPERIMENTAL WATERSHEDS (ADAPTED FROM BAKER ET AL., 1971).

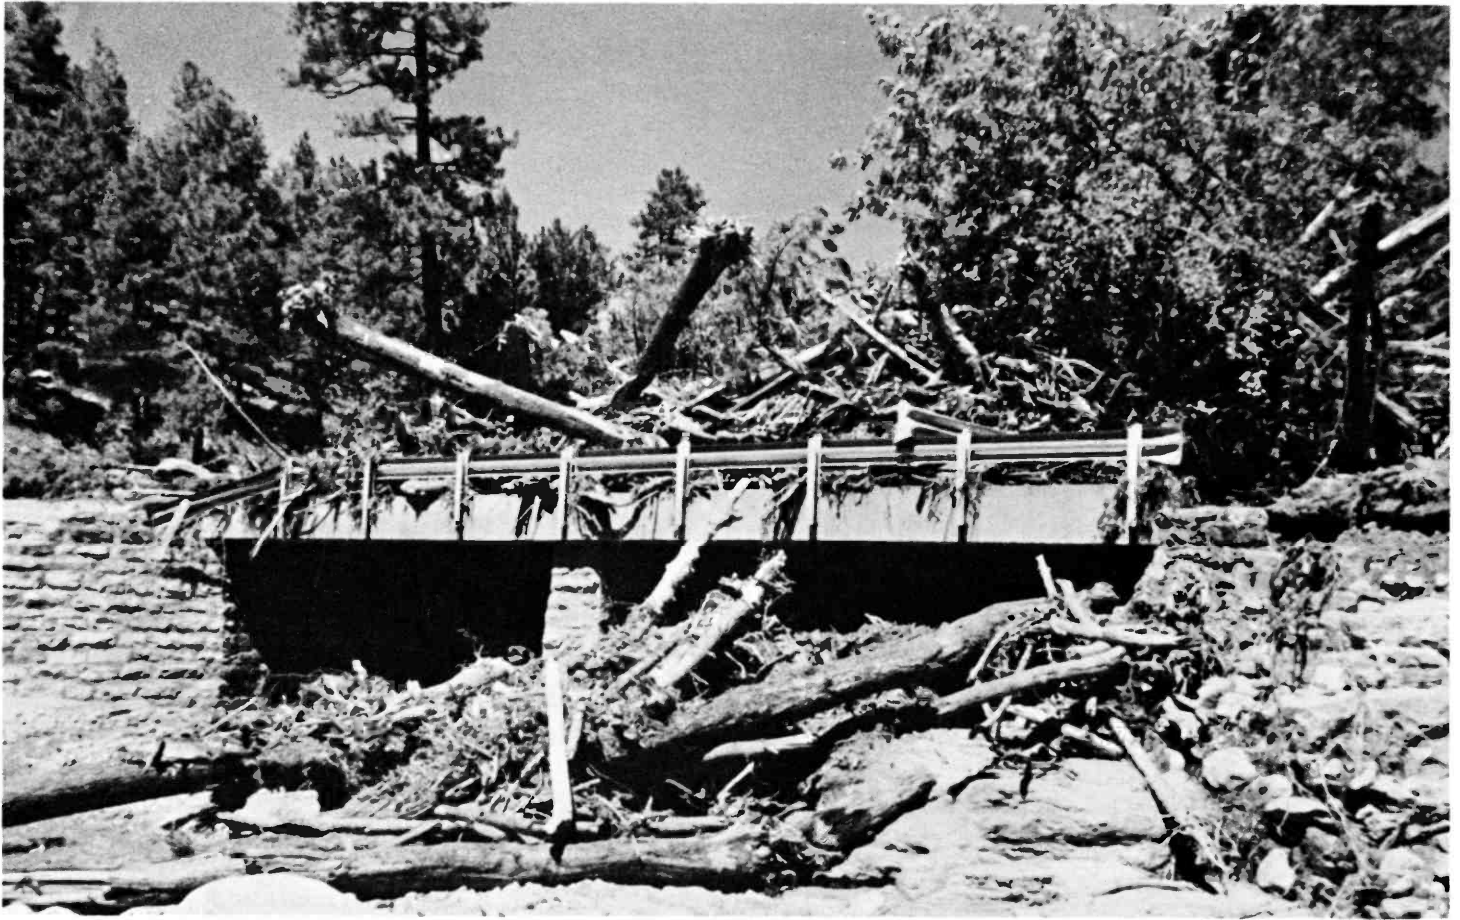
FIGURE 14. VIEW OF DOWNSTREAM FACE OF TONTO CREEK-HORTON CREEK BRIDGE AFTER THE 1970 LABOR DAY FLOOD. SEVERAL LIVES WERE LOST AT THIS LOCATION. (COURTESY USDA FOREST SERVICE).

Losses and Damages — Tragically, 23 lives were reported lost in central Arizona (Russell, 1970). The greatest loss of life occurred in Gila County, where 14 lives were lost in the Kohl's Ranch area on Tonto Creek (Figure 14), and one life was lost in Camp Creek Wash north of Carefree, three in Mesquite Wash east of Canyon Lake, three in

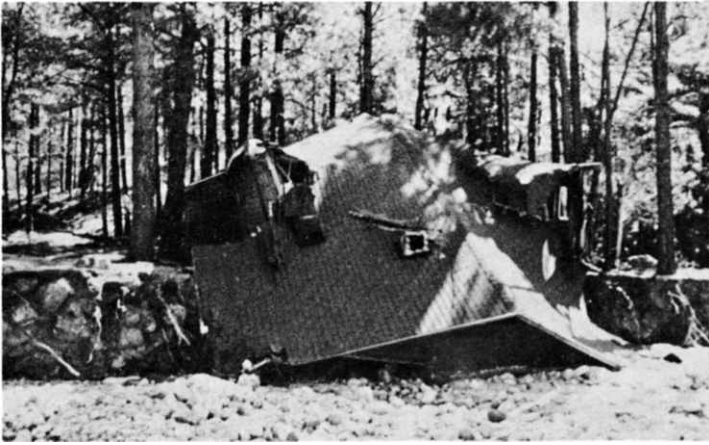
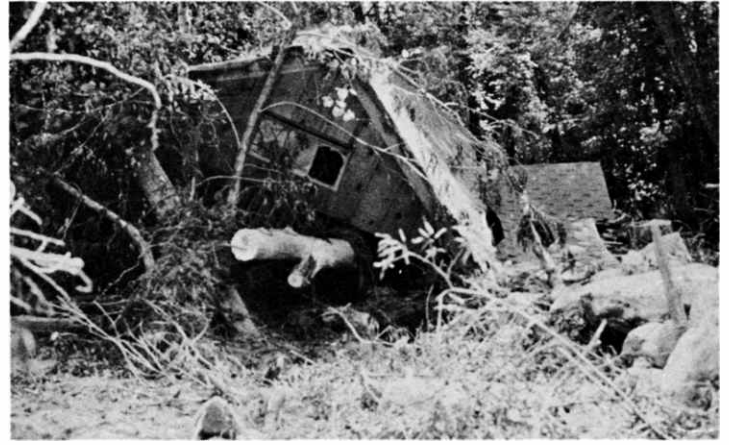
FIGURE 15. DAMAGE TO CABINS ALONG TONTO CREEK DRAINAGE (COURTESY USDA FOREST SERVICE).

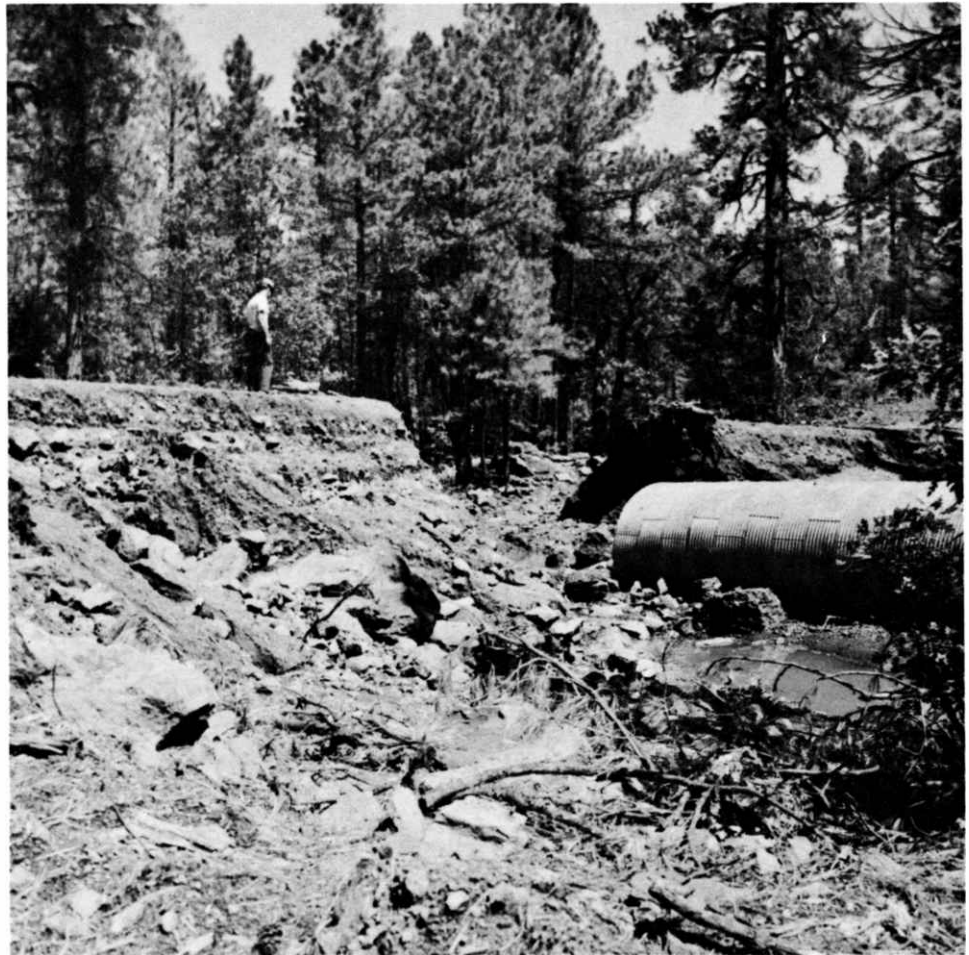
FIGURE 16. DAMAGE TO FOREST ROAD ON THE COCONINO NATIONAL FOREST (COURTESY USDA FOREST SERVICE).

Damage to highways and roads, including interstate, primary, secondary, and private systems, was widespread throughout central and northeastern Arizona (Figure 16). Landslides blocked the access to many right-of-ways, culverts plugged with debris caused many washouts, and road surfaces were often eroded by flood waters. An indication of the extent of damage to highways and roads may be derived from a listing of Emergency Relief Fund projects administered through the Arizona Highway Department (Hendrick, 1972).

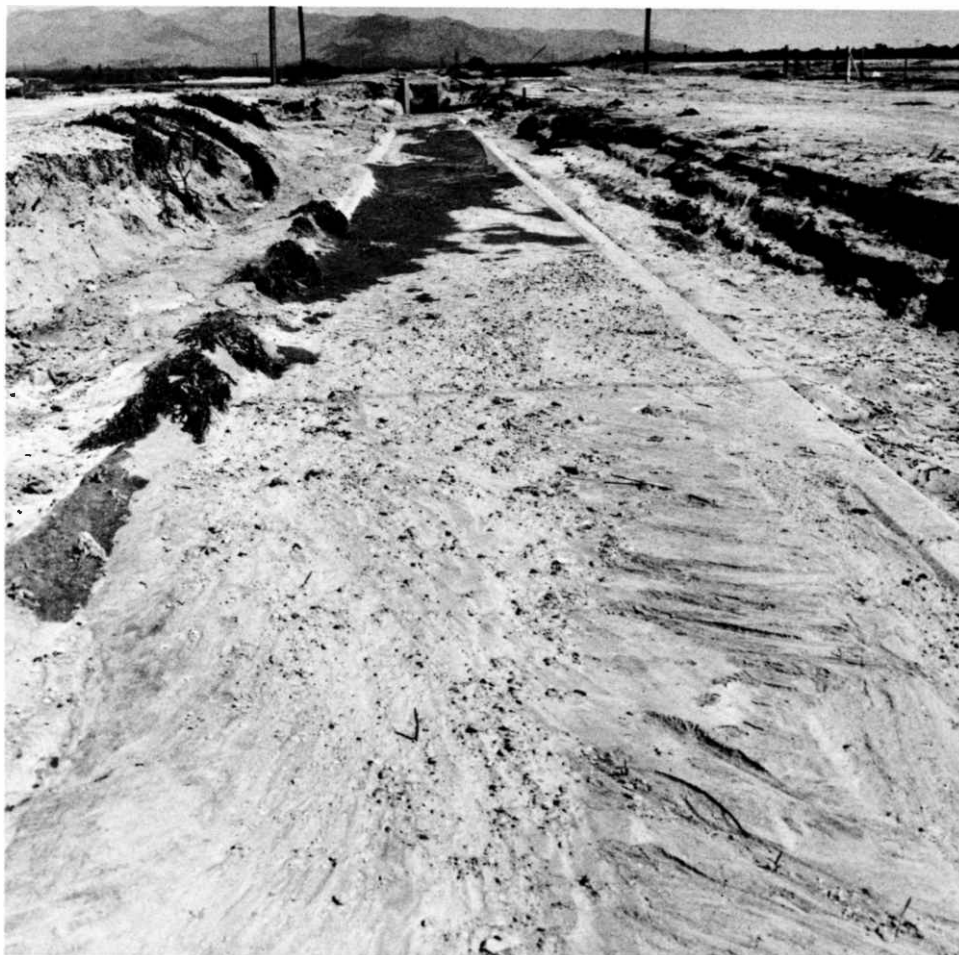
FIGURE 17. IRRIGATION CANAL FILLED WITH SAND AND SILT IN THE ROOSEVELT IRRIGATION DISTRICT (COURTESY USDI BUREAU OF RECLAMATION).

losses and damages to croplands in this area (Figures 17 and 18).

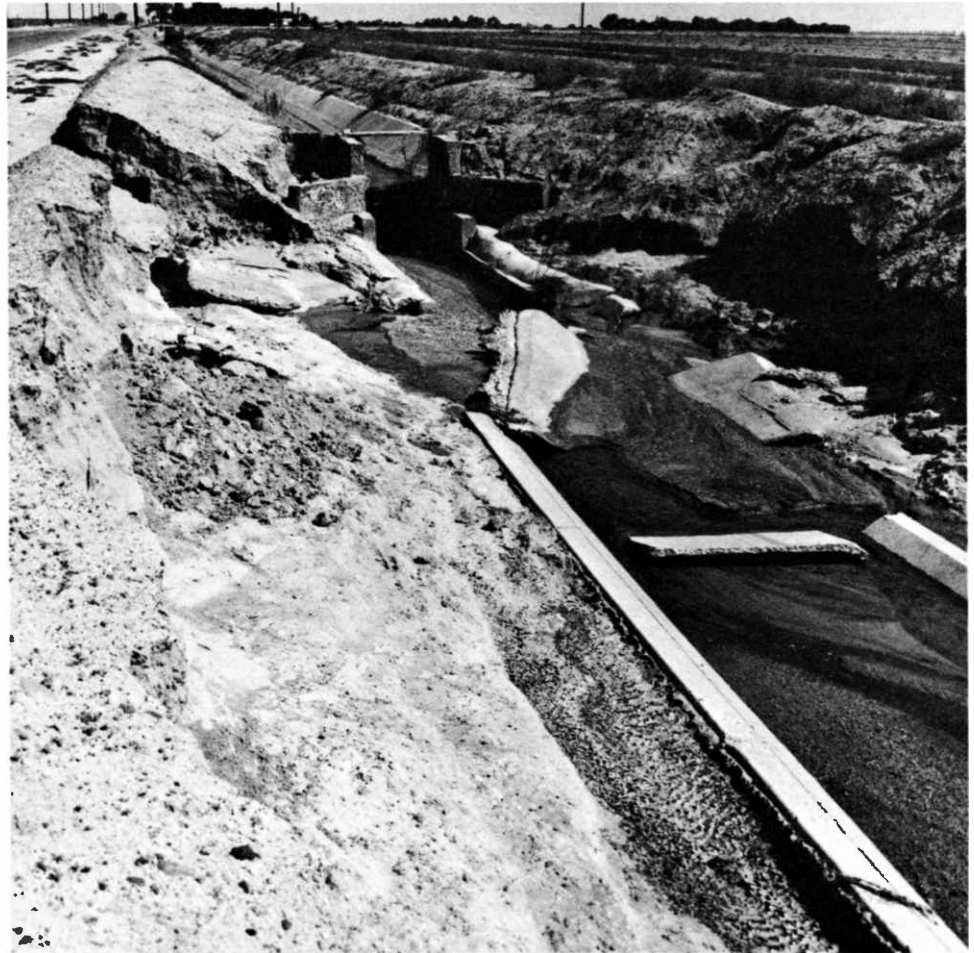
FIGURE 18. STRUCTURAL DAMAGE TO IRRIGATION CANAL SYSTEM IN THE ROOSEVELT IRRIGATION DISTRICT (COURTESY USDI BUREAU OF RECLAMATION).
