# A 10.6 $\mu\text{m}$ TERRESTRIAL COMMUNICATION LINK\*

**FRANCIS E. GOODWIN and THOMAS A. NUSSMEIER**

**Hughes Research Laboratories  
Malibu, CA**

**Summary** This paper reports the development of an experimental type 10.6  $\mu\text{m}$  laser communication system, consisting of a transmitter terminal and a receiver terminal, designed to operate one way over a nominal five-mile path. The system provides a 5 MB/s digital data channel using a frequency shift keying format and optical heterodyne detection with a mercury cadmium telluride detector operating at a temperature of 77°K.

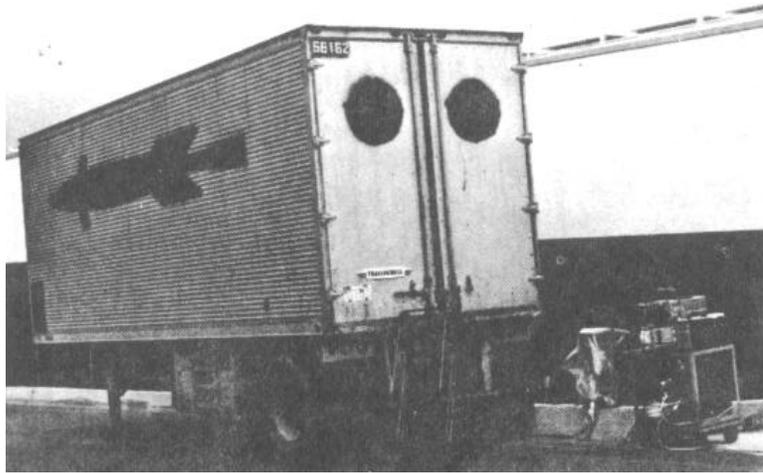
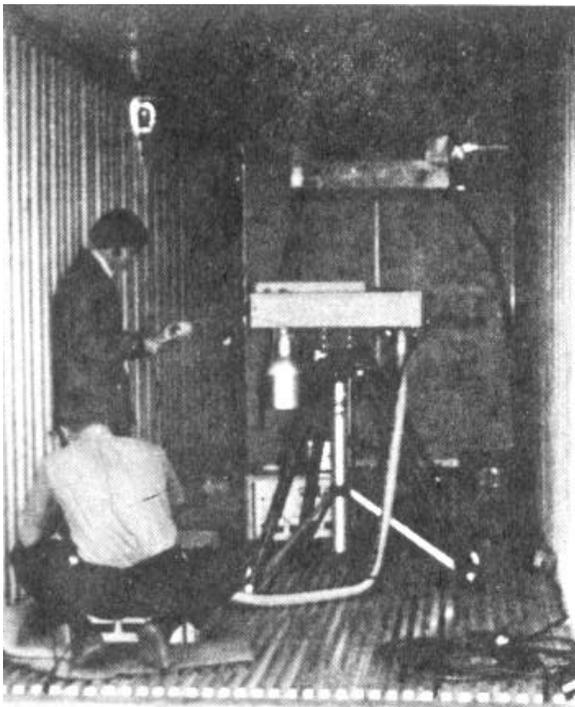
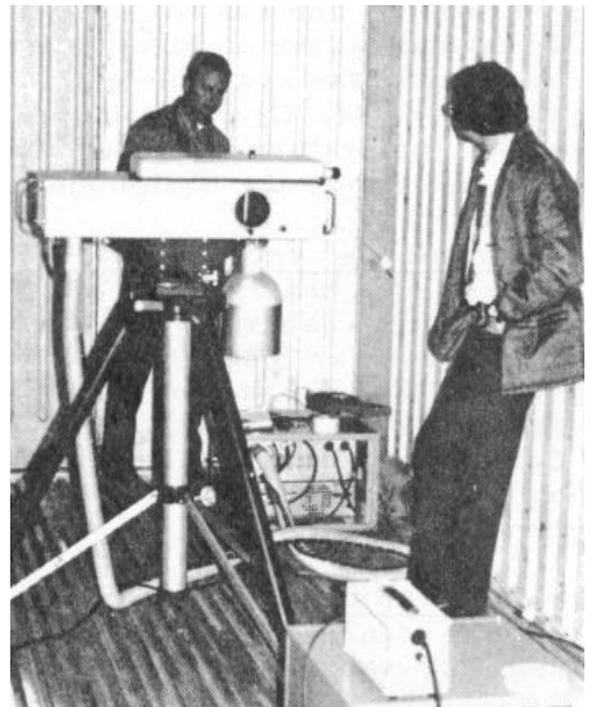
•  
**Fig. 1. Environmental testing.**

**Environmental Tests** The transmitter and receiver were set up in the test chamber (Fig. 1(c)) pointed at each other, with the shutter closed and the manual attenuator in place, simulating a signal level at about five miles. The system was cold soaked for 5 hours at an indicated temperature of 35°F (1°C), which was as near 32° as the chamber would regulate. The refrigeration plant caused vibration of the entire chamber, and the system had to be repainted at the beginning of the test. Despite the vibration, the system locked up and began transmission within twenty minutes of activation and operated normally.

Figure 1 shows the equipment during the environmental testing.

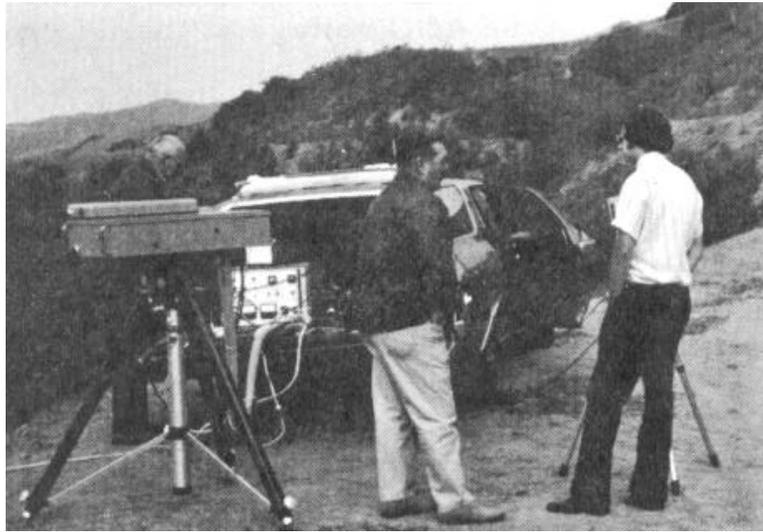
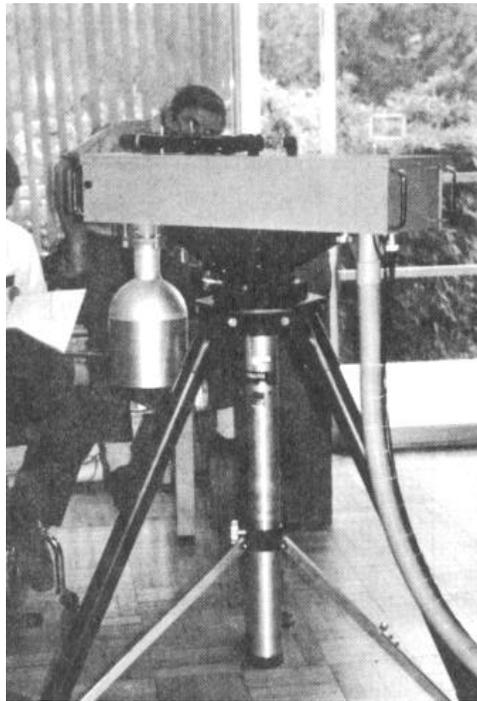
(a) Transmitter

**Fig. 2. 4.1-mile test range.**

**Performance over 4.1-Mile Test Path** For this test the transmitter was set up on a Hillside fully exposed to the weather with the receiver located inside a laboratory at the Hughes Malibu facility. Tests were conducted over an 8 hour period from 9:45 a.m. to 5:45 p.m. on 18 October 1972. Weather observations made at the receiver site are shown in Table II.

Communication from the transmitter to the receiver was maintained using the laser equipment once acquisition was complete. Figure 2 shows the system set up for the 4.1-mile tests.

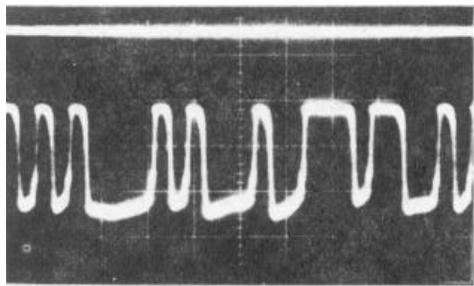
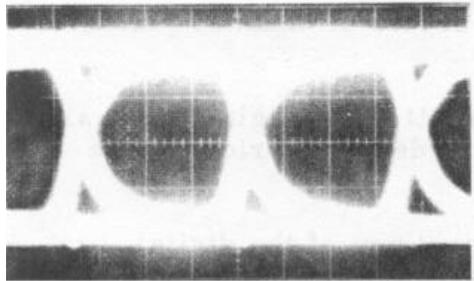
(a) 1.5 MBit/sec DATA STREAM

(b) 1.5 MBit/sec "EYE" PATTERN

**Fig. 3. Waveforms over 4.1 mile link with 33 dB attenuation in beam.**

Waveform measurements are shown in Fig. 3. Figure 3(a) is a sample of the bit stream after transmission through the system at 1.5 mB/s, with Fig. 3(b) showing the “eye pattern” output. Attenuation in the beam at this time was 33 dB.

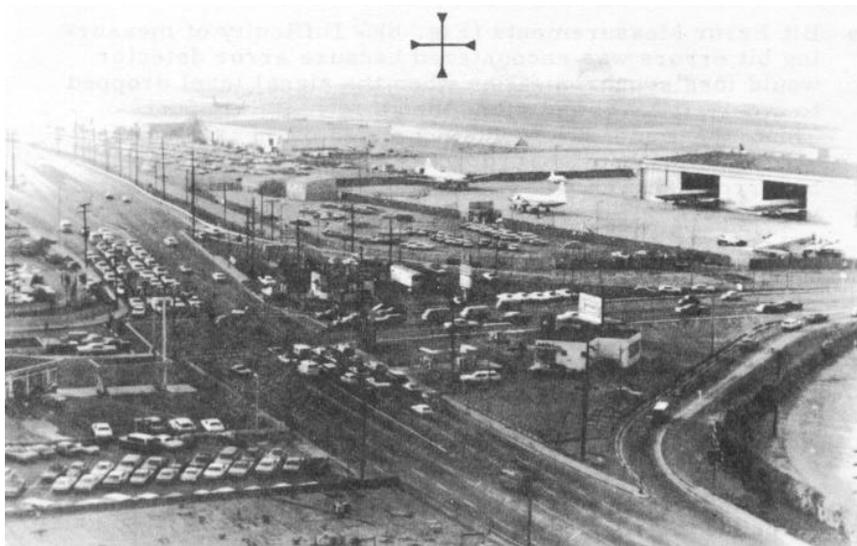
**Fig. 4. View from 11<sup>th</sup> floor window of Space and Communication Building 366. Malibu transmitter location shown by arrows.**

The receiver terminal was located on the eleventh floor of the Hughes Space and Communications Group building, (366) in El Segundo, California. The window pane on the west exposure was removed and replaced with a plexiglass panel with a 6-in. diameter hole cut for the beam to enter. The receiver head was situated to receive energy through the 6-in. hole. Peripheral equipment at the receiver terminal included a television monitor, a HP 8553 spectrum analyzer and a chart recorder. A view from the eleventh floor window is shown in Fig. 4.

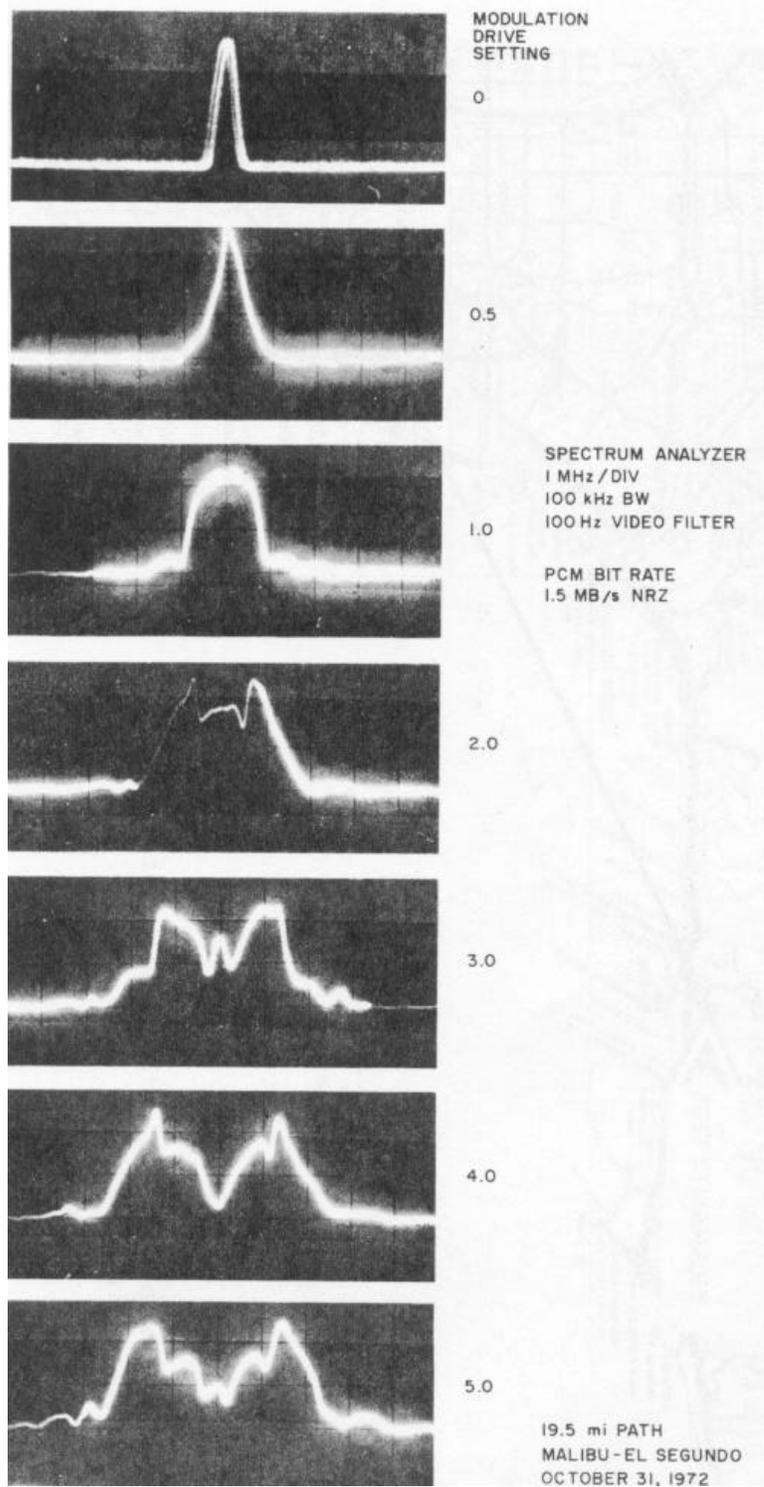
**Fig. 6. Channel quality - 30 MHz spectrum.**

- **Channel Quality** The following series of channel quality tests were conducted on 31 October:
  - 30 MHz i.f. Spectrum (Fig. 6) - Using a digital input signal, the i.f. spectrum was recorded for various drive levels of the transmitter input.

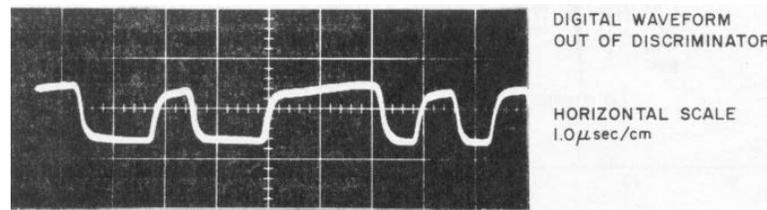
**Fig. 7. Channel quality - digital waveform.**

- Video Spectrum - The video spectrum of the digital data was measured on the spectrum analyzer for a full transmitter modulator drive level.
  - Digital Waveform (Fig. 7) - The digital waveform was measured at the output of the discriminator.

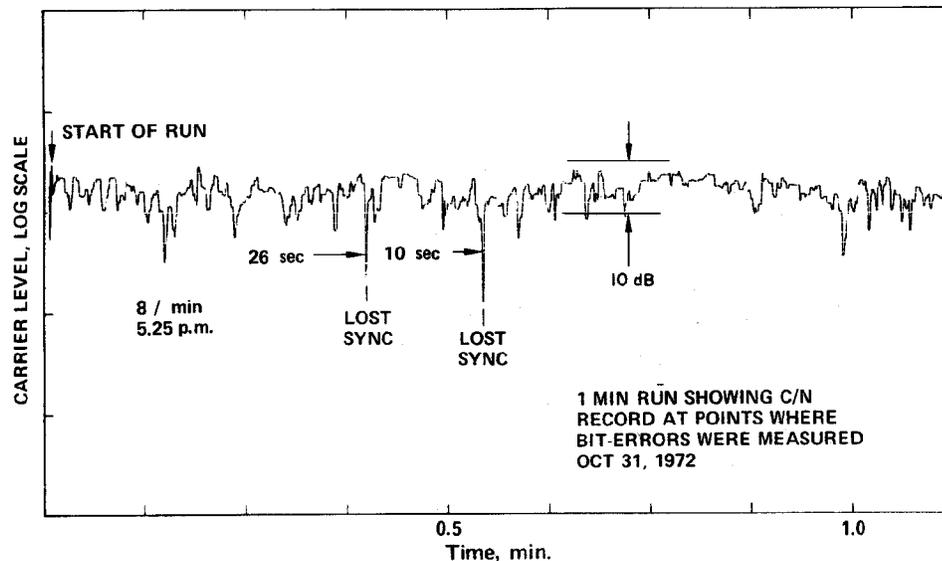
**Fig. 8. Bit-error measurements (one minute sample).**

- Eye Pattern Tests - Eye patterns were photographed for various exposures showing clear decision areas.
  - Bit Error Measurements (Fig. 8) - Difficulty of measuring bit errors was encountered because error detector would lose synchronization when the signal level dropped to a certain level and more than a few bits are lost. Thus, these measurements consisted of measuring the average time between drop-outs during which time no bit errors occurred. The average time between errors was 32.4 s. If one assumes at least 1 bit error during each dropout, the calculated minimum bit-error rate is  $2.05 \times 10^{-8}$ . If 100 bits are lost during each dropout, the bit-error rate is  $2.05 \times 10^{-6}$ .

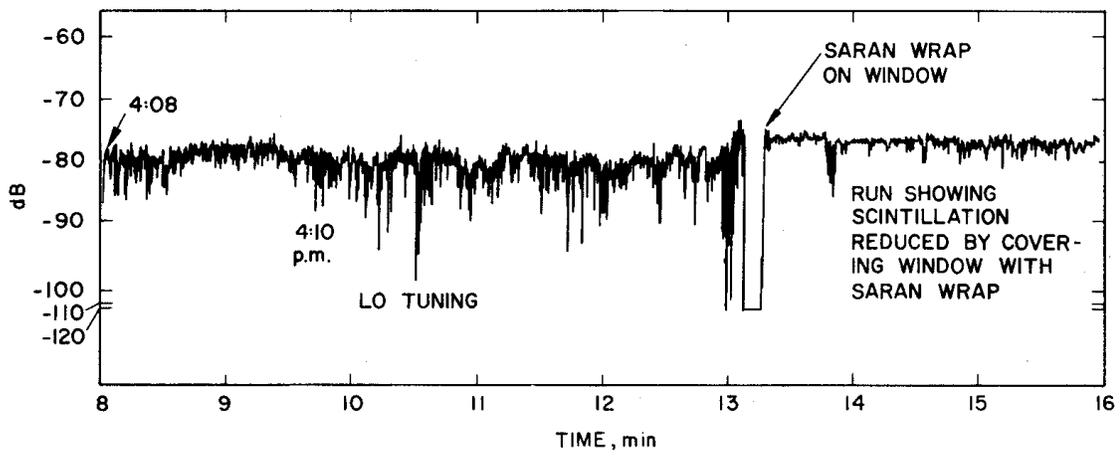
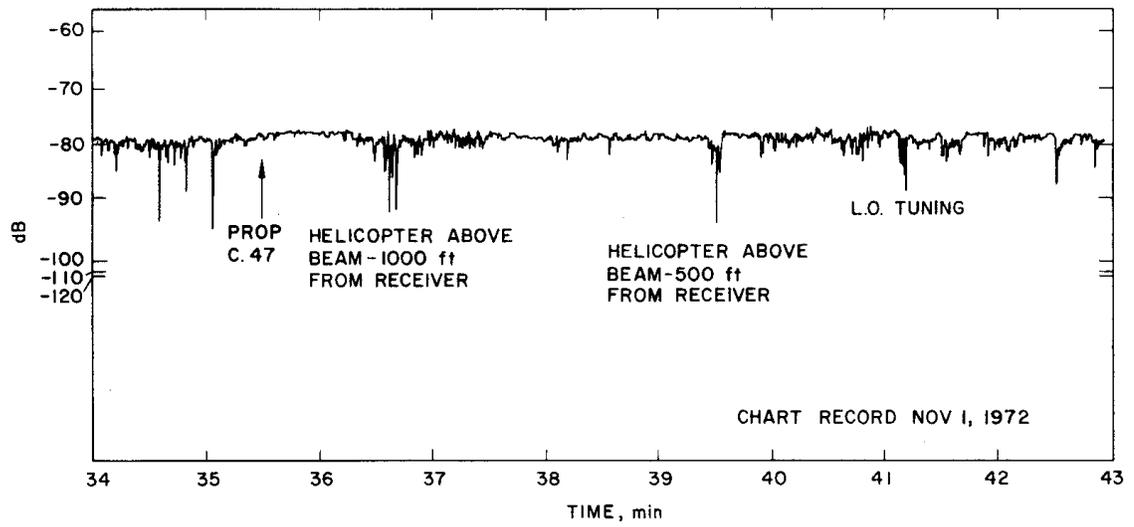
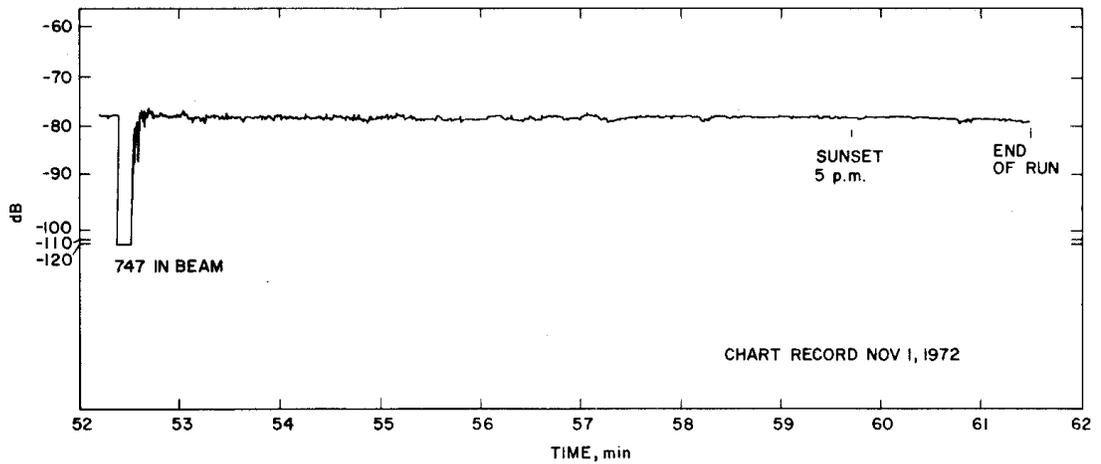
Fig. 9. C/N measurements - continuous 1-h run (8-min samples).

- C/N Calibration - Using a test signal injected at the output of the detector preamplifier, a C/N calibration was made. The level of the injected signal is shown in dBm in Fig. 9.
- Continuous 1-hour run (Fig. 9) - Using a reduced chart speed, a continuous 1-hour run was conducted. Figure 9 shows three 8-min samples from this run. This run started at 4 p.m., one hour before sunset, with scintillation depths reaching 10 dB. At 4:15 p.m. a sheet of saran wrap was stretched over the port hole in the window to help eliminate gusts of cold air entering the port. An immediate reduction in the scintillation amplitude was noticed.

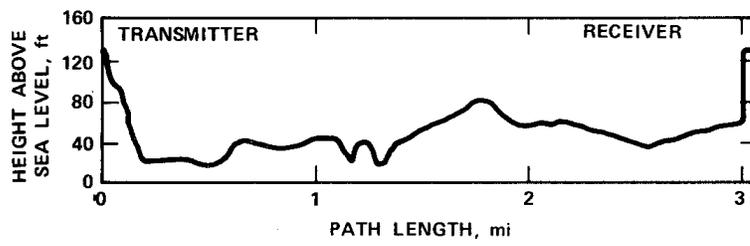
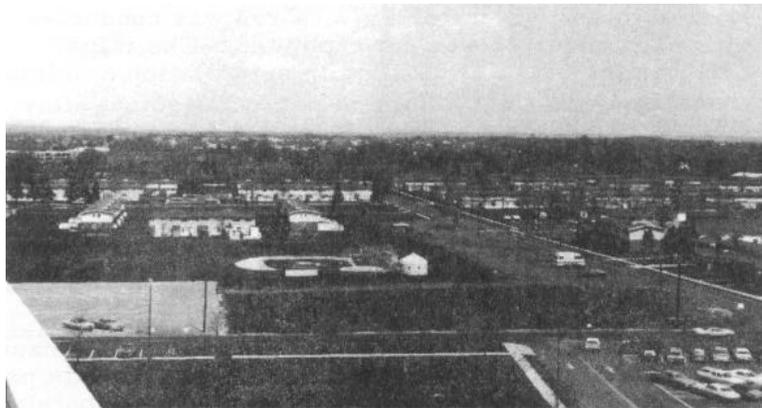
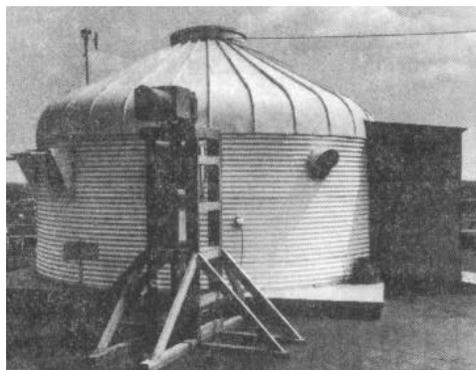
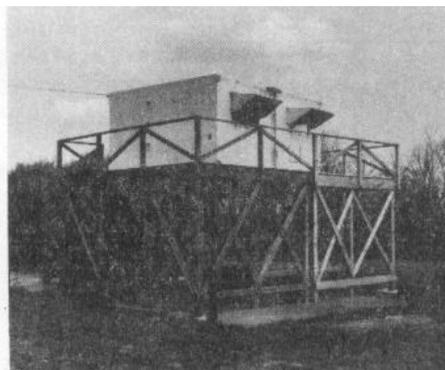
Path profile

**Fig. 10. Fort Monmouth 3-mile test range.**

**3-Mile Test Range** The line-of-sight atmospheric test facility, located at Fort Monmouth, consists of two shelter installations and meteorological measurement equipment. Figure 10 shows the path profile between the terminals; a photograph of the path as seen from the receiver shelter, a photograph of the transmitter shelter, and the receiver shelter located atop a four story building.

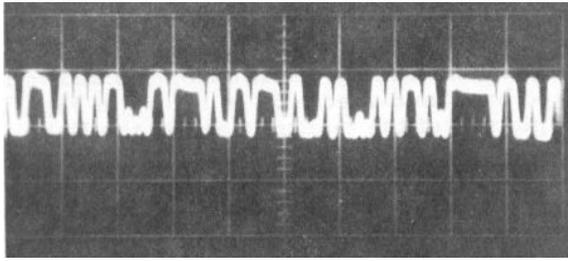
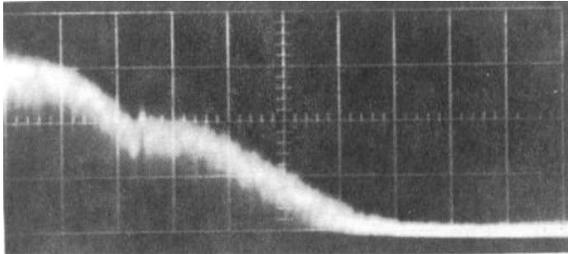
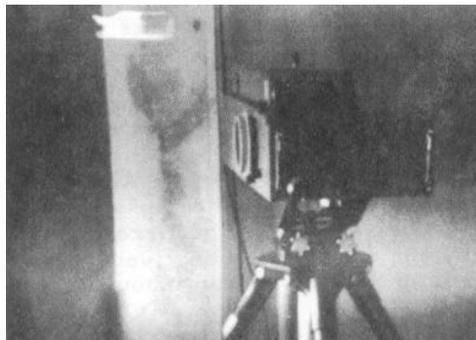
(a) Digital waveform at 4.608 MB/s.

(b) Baseband spectrum for 4.608 MB/s digital signal

(c) TV picture of transmitter over three mile link

**Fig. 11. Signal characteristics.**

- **Frequency Spectrum Tests** The received pseudorandom bit sequence as photographed from an oscilloscope is shown in Fig. 11(a), and its demodulated baseband spectrum is shown in Fig. 11(b). Figure 11(c) shows a TV picture of the transmitter via the link.

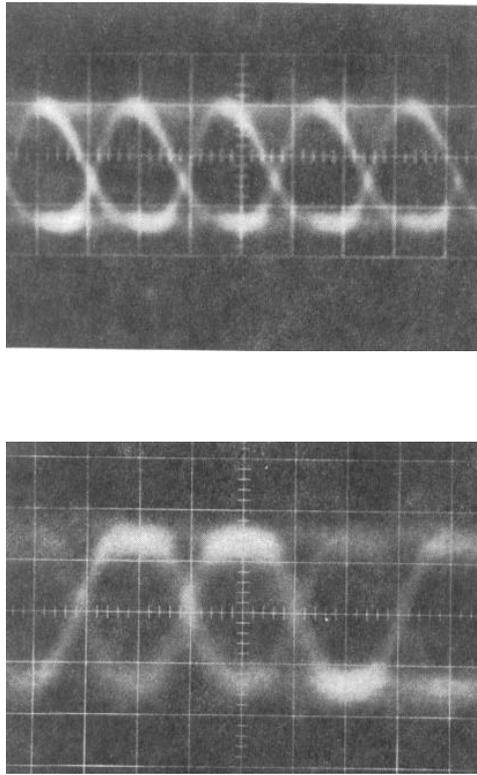
**Fig. 12. Eye patterns of 4.608 MB/s signal direct (top) and through system (bottom).**

- **Eye Pattern Tests** The eye pattern tests were conducted by transmitting the pseudorandom bit sequence and observing multiple traces on an oscilloscope sweeping at a submultiple of the bit rate. Figure 12(a) shows an eye pattern at 4.608-MB/s rate with a sequence length of 511 bits in a direct back-to-back test. A typical received eye pattern through the system, Figure 12(b), shows a very clean decision center even with approximately 15 dB fades due to scintillations. In general, the eye pattern measurements have indicated an excellent average error rate under clear weather conditions. During heavy rain or fog with visibility of less than 3/8 of a mile the eye pattern was much poorer indicating poor error rate. It has been estimated that with full collimation, error rate of better than  $1 \times 10^{-6}$  would be achieved for all but the most severe weather conditions.

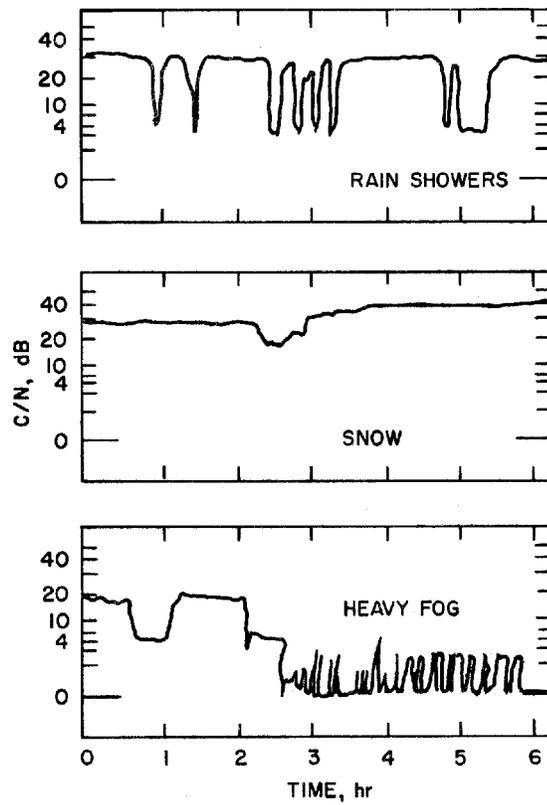
**Fig. 13. Average carrier level during various weather conditions.**

The typical chart recording for moderate to heavy rain showers is shown in Fig. 13(a). The rainfall rate for this particular example is approximately 3/8 in. /hour. Light to moderate rain caused very little signal degradation while heavy fog almost inevitably caused a loss of signal. Figure 13(b) shows the typical pattern for heavy fog where the fog temporarily lifts and then returns. It is interesting to observe the last part of this recording where the system is attempting to relock.

Only light to moderate snowfall occurred during the test period and is shown in Fig. 13(c). In this chart the signal loss was approximately 10 dB.
