TELEMETRY TRACKING OF SUMMER TRANSPLANTED ELK IN SOUTH CENTRAL WYOMING

RICHARD W. WEEKS and JERRY J. CUPAL
Electrical Engineering Dep.
Univ. of Wyo., Laramie

Summary Transplanting elk into regions where the native elk population is low is relatively common practice. Generally, these releases have been made in winter. This paper discusses the telemetry system developed for use on elk, and the behavior of elk transplanted during the summer. An optimum time for transplanting of elk appears to be during the rutting season.

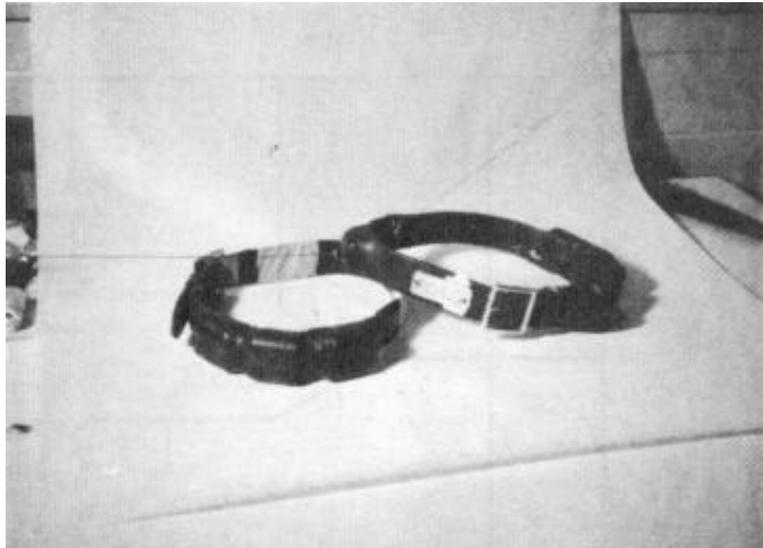
Fig. 5 - Two Collars with Whip Antennas Ready for Installation on Cow Elk Prior to Transplantation

The whip antenna was a 1/4 wave whip (172 MHz operating frequency) mounted in the center of a partial ground plane which consisted of a thin copper strap 1 1/2 inches wide and 18 inches long secured to the top of the belt. In air, this antenna had a driving point impedance represented by 390 ohms in parallel with 9 pf. When this collar was placed around the neck of one of the experimenters, the impedance characteristics changed to a resistance of 130 ohms in parallel with 12 pf. The range of this system was greater than 10 miles when the antenna was in free space. The signal strength, measured at 1/2 mile, was attenuated approximately 25% when the collar was placed on the neck of a domestic animal (horse).

On the collars used for the first transplant, the final packaging covered the electronics and the batteries with several layers of fiberglass cloth coated with resin (Fig. 4 and 5). The final collars (Fig. 5) had whip antennas made of .040 inch dia stainless steel wire. For the second set of collars, the entire battery-electronics package was potted into a solid brick of resin. This brick was reinforced with a layer of fiberglass cloth epoxied to the outside of the brick. These transmitters were equipped with loop antennas built into the collars (Fig. 6).

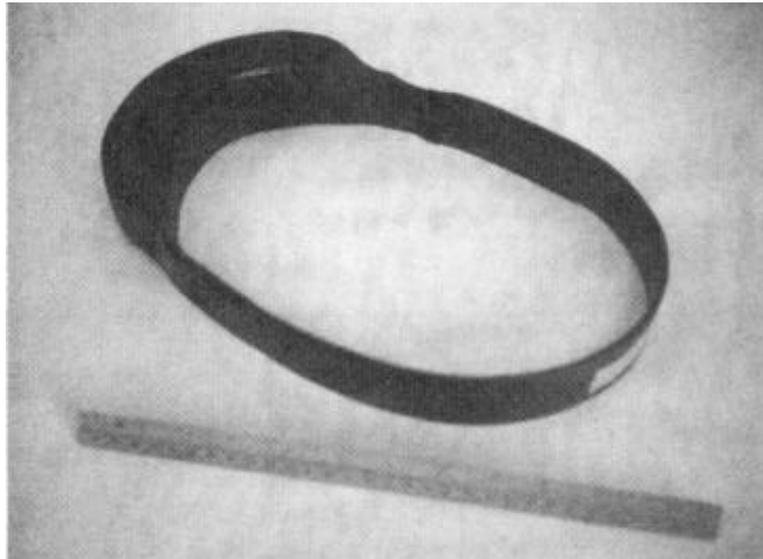
Fig. 6 - Finished Transmitter With Loop Antenna Built into the Neckband. A One Foot Ruler is Shown in Foreground.

The loop antenna used in the second transplant was a circular half-wave dipole (a half-wave dipole that had been circularly layed around the collar). Fortuitously, the half-wave length at 172 MHz turned out to be the circumference of the collar required for a mature cow elk. These loop antennas tend to have good radiation efficiency. The measured input characteristics of this antenna were 310 ohms resistive in parallel with .1 μh inductance when measured in air. When the antenna was wrapped around the chest of a large dog measuring 27 inches in circumference, it measured 430 ohms resistive in parallel with .6 μh inductive. The signal strength of this antenna was measured at approximately 1/2 mile distance and was found to be affected by a factor of two or three between the free air signal strength and the signal strength when the collar was placed around the neck of an
