IN-BORE ACCELERATION MEASUREMENTS OF AN ELECTROMAGNETIC GUN LAUNCHER

Edward F. Bukowski, T. Gordon Brown, Tim Brosseau
U.S. Army Research Laboratory
Advanced Munitions Concepts Branch
AMSRD-ARL-WM-BA
Aberdeen Proving Ground, Maryland 21005

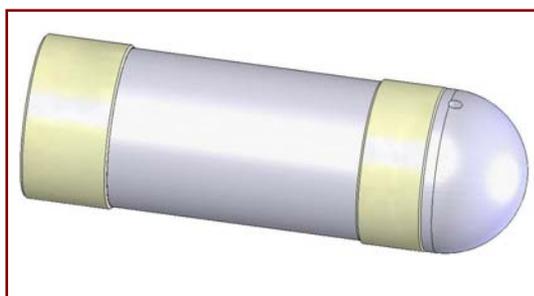
Figure 1: Test Projectile

The first step in this project was the development of a flight projectile for use in the EM gun. The projectile design used for these tests is shown in figures 1 and 2. The projectile had dimensions of 11.53cm in length and 3.81cm in diameter. Both inert, or dummy, rounds and instrumented rounds were fabricated. The dummy rounds were made of solid aluminum and would be used as preliminary shots to verify the test set-up. The instrumented rounds were also made of aluminum with a solid nose section and hollowed out body which would hold the electronics package. Each round had a weight of around 250 grams and included nylon bands which would insulate the projectile from the rails. An EM armature was used in each test to push the projectile down the tube and would become detached once the projectile exited the gun.

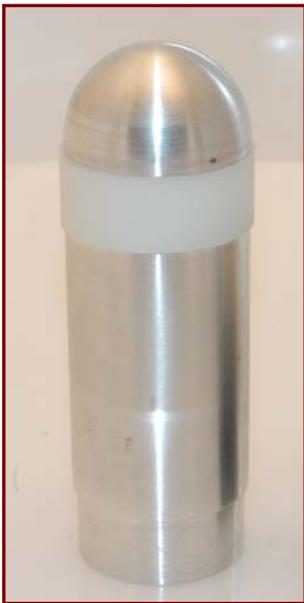
Figure 9: Dummy Projectile

Dummy rounds, which were identical in shape and size to the instrumented rounds, were used to verify that the test setup would work as expected. A major concern was whether or not the soft-catch recovery system would indeed successfully capture the rounds since this had never been tried before. The first two projectiles fired, shown in figures 10 and 11, were successfully caught and recovered, but were severely damaged during the process. In order to avoid damage to subsequent rounds, the catch tube configuration was modified in-between each of the tests until an optimum setup was found. A third dummy round was fired and successfully recovered with no apparent damage as shown in figure 12.

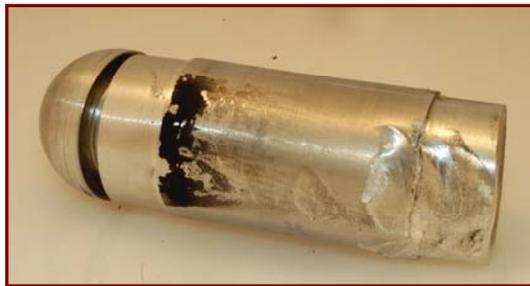
Figure 10: Dummy Projectile #1

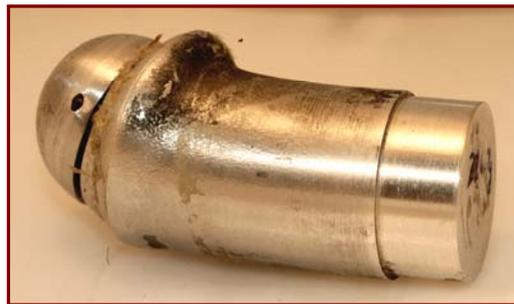
Figure 11: Dummy Projectile #2

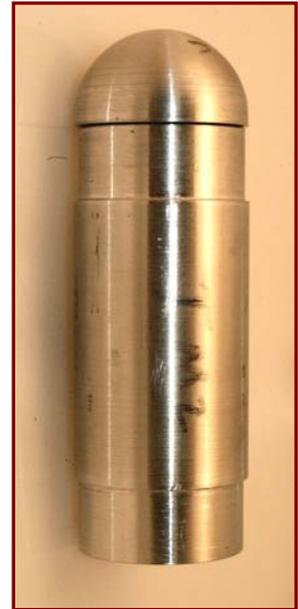
Figure 12: Projectile #3
Successfully Recovered

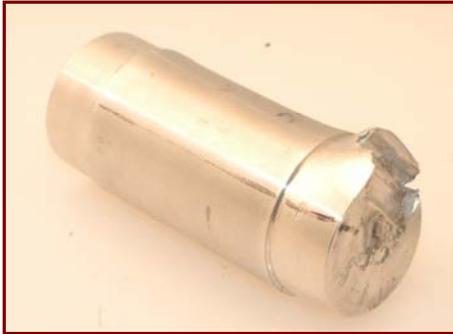
Figure 13: Unit #1 After Recovery
Back End of Projectile Damaged

After the first successful recovery of a dummy projectile, the first instrumented round, unit #1, was fired. Unfortunately, the round was damaged during the shot, figure 13, and no data was recovered. In order to determine the exact cause of failure, an X-ray analysis of unit #1 was conducted, figure 14, and then the electronics module was extracted, figures 15 and 16. It was determined that the reason for failure was due to damage to the batteries located in the back end of the projectile. Additional testing showed that while the batteries were no longer functional, the electronics and sensors were still working properly. This was very encouraging considering the amount of damage present on the round.

After further consideration, it was concluded that the damage to the round was not caused by the recovery system, but rather by the armature hitting into the back of the projectile once in the catch tube. It was initially believed to be an isolated incident and firing of the instrumented projectiles continued. Unit #3 was the next projectile fired and was successfully recovered with no damage to the projectile. Data was successfully downloaded from the unit and is examined in the next section. However, after firing unit #3 a second time, the unit was damaged and the data was lost due to a failure of the batteries. Photos shown in figures 17 and 18 prove that the damage was once again caused by the armature impacting the back of the projectile once inside the catch tube. While this was initially thought to be an isolated incident, these results showed that further modifications to the recovery system were necessary.

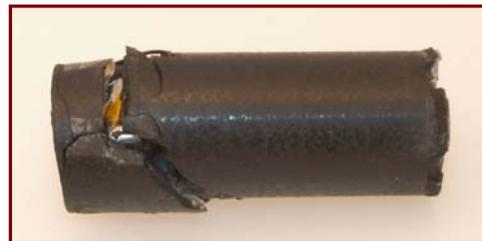
Figures 15 and 16: Unit #1 Electronics Module After Extraction
Back End of Module (location of batteries) Badly Damaged

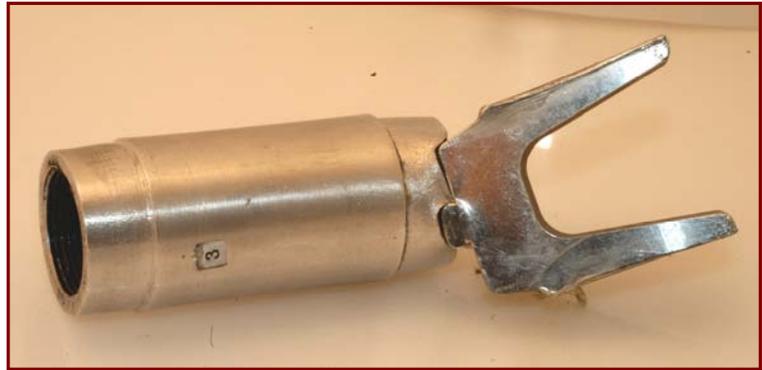
Figure 18: Unit #3 with Recovered Armature
Damage Apparently Caused By Armature Impact into Projectile
