**DEVELOPMENT OF EARTH FISSURES
IN PICACHO BASIN, PINAL COUNTY,
ARIZONA FROM 1959 TO 1989**

A Report to the U.S. Bureau of Reclamation and
the Arizona Department of Transportation

Arizona Geological Survey
Open-File Report 89-10
December 1989

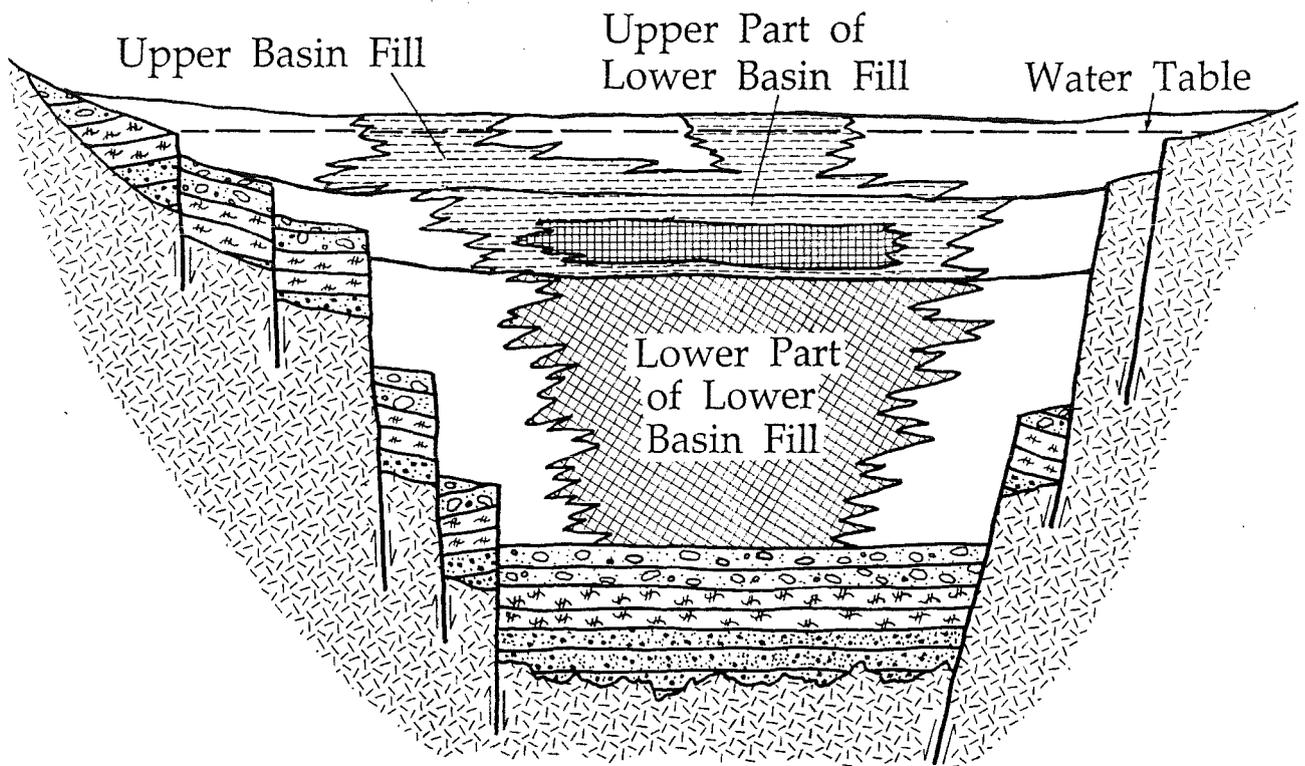
Picacho basin is a deep structural trough filled with terrigenous deposits of middle and late Cenozoic age (Figure 3). Units that pre-date the Basin and Range disturbance include

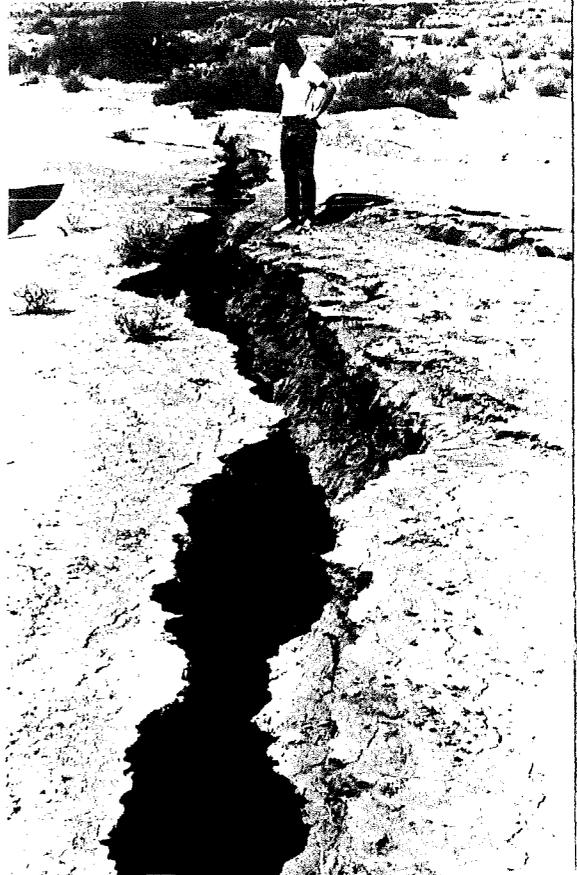
Figure 4. Very young fissure (16332b on Table 1) with vertical walls, irregular floor, and no vegetation concentrated along it. This fissure rendered a dirt road impassable. See Plate 6 for location.

up to 500 m (1640 ft) or more. Fissure walls are very steeply sloping or vertical (Figures 4 and 5), and fissures may be several meters (tens of feet) to tens of meters (scores of feet) deep (Strange, 1983). It has been postulated that some fissures may extend from the ground surface to the original water table that was present before excessive ground water extraction drained the aquifer (Holzer and Davis, 1976). Very young fissures interrupt drainage channels that cross them and display no "tributary" drainageways (headcuts) that feed into the fissures. They have no concentrations of vegetation along them, but there may be disrupted plants which have fallen or shifted. Some display series of en echelon cracks. The bottoms of very young fissures (where observable) are steeply sloping, irregular, and V-shaped. In other cases, coherent down-dropped "graben" blocks occur.

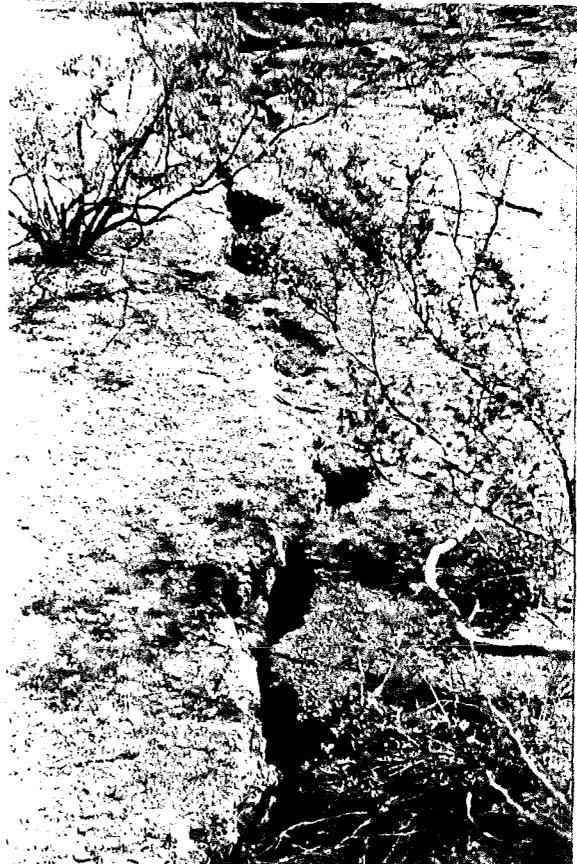
Figure 5. Another example of a very young portion of a fissure (14413 on Table 1), showing a discontinuous crack up to 19 cm (7.5 in.) wide with vertical walls and little disturbance of surroundings. See Plate 1 for location.

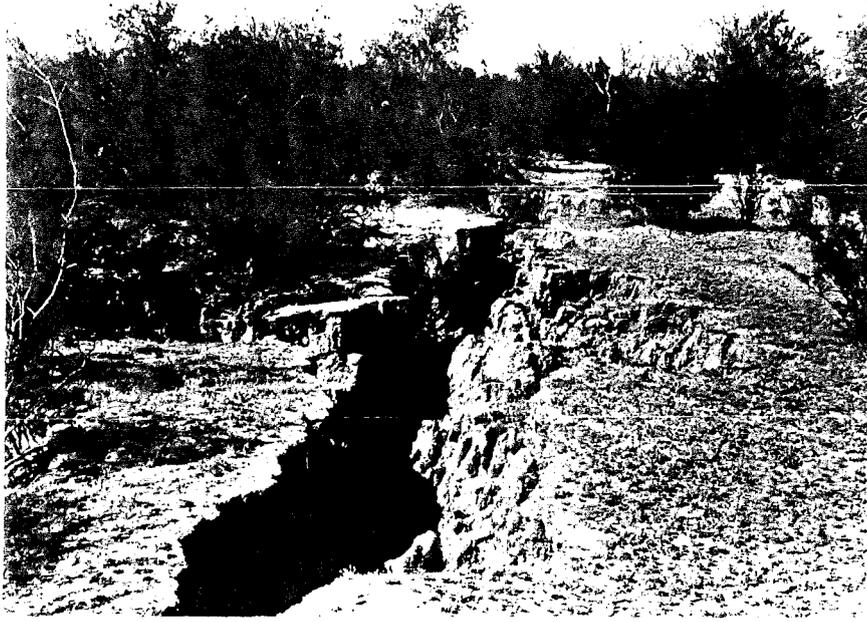
Figure 6. Young fissure (9311b on Table 1), which has undergone erosion and mass wasting, is wider and has less steeply sloping walls than a very young fissure. See Plate 2 for location.

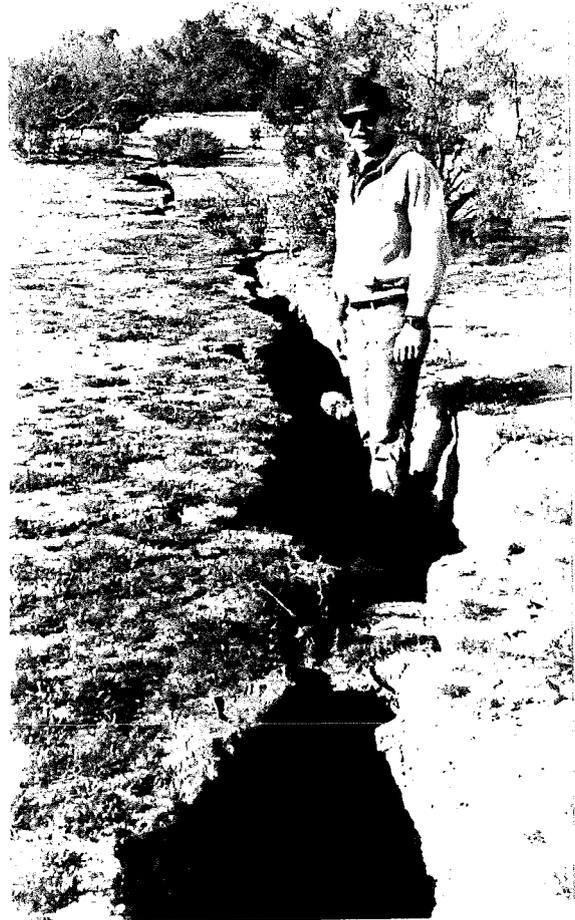
Figure 7. Young fissure (1522 on Table 1) is becoming a fissure gully. See Plate 1 for location.

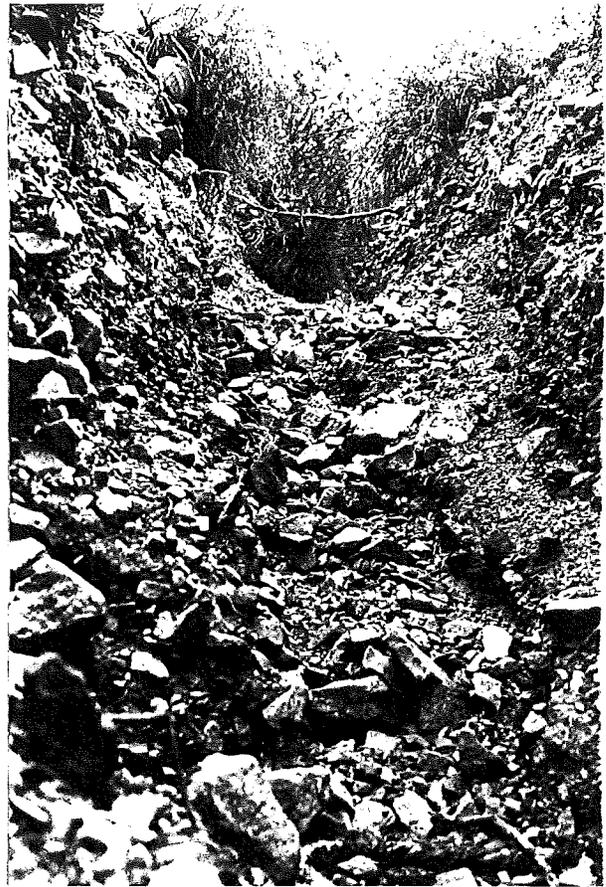
Figure 8. Flat floor and U-shaped cross section typical of mature morphology. This fissure (332 on Table 1) is classified as young based on a consideration of all of its morphologic parameters. See Plate 1 for location.

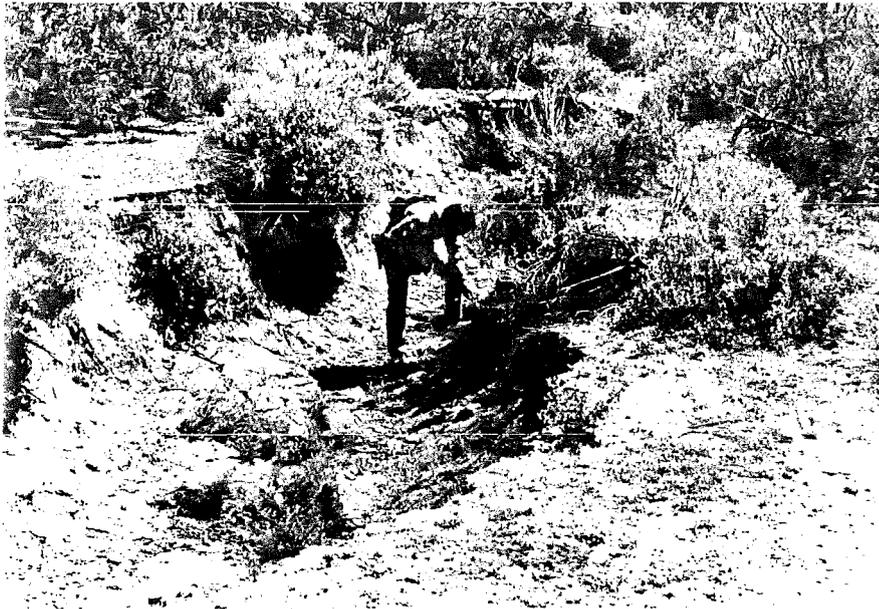
Figure 10. Old fissure (28331 on Table 1) is shallow because of infilling by sediment. Notice flat floor, gently sloping wall on right, and presence of vegetation. See Plate 1 for location.

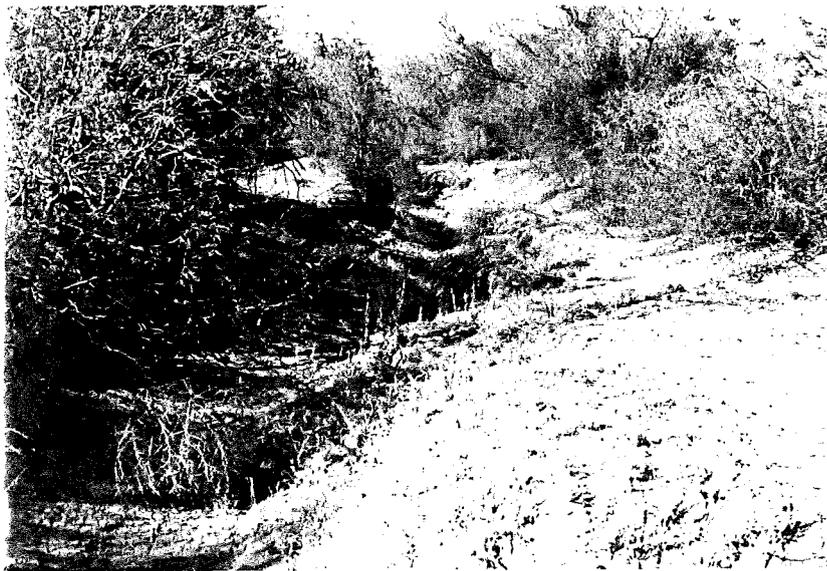
Figure 11. Old fissure (8311b on Table 1) is characterized by smooth slopes, large width, shallow depth, and rounded profile. Large plants line the fissure. See Plate 1 for location.

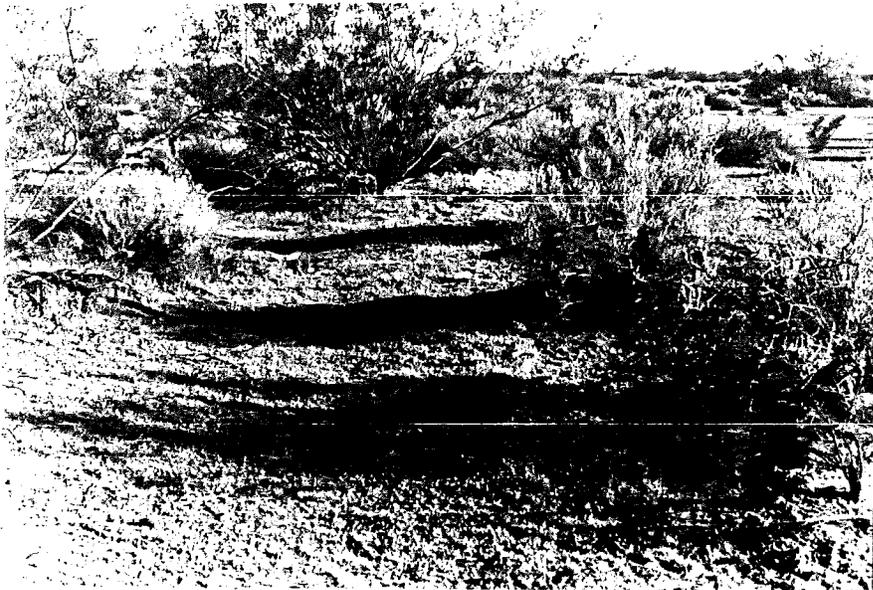
Figure 12. Very old fissure (6431 on Table 1) appears as a barely discernible swale lined with widely scattered creosotebush. See Plate 6 for location.

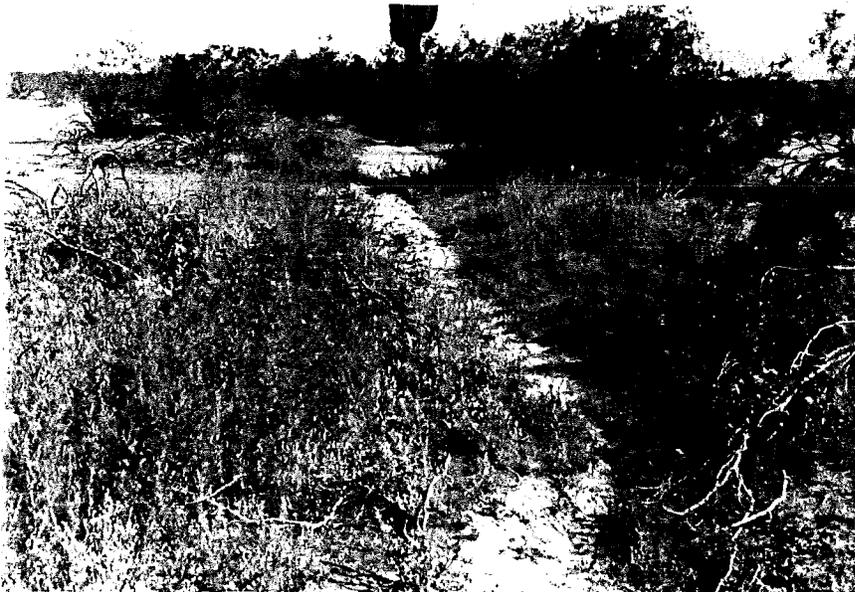
Figure 13. Very old portion of an old fissure (6411 on Table 1) is subtle and almost completely filled with sediment. A band of concentrated vegetation is the most striking indication of the feature's presence. See Plate 6 for location.

5) Very Old Fissures. Very old fissures, and those that occur in rapidly subsiding sub-basins or in areas with high sedimentation rates, may be difficult to recognize. They appear as faint discontinuous lineaments on aerial photographs and some are nearly invisible in the field. Fissure gullies are completely or almost completely filled with sediment, so walls are nonexistent or very low (up to 15 cm [6 in.] high) and gently sloping (Figure 12). Floors are flat and smooth, although some display mudcracks that are larger, thicker, and better developed than mudcracks on adjacent ground. Cross sections are so subdued and regular along some very old fissures' entire lengths that the possibility must be considered that the features are actually abandoned streambeds, wagon trails, canals, or other types of man-made furrows. "Tributary" drainageways are long and in many cases are filled with sediment. Vegetation is not as concentrated as it is along some fissures that are not quite as old, but it may still be the most compelling indication that the feature actually is a very old fissure that retains water longer than the surrounding land (Figure 13).

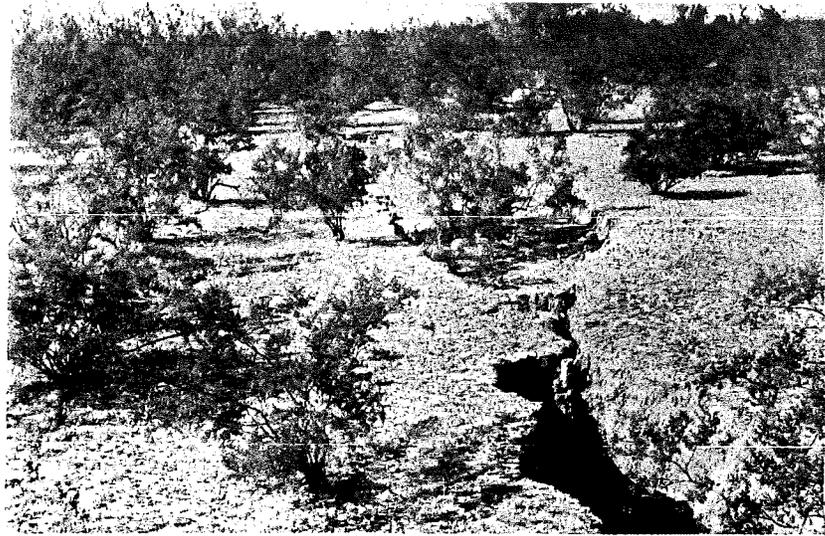
Figure 14. Young and very young cracks (9311b on Table 1) indicate that the old fissure located outside of the field of view to the left has been reactivated recently. See Plate 2 for location.

Evidence of reactivation of earth fissures was discovered at 20 of the 51 field sites visited. Reactivation is manifested in two ways: 1) Younger cracks, pits, and/or depressions occur adjacent and subparallel to a fissure. Such features found along very young fissures merely indicate on-going development, but along subdued older fissures they demonstrate reactivation (Figure 14). Subparallel surficial cracks may represent only a single fissure at depth. 2) One or more benches exist above the bottom of the main fissure gully (Figure 15). Such benches may show the location of a previously formed fissure floor which has been broken by renewed tension (indicating reactivation). Alternatively, they may be simply bridges that formed as the fissure filled with sediment which was subsequently partially removed by erosion, or they may result from delayed compaction of fill sediment (not related to reactivation). Benches above the floors of "tributary" stream channels emptying into fissure gullies, however, do indicate possible reactivation.

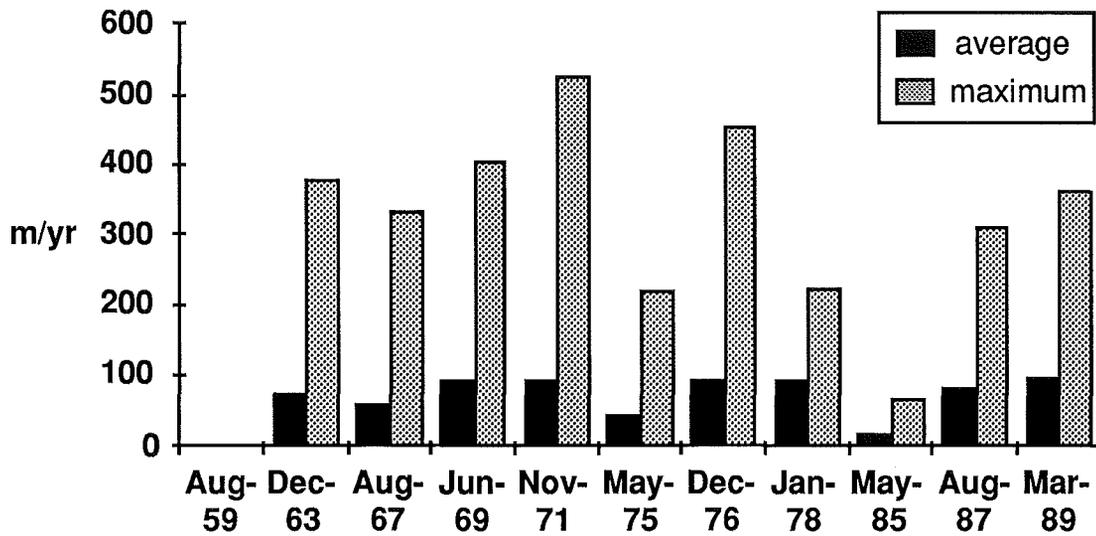
Figure 16. Propagation rates of individual fissures in the portions of Picacho basin covered by repeated aerial photo surveys. "Average" values represent the average rate of lengthening of those fissures that were active during any given interval; "maximum" values are the maximum rate of lengthening observed for any fissure during the same interval. The average rate of lengthening for all fissures active between 1959 and 1989 is 76 m/yr.

Propagation Rates. Rates of lengthening (or gap-filling) vary substantially from air photo survey interval to interval. The average propagation rate of individual fissures over the entire 29.5-year period of record is approximately 76 m/yr (249 ft/yr). This rate was calculated by dividing the total length of fissures that developed during each interval between air photo surveys by the number of fissures that lengthened during each interval; fissures that were not active were not included in the calculations. Average rates range from approximately 100 m/yr (330 ft/yr) during the past two years to approximately 20 m/yr (66 ft/yr) between 1978 and 1985 (Figure 16). The maximum propagation rate of any fissure in the study area is 529 m/yr (1736 ft/yr). During the interval from 1976 to 1985, no fissure lengthened more rapidly than 70 m/yr (230 ft/yr). Clearly, fissures may propagate rapidly, and apparently they tend to lengthen most rapidly during intervals when many fissures are active (see below for further discussion).

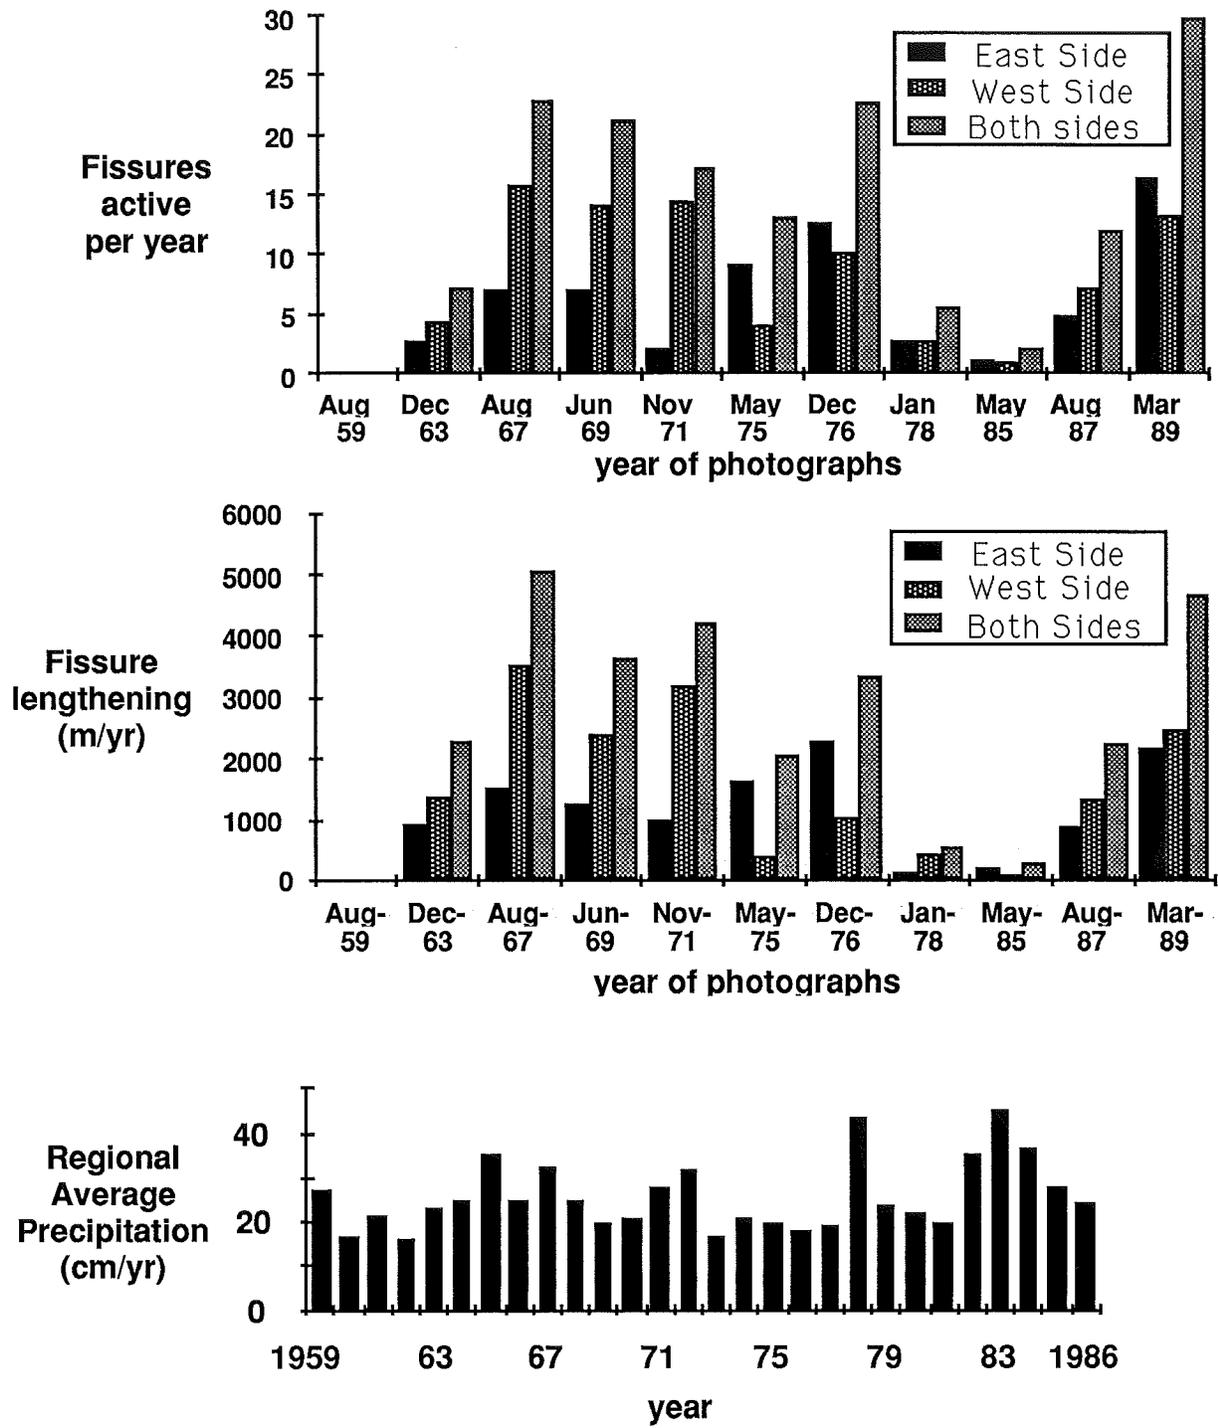
Figure 17. Active fissures and lengths of fissures developed on the east and west sides of Picacho basin, and regional trends in annual precipitation for the years since 1959. Rates are normalized to an annual basis because of the different intervals between aerial photo surveys.

Patterns of fissure activity are more complex if the east and west sides of Picacho basin are considered separately. The mid- and late 1960's was the period of maximum activity in the Casa Grande Mts. quadrangle, on the west side of the basin. During this interval the Newman Peak quadrangle (Red Rock NW orthophotoquad), on the east side of the basin, experienced moderate to low levels of fissure activity. In the early to mid-1970's the situation was reversed, with high rates of activity in the Newman Peak quadrangle and low to moderate rates in the Casa Grande Mts. quadrangle. Thus, the east and west sides alternately experienced moderate to high rates during these intervals. There has been little difference in rates of fissure activity on either side of the basin since 1976.

Total Propagation Rates. The most quantitative measure of activity is the total length of fissures that developed between air photo surveys. This measure, also normalized to rate of lengthening per year, reveals the same general patterns as the number of active fissures per year discussed above. The highest rate of fissure-lengthening occurred during the 1963-1967 interval, but the rate during the 1987-1989 interval is almost as high (Table 2; Figures 17 and 18). In the 1960's, primarily the west side of Picacho basin experienced high rates of activity, and the east side was more active during the early to mid-1970's. The east and west sides exhibited nearly identical rates from 1977 to the present, with very little lengthening occurring between 1977 and 1985, and increasing rates since 1985.

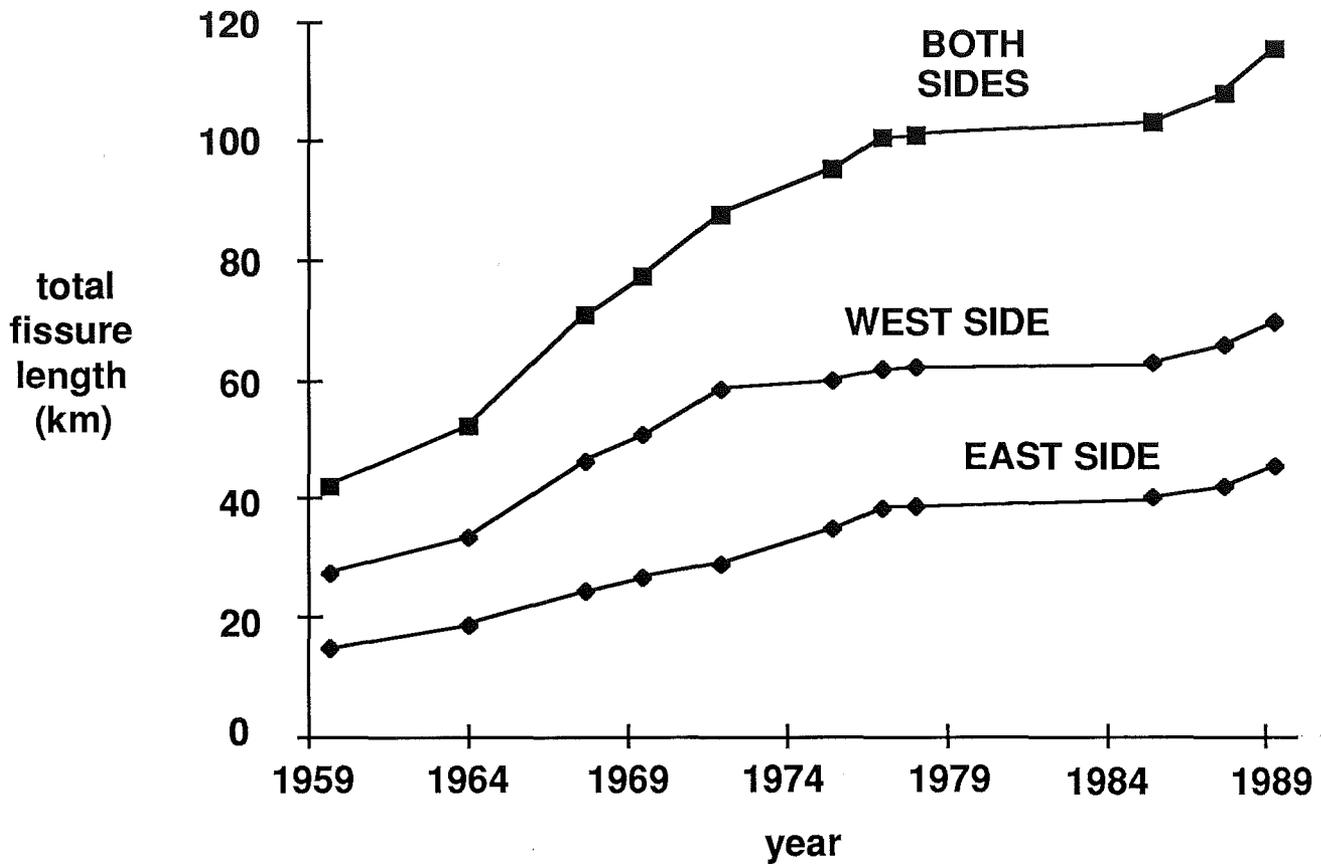
Figure 18. Cumulative lengths of earth fissures measured from repeated aerial photo surveys, Newman Peak and Casa Grande Mountains 7 1/2' quadrangles on the east and west sides of the basin, respectively. The slopes of the curves are the rates of fissure lengthening. There are some differences in the rates of fissure development on the east and west sides of the Picacho basin in the 1960's; both sides of the basin had very low rates of fissure development in the late 1970's and early 1980's, and rates of fissure development have increased on both sides in the late 1980's.

Substantial numbers of fissures existed on both sides of Picacho basin prior to 1959. In the area covered by repeated air photo surveys on the east side of the basin, approximately 46 km (29 mi) of fissures were recorded on the 1989 photographs; about 32% of these (15 km [9 mi]) existed in 1959. On the west side, approximately 70 km (44 mi) of fissures were observed on the 1989 photographs, and about 39% of these (27 km [17 mi]) existed by 1959. Thus, each side has undergone a similar pattern of development, but the west side has had consistently greater cumulative fissure length (Figure 18).
