Re-aluminization of the 6.5m primary mirror at the MMT Observatory

William Goble¹, J. Duane Gibson, Dallan Porter, Ricardo Ortiz
MMT Observatory², University of Arizona, Tucson, AZ, USA 85721-0065

The MMT Observatory (MMTO) initiated a series of coating process improvement projects after an issue with the coating system in 2010 resulted in blemishes on the 6.5m primary mirror coating. Formally started in 2013, these projects focused on four major tasks: 1) development of a software-based system to control the tungsten filament power sources, 2) characterization of an integrally wound tungsten and aluminum filament, 3) prevent stray molten aluminum droplets from contacting the isolation membrane separating the high and rough vacuum sections of the system, and 4) assemble a coating facility capable of performing full-scale system testing. The completion of these projects was realized with the successful re-aluminization of the MMTO primary mirror in 2016. With a focus on the implementation of the process improvements, the present state of the MMTO coating system is described along with data from the 2016 re-aluminization.

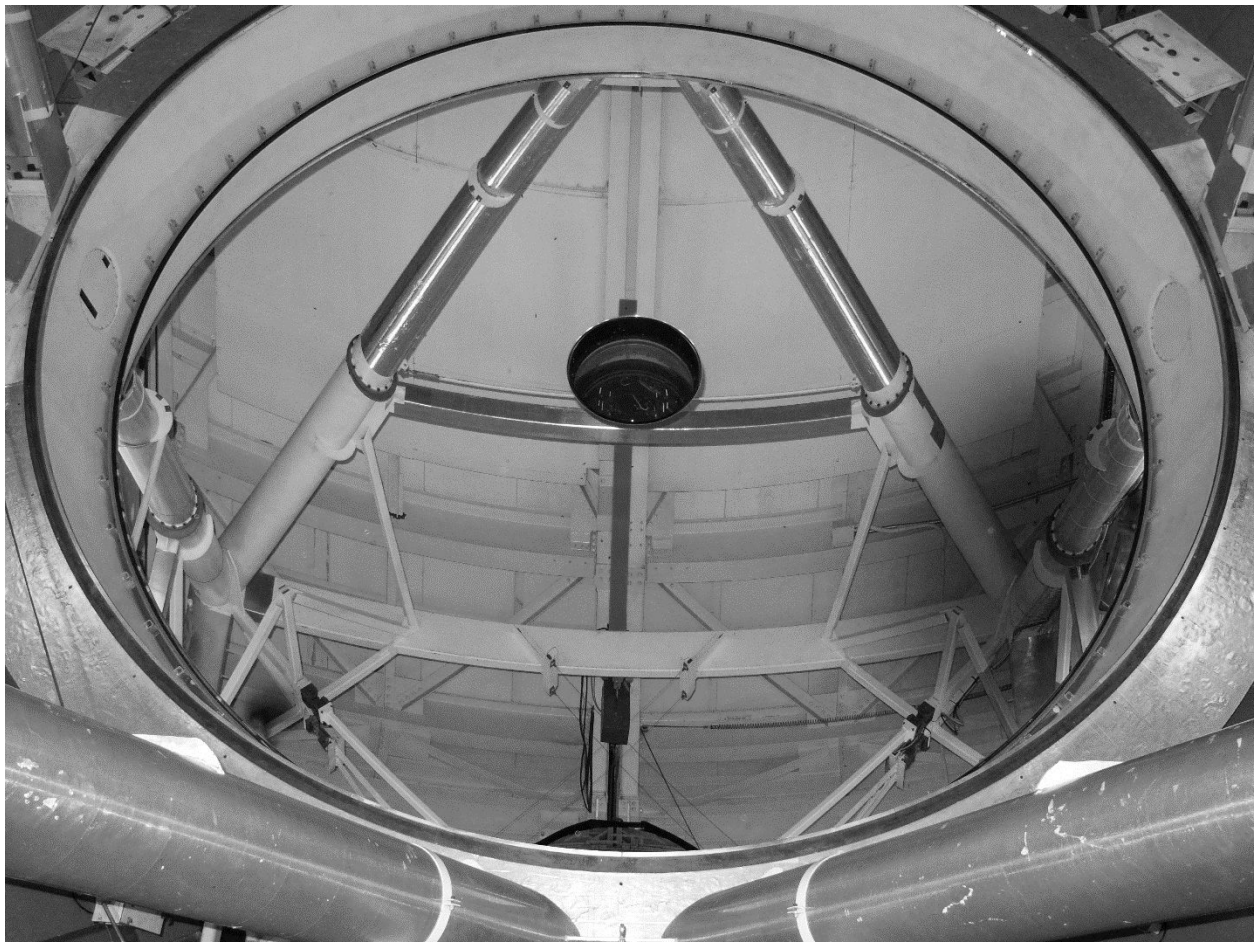
Figure 2 – MMTO 2010 mirror coating blemish. Two regions of the coating were contaminated. The largest brown spot is located around the 4 o'clock position (when looking at the surface of the mirror), and a smaller spot is located around the 7:30 position. A 0.61m (24-inches) wide x 6.1m (240-inches) long x 0.05mm (.002-inches) thick stainless steel sheet had been resting on the lower section of the isolation membrane (roughly between the 4:30 and 7:30 positions). This sheet prevented additional damage to the membrane and most likely greatly reduced the blemished area.

Although the coating deposited on the primary mirror in during 2010 summer shutdown was serviceable, this coating suffered from two visibly pronounced brown blemishes on the mirror surface as seen in figure 2. These brown regions resulted from the isolation membrane being compromised when stray molten aluminum droplets from the filaments contacted and melted through the membrane. A subsequent analysis of the data from this coating indicated the damage occurred when the filaments were warming up and before aluminum started to be deposited on the glass substrate. Since

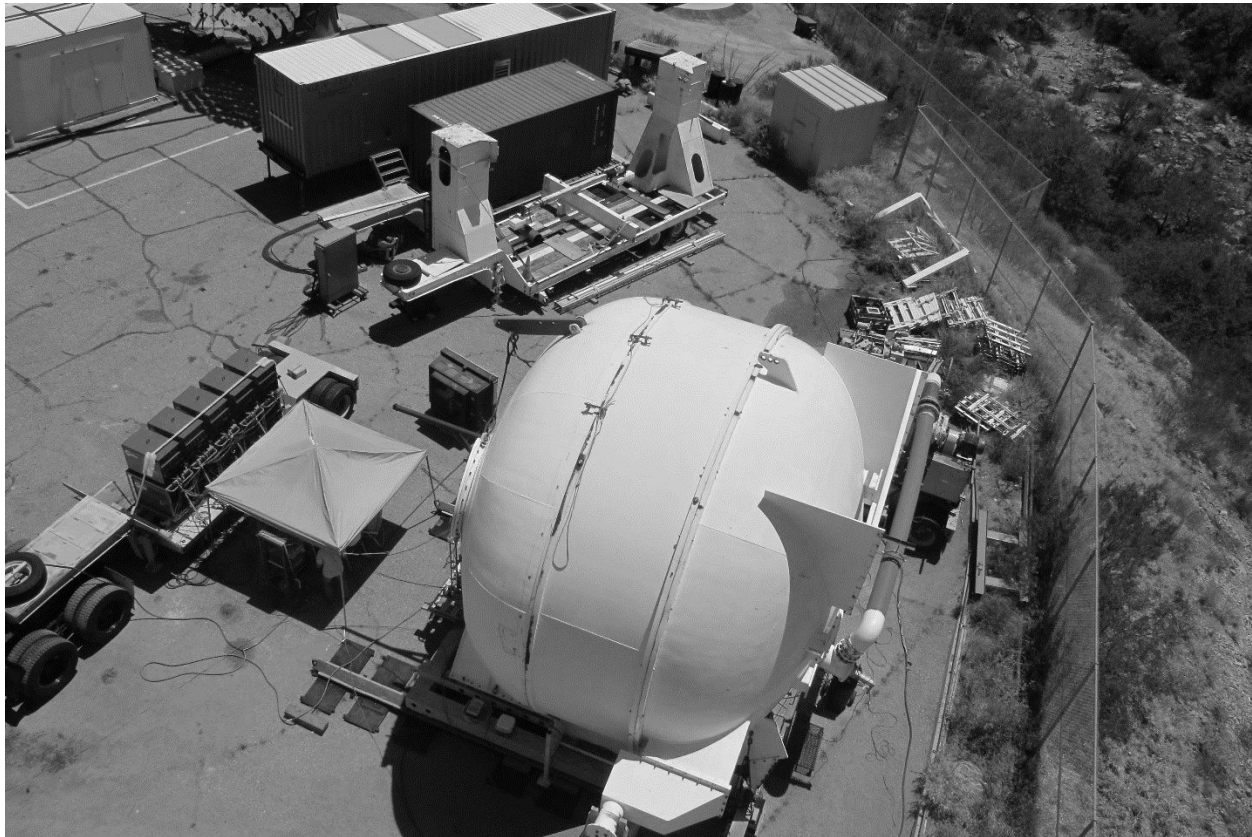
Figure 3 – MMTO full-scale coating test facility. There is enough electrical power available to run the vacuum pumps, but a mobile generator (in the long shipping container near the top of the image) was rented to provide power to the welders.

In the process of coating another 6.5m mirror, the MMTO acquired the components necessary to create a complete vacuum chamber without the mirror cell. These components had been in long term storage at the Fred Lawrence Whipple Observatory⁶ Base Camp facility in Amado, AZ. Assembly of the vacuum chamber at Base Camp started in the fall of 2015, and the first coating system test utilizing the new software-based system to control the power to all 200 filaments was performed on May 5th, 2016. This facility, as shown in figure 3, is only intended for system testing and was not designed to accommodate actual mirror coatings.

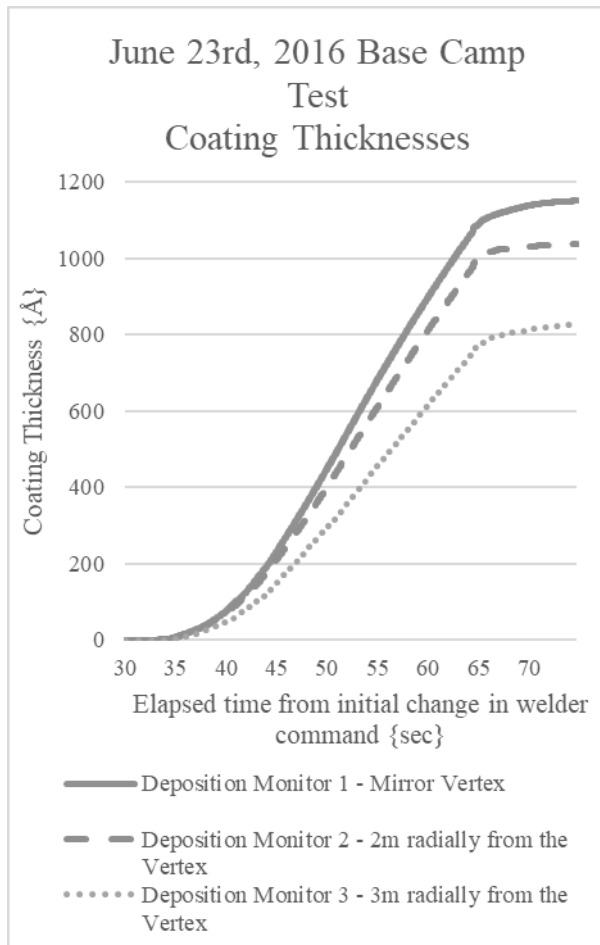
Figure 6 – Recorded coating thicknesses at different radial positions during the June 23rd, 2016 Base Camp test.

For the Base Camp tests, three deposition monitors were installed in the vacuum chamber on a fixture that approximated the optical surface of the MMTO primary mirror. For the first two tests, two of the deposition monitor crystals were installed at a location approximating the mirror vertex; this was done to replicate the coating system at the telescope in which two crystals would be installed near the vertex of the mirror in order to have redundant deposition rate and thickness measurements. The third crystal was installed at a location approximating the outer edge of the mirror at the 6 o'clock position (when facing what would be the optical surface). The full-scale tests at Base Camp were the first instance in which deposition data had been recorded at the outer edge of the mirror. During the first two full-scale tests, the coating thickness recorded near the edge of the mirror was roughly 75% of the center thickness. A visual inspection of the witness slides confirmed the applied coating was thinner at the outer edge than at the mirror vertex. Project deadlines did not allow sufficient time to investigate this issue, so a project decision was made to stop the coating process during next full-scale-system test when the center thickness was 1100 Å. This thickness was selected to help ensure the coating at the outer edge of the mirror would be thicker than 800 Å. In addition to increasing the target coating thickness for the June 23rd Base Camp test, the deposition monitor crystals were relocated to provide deposition measurements at three distinct radial locations: the mirror vertex, 2m from the vertex, and 3m from the vertex. The deposition data from these locations, figures 6 and 7, illustrate that the coating thickness can be expected to vary radially across the mirror. The recorded coating thickness at each location was: 1150 Å at the vertex, 1040 Å 2m from the vertex, and 830 Å 3m from the vertex. Based on these measurements, the coating thickness is probably reasonably uniform from the vertex to a radial distance of 2m, for the thicknesses measured at these locations are within 10% of each other. Similar to the first two full-scale tests, the thickness near the outer edge is 72% of the thickness measured at the vertex. The maximum deposition rate at each location varies in a manner similar to the thickness, for the maximum rates recorded were: 47 Å/s, 42 Å/s, and 33 Å/s, respectively. If resources are available before the next MMTO primary mirror coating, the facility at Base Camp will be used to determine the uniformity of the coating thickness provided by the existing system. Solutions to possibly improve the uniformity of the coating thickness may also be explored at that time.

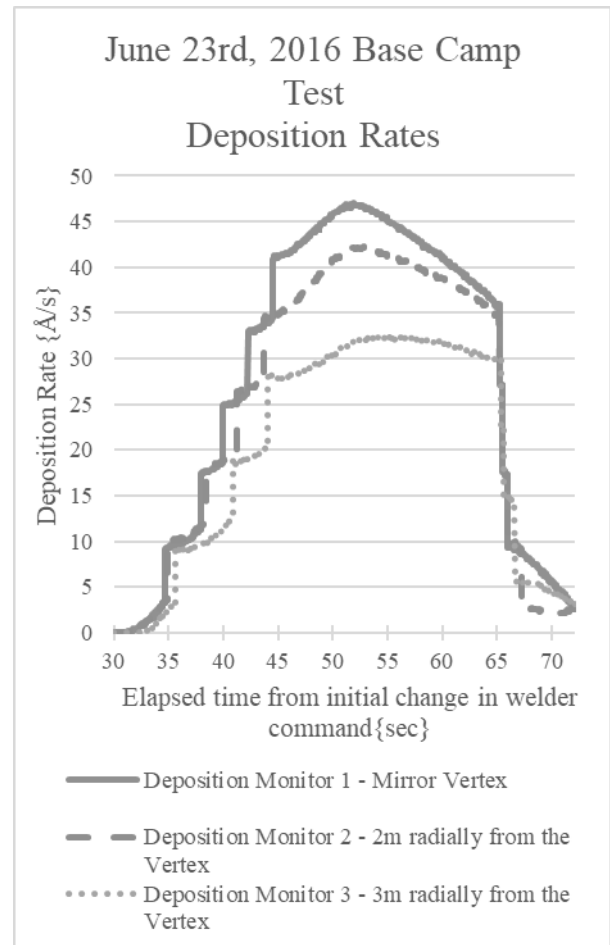
Figure 7 – Deposition rates at different radial positions during the June 23rd, 2016 Base Camp test.

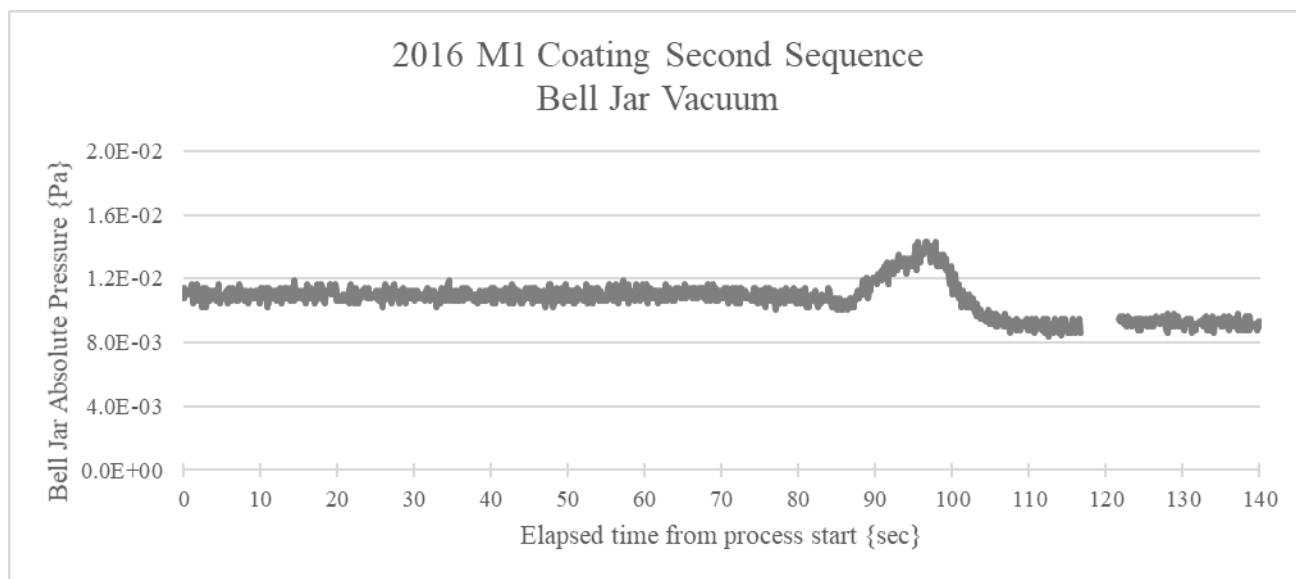
Figure 11 – Bell jar vacuum during the second primary mirror coating sequence. The bell jar pressure rose to 1.4×10^{-2} Pa (1.1×10^{-4} torr) during the coating process. For unknown reasons, logging of the vacuum data sensors stopped briefly when the filament power was shutoff.

this was better than Base Camp testing would have predicted (85% of the thickness at the vertex). The bell jar vacuum only rose to 1.4×10^{-2} Pa (1.1×10^{-4} torr) during this coating sequence.

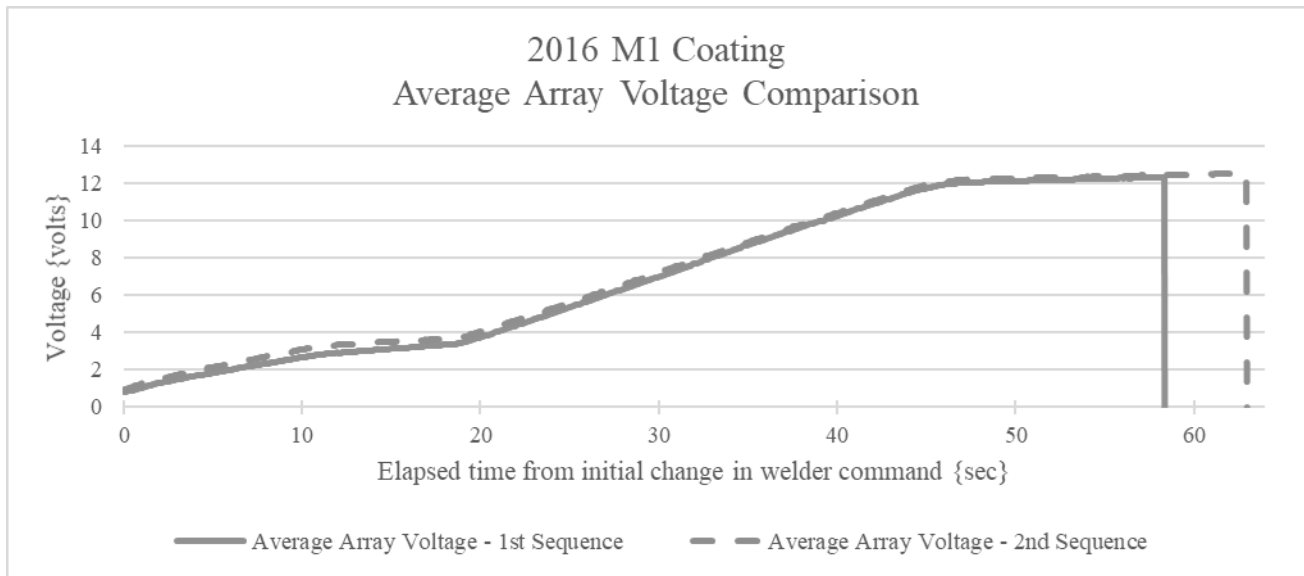
Figure 12 – Array voltage for both primary mirror coating sequences. The graphed array voltage is the average of the ten arrays measured at the electrical feedthroughs on the bell jar. The same welder command profile was used for both coating sequences.

Since the welders are voltage-controlled power supplies and the same welder-command profile was used for both coating sequences, the average array voltage was very similar between the two coating sequences, figure 12. However, the average array current was different, figure 13. This could be attributed to the aluminum being better distributed on the surface of the tungsten wire at the start of the second coating sequence (pre-wetted filaments).

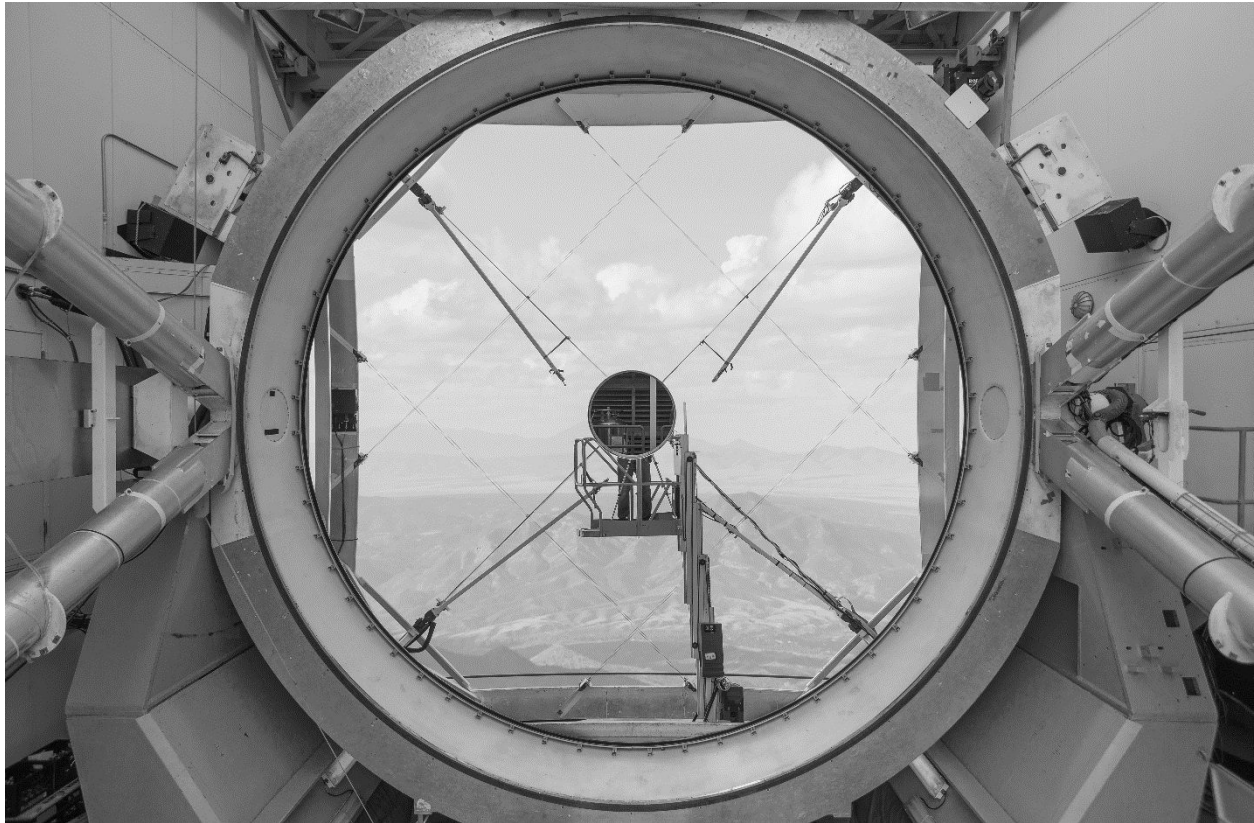
Figure 14 – MMTO primary mirror shortly after being recoated in 2016. This image was taken after all of the coating equipment had been removed but before the telescope was returned to normal operations.

After a three-day holiday weekend, the bell jar was opened on September 6th, 2016 to reveal a high quality coating. A few cleaning marks (small localized spots where the coating appears hazy under certain lighting angles) were present, especially in the 3 o’clock position (when facing the optical surface) of the mirror. This area is near the east access platform and is where personnel leave the mirror surface at the end of the cleaning process. In two places, a very small region (approximately 2cm wide x 8 cm long) near the outer edge of the mirror was not coated with any aluminum. These bare areas were most likely shadowed from the filaments by the isolation membrane or the aluminum shield.

Witness slides from both the center and the perimeter of the mirror were completely opaque, so the slides appear to be consistent with the recorded thickness measurements. While a tape test was not performed on the primary mirror, no adhesion issues were noted when the tape test was performed on randomly selected witness slides. Figure 14 shows the MMTO primary mirror after all of the coating equipment had been removed from the telescope.

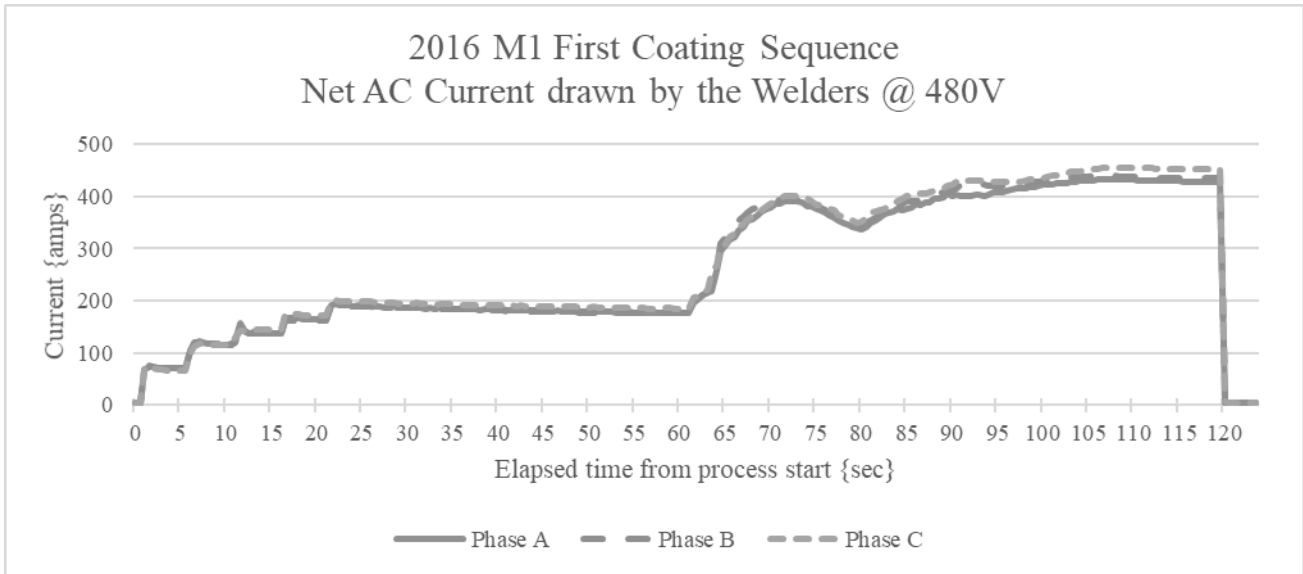
Figure 15 – Current drawn by the ten welders during the first coating sequence. The power from the generator set to the breaker panel for the welders was delivered via seven 4/0 cables, two for each phase and a ground. The current probes for each phase were wrapped around both wires of the respective phase.

During the first coating sequence, a Fluke Corporation⁷ 435 power analyzer was used to record the incoming AC power to the welders from the rented 1250 kVA generator set. Figure 15 shows the peak current for each phase throughout the coating process. With a maximum recorded current of 480 amps at 480 volts, the generator set could potentially be downsized for future coatings. While this unit was anticipated to have much more capacity than required, a key factor for selecting this specific generator set was the short wheelbase trailer the unit was packaged on; this allowed straight-forward transportation to and from the summit of Mount Hopkins.
