Arroyo Formation, Juab County, Utah, 1983

James L. Baer

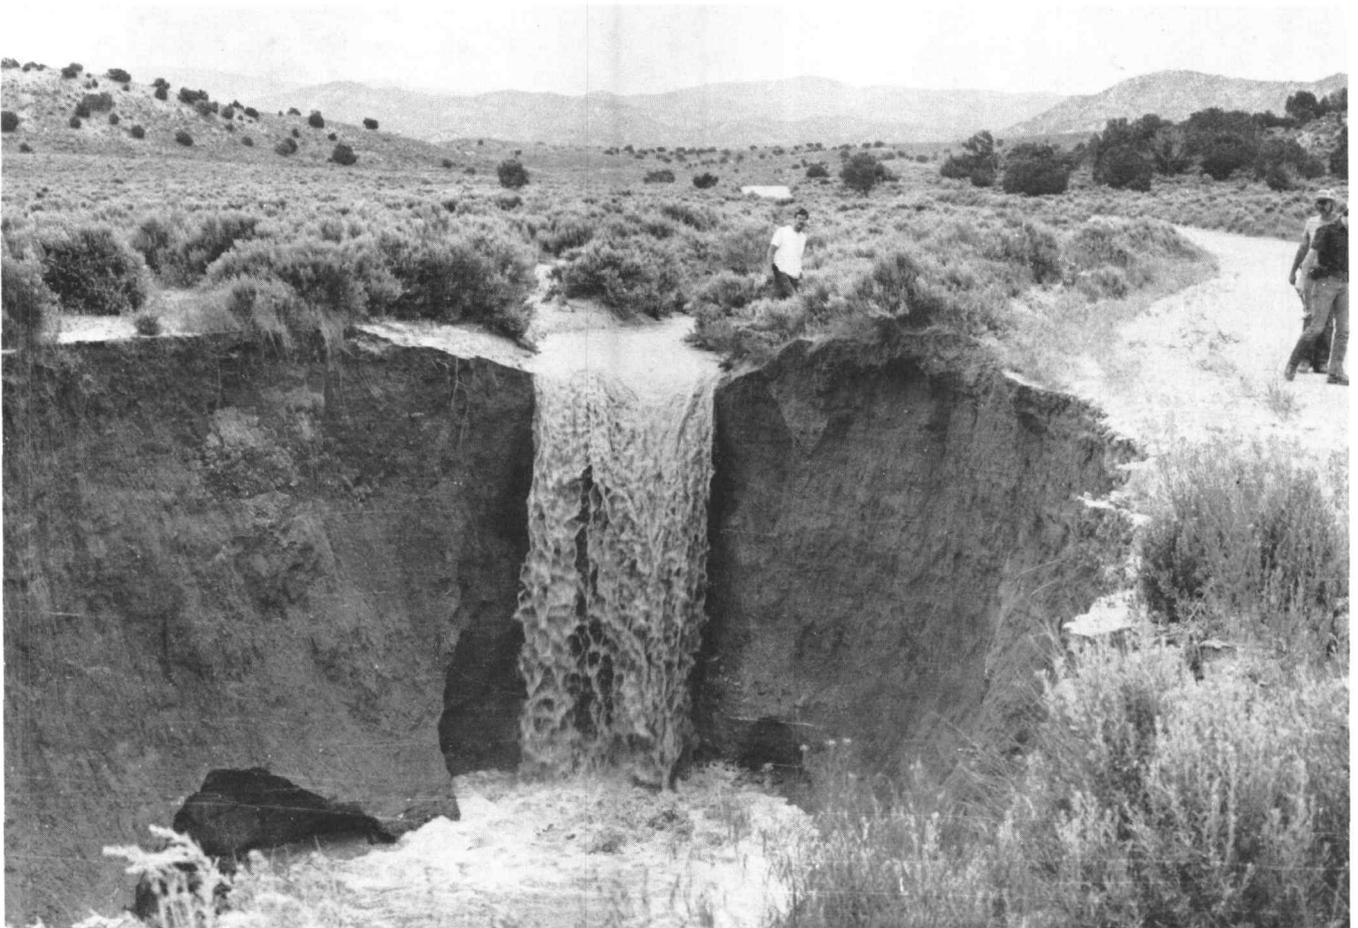
Waterfall as it was at the beginning of first observation, June 11. Fall is nearly 20 feet.

On June 11, 1983, while conducting a field geology class, I happened upon a waterfall in Chriss Creek. The waterfall had developed over a 17- to 20-foot elevation difference and the newly developed arroyo differed markedly in size and shape with the upstream channel. The waterflow, which at that time was flowing approximately 55 cubic feet per second was eroding the streambed at a high rate. After a short observa-

On June 11, the erosion was observed for six hours. The rate of headward erosion was 4.7 feet per hour with a volume of 1450 cubic feet of material being eroded per hour. The process was unvarying. The waterfall developed a 10 to 14 foot wide plunge pool at its base where this whirling water would undercut both banks as well as upstream. The material being eroded was wet, unconsolidated silt with lenses of

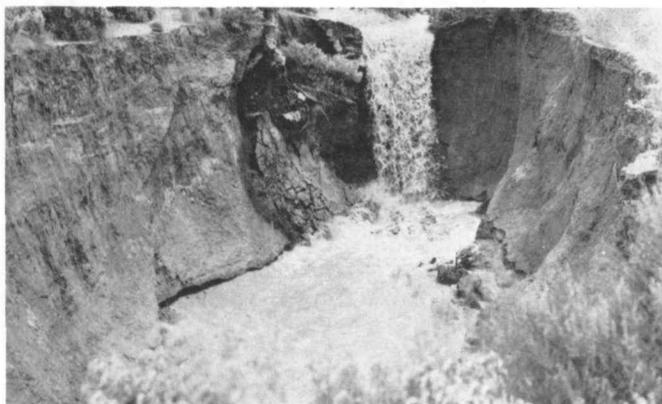
Bank erosion occurred by undercutting and gravity fall of blocks. Here a block falls from the left bank during the first day of observation, June 11.

fine sand and occasional thin gravel layers. This material was easily eroded by the moving water. But it was the caving from the banks that was the major contributor to erosion volume. These blocks would fall at a rate as high as one every three minutes. Some blocks were 16 feet long, 13 feet high, and 3 feet deep. The area was covered with sagebrush at a density of one per 30 square feet. There were also small patches of grass that dotted the landscape. The plants offered little impedence to the advancing erosion primarily because the cutting took place 10 to 12 feet below the root systems of the sagebrush. The sagebrush served mostly to hold together the blocks before they fell into the stream. The sagebrush crested blocks would sometimes serve as temporary dams that would block the stream momentarily. Eventually, the water would spill over the debris and within a few minutes there would be no trace of the block as the detached sagebrush plants washed downstream. Occasionally, these sagebrush plants would hangup and create an eddy or small whirlpool in the stream. This would allow the stream to undercut the bank downstream from the waterfall and cause isolated blocks to fall, further widening the new channel. Crude measurements of the water volume indicated approximately 55 cubic feet per second going over the fall. At this time the water was falling between 18 to 20 feet.

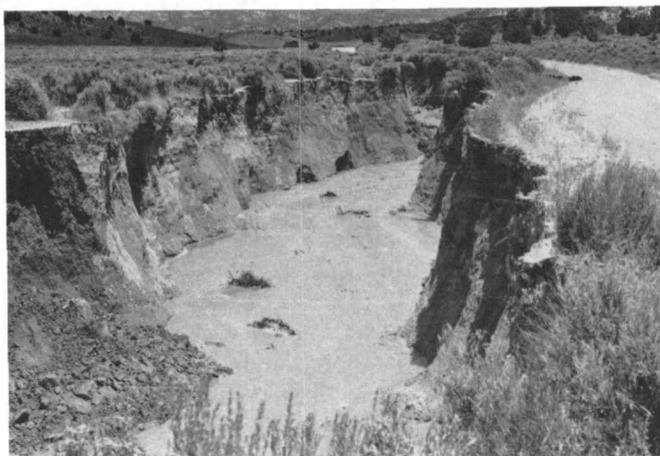
Headward erosion as seen from the spot of figure 1 on June 13. Waterfall has moved 440 feet upstream in 48 hours.

During the 48 hours that followed, the channel cut headward nearly 440 feet at a rate of 9.1 feet per hour and a volume of approximately 3100 cubic feet per hour was carried away. By now, the erosion had progressed so far upstream that a

picture taken from the spot of the first day's observation did not show the waterfall. During this period, the erosion had cut into a nearby road, threatening safe passage.

The second period of observation, June 13, was 5.5 hours in length. The erosion scheme was the same, but the rate had increased over four times. Headward erosion was 21 feet per hour, and the eroded volume had increased to 7,100 cubic feet per hour. The fall had decreased slightly to 16 feet, but the average channel width had increased to 21 feet. The approximate rate of water flow had increased to approximately 70 cubic feet per second, and the water level was noticeably higher in the upstream channel.

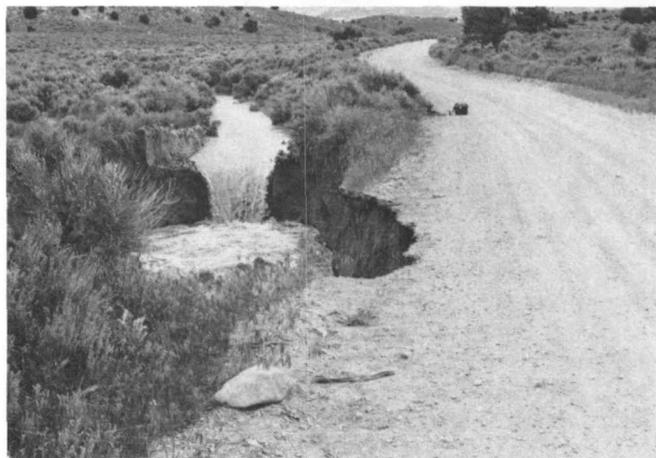
Waterfall at time of last day of observation, June 15. Fall is now just less than 6 feet. Erosion had taken away part of nearby road.

No observation could be made for the next 52 hours because of other responsibilities. Upon return to the site on June 15, the waterfall was much less (Fig. 4). During the 52

hours, the headward erosion had progressed another 597 feet at a rate of 11.5 feet per hour, nearly 10 feet per hour less than the previous observation, clearly showing the erosion rate was lessening. During the four hours of observation on June 15, the headward erosion was progressing at 0.7 feet per hour—virtually a snail's pace. The stream was now to

where it occupied less than its prescribed channel and was flowing approximately 36 cubic feet per second and the fall was 6 feet and decreasing.
