Woodland Drag Chain Seeder

Joseph A. Wagner

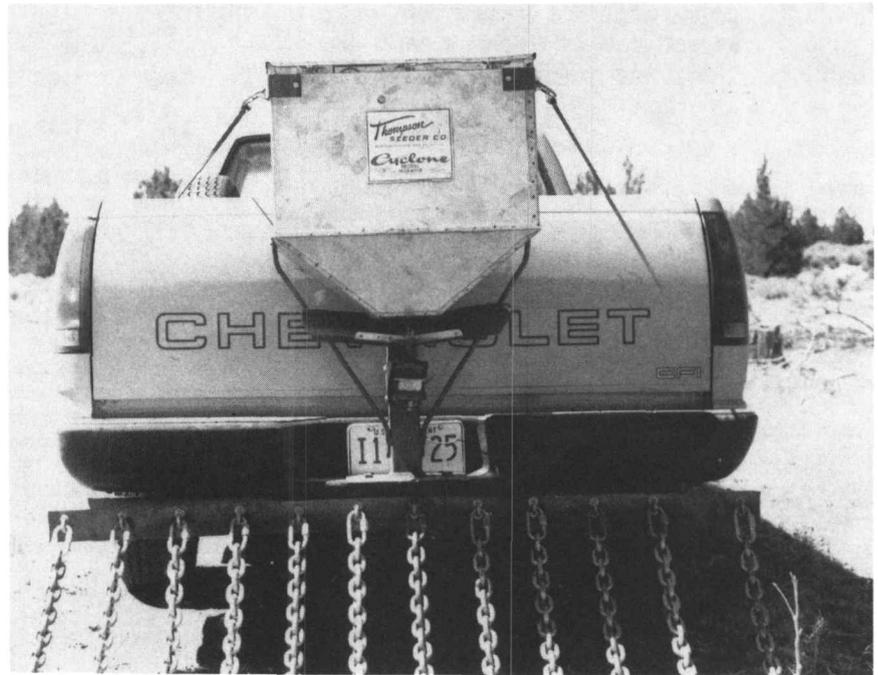
Rear view showing the bumper mounting of the cyclone seeder, drawbar and drag chains with quick-link mounts.

A second cyclone seeder and drag chain system was developed to overcome the above short-comings. The seeder was a 12-volt electric Thompson cyclone-type mounted on top of the bumper of a standard pickup truck.¹

The drag chain apparatus fits below the seeder and beneath the bumper of the pickup. The seed is distributed and covered by the drag chains in one pass of the vehicle. The drawbar was made from a six-foot length of four-inch angle iron. U-bolts were fastened at six-inch intervals on the drawbar and provide the attachment point for the individual drag chains. The chains are 1/2-inch coil links, attached in alternating 10 and 12 foot lengths across the width of the drawbar. Attachment of the drag chains to the drawbar is made by 1/2-inch Quick Links attachments which allow the chains to be easily removed from the drawbar for transport and stor-

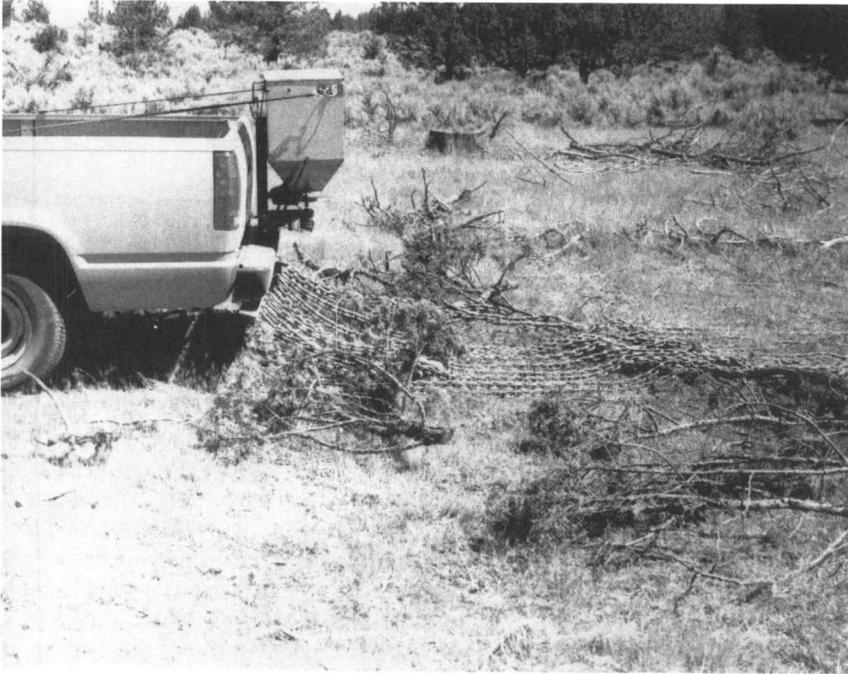
Side view showing the action of the drag chains over woodcutting debris.

The straight length of chain rarely hangs up on debris or stumps, even under very trashy seeding conditions. The chain will pick up small branches, but is basically self-cleaning due to the twisting motion of the chain.

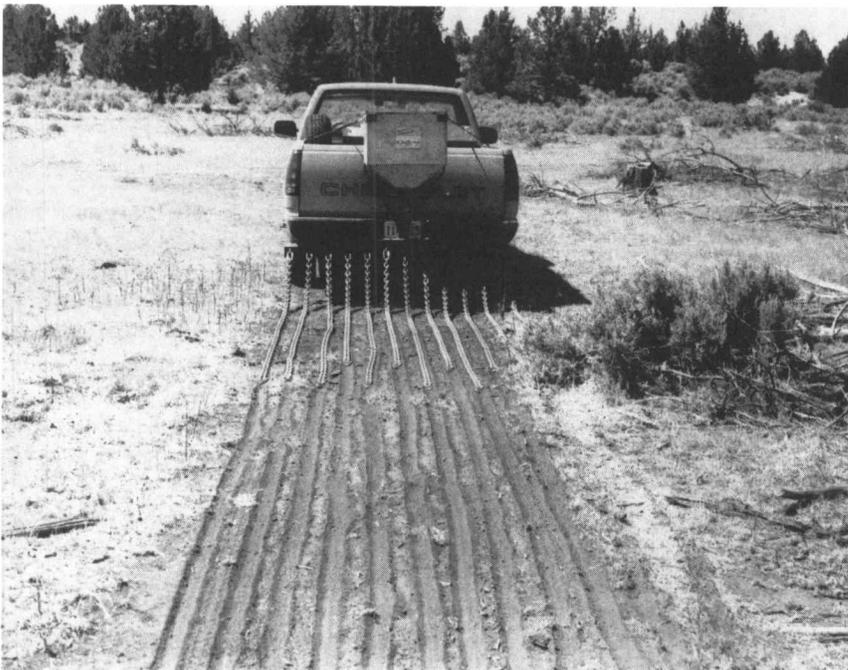
View demonstrating the seed covering pattern created by the series of drag chains.

The seeder is equipped with an electric rheostat control that determines the speed and dispersal distance of the seeder. The optimum dispersal distance is 7 to 8 feet, leaving 2 to 4 feet of the drag chains to cover the seed with soil.
