## Water Quality in Wyoming – The Sage Creek Project

By Mark D. Shirley

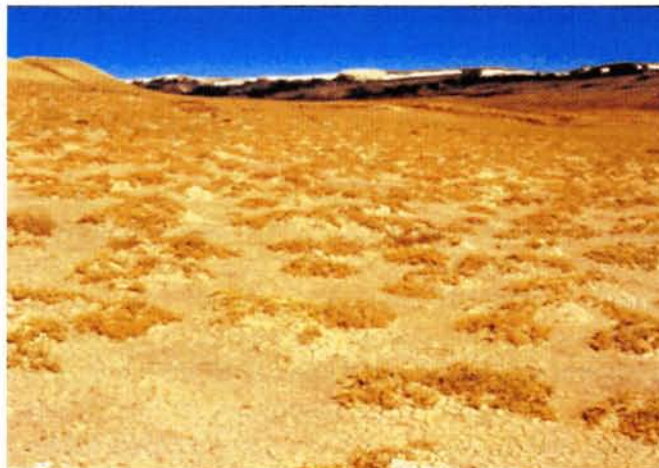
*Upland site typical of the Sage Creek Basin. Gardner's salt-bush is the dominant plant with a high amount of bare ground. Infiltration rates are low on these sites with clay soils resulting in high runoff and sedimentation rates.*

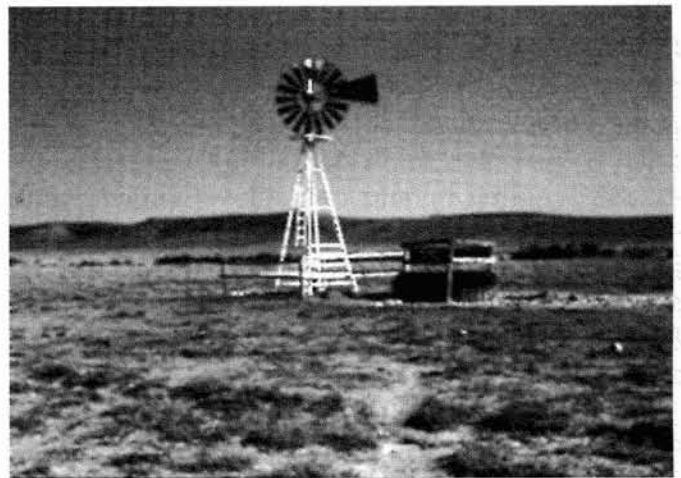
*Upland water developments allow for improved livestock grazing distribution and reduce impacts to riparian areas.*

An important aspect of the Sage Creek Project has been the implementation of a planned grazing system in a majority of the watershed. The length of grazing periods has been shortened allowing longer recovery periods. Implementation of the grazing system required upland water developments and cross-fencing. These practices also lessened grazing pressure on riparian areas. An increase in woody species within the riparian zone, in particular willows, has occurred with the change in grazing management.

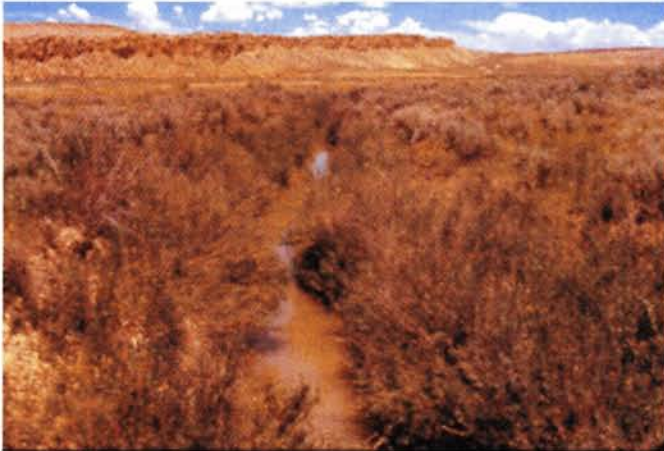
*Improved riparian area on Sage Creek. A change in the grazing system has provided a recovery period for plants during the growing season resulting in an increase of woody species such as willows.*

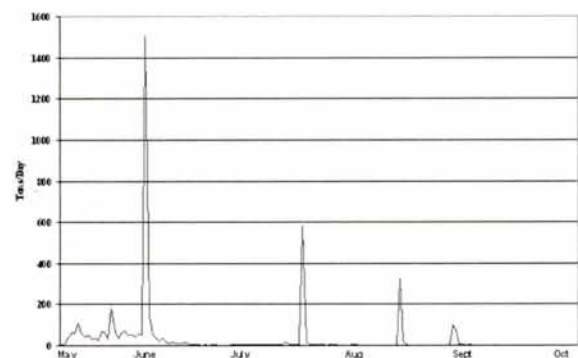
**Fig. 1.** *Estimated Sediment Discharge from Sage Creek in 1999. The spike in discharge on June 15<sup>th</sup> occurred in response to a 0.39 inch rainfall event.*

Measurement of nonpoint source pollution is difficult because of its diffuse nature and inherent variability. Monitoring has revealed the “flashy” nature of Sage Creek in relation to precipitation events. Dramatic increases in flows and sediment concentrations occur in response to precipitation events, particularly summer thunderstorms. A combination of clay soils with low infiltration rates and incised channels contribute to peaks in the hydrograph during storm events. A large percentage of total season sediment discharge can occur in a few days as a result of one precipitation event (Fig. 1).
