Managing Cows With Streams in Mind

By Pete Bengueyfield

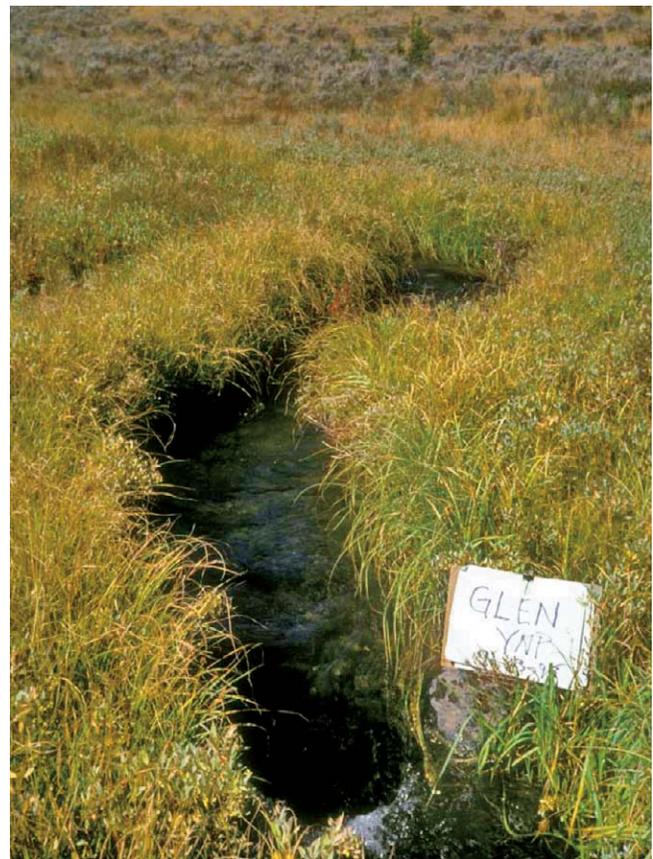
Figure 1.

Of all the indicators of a correct channel type, the channel cross-section—the relation between its width and depth—is perhaps the most revealing. For it is this relationship that determines whether or not the stream can perform the various tasks that lead to a healthy riparian area. Streams most affected by livestock occur in meadows, which are generally in fairly wide valley bottoms with little slope. This physical setting produces streams that are flat, crooked, narrow, and deep. Streams with these characteristics effectively move sediment because their velocity varies little across the channel; they reduce stream-bank erosion because they flood at regular intervals, thereby spreading out peak flows; they maintain saturated stream banks because they are deeper than they are wide, thereby supporting riparian vegetation with strong root systems; and they produce good fish habitat in the form of undercut banks. Figure 1 shows a well-functioning meadow-type stream of the kind that is most suscep-

tible to livestock. It is narrow and deep, with dense willows and sedges on the banks, and these species extend outward to the change in slope that defines the floodplain.

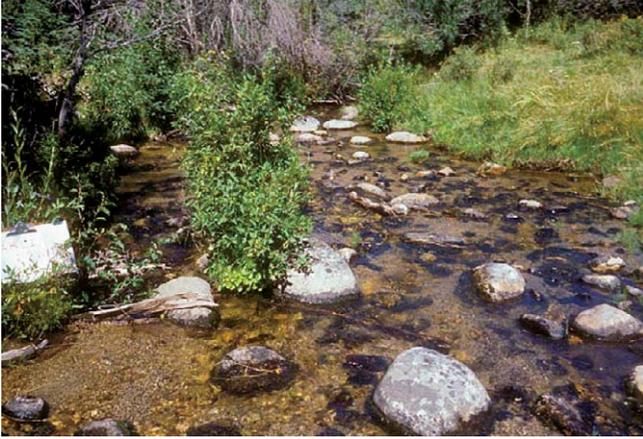
Figure 2.

This brings us back to where cows become important. The most widespread impact livestock have on riparian areas is trampling stream banks. Trampling can cause an increase in stream width, making the channel wider and shallower, with slower-moving water. As a result, sediment is deposited in the center of the channel rather than on the banks; less water gets to the floodplain so bank erosion increases; the storage of water in the banks decreases, forcing streamside plants to shift from willows and sedges to drier site species with less dense roots; and fish habitat is lost. Clearly, if we are going to maintain riparian areas, we are going to have to limit the amount of stream-bank alteration as a result of livestock trampling. Figure 2 shows a reach that has been heavily damaged by trampling. The stream is wide and shallow, with poor riparian vegetation on the stream banks, and it has a high amount of fine sediment in the channel bottom.
