Performance Evaluation of Water Harvesting Catchments

G.W. FRASIER, K.R. COOLEY, AND J.R. GRIGGS

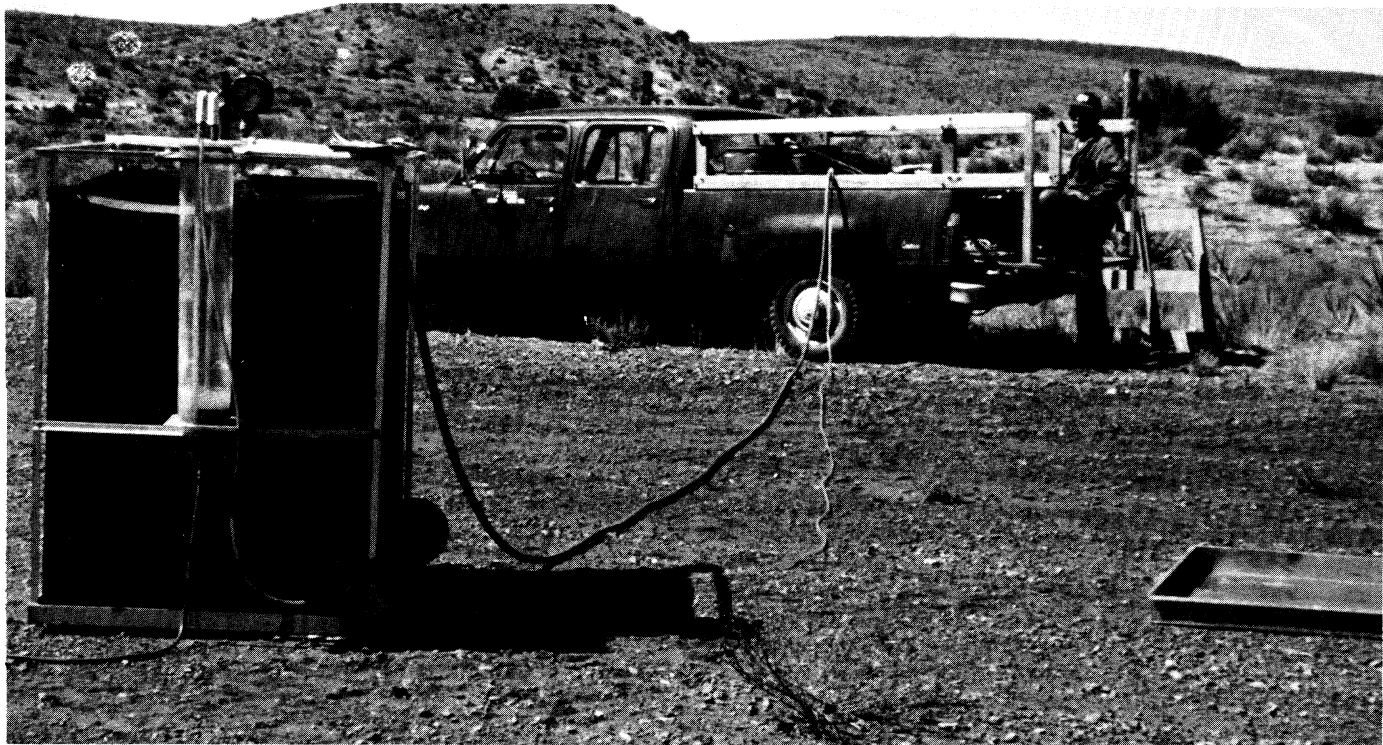
The sprinkler system used in the studies is shown in Figure 1. Water was sprayed downward from a height of 152 cm onto a 1-meter square test area from a single, low pressure, wide angle, fine drop size, full square spray nozzle. The test area was located in the center of the spray

pattern and defined by a metal shield sealed to the soil surface by a foam rubber cushion on top of a layer of bentonite clay. The runoff water from the soil was trapped at the lower side of these test area and collected by a small vacuum line for measurement in a graduate plastic chamber. Wind disturbance of the spray was minimized by a curtain fastened to the framework. Water sprayed outside the 1-square meter test area was collected in a channel around the metal shield and conveyed away from the test area. The spray application rate was set prior to testing by placing a metal pan over the test area and adjusting the water pressure at the nozzle until a constant spray rate of 45 to 50 mm/hr was achieved. Without shutting off the spray, the pan was removed, and the water was then sprayed directly onto the catchment surface within the test area for 10 to 15 minutes. The sprinkler was then moved to a new location on the catchment surface and the procedure repeated. Two to three sites were usually evaluated on each catchment.

Fig. 1. Portable sprinkler for determining runoff efficiencies.

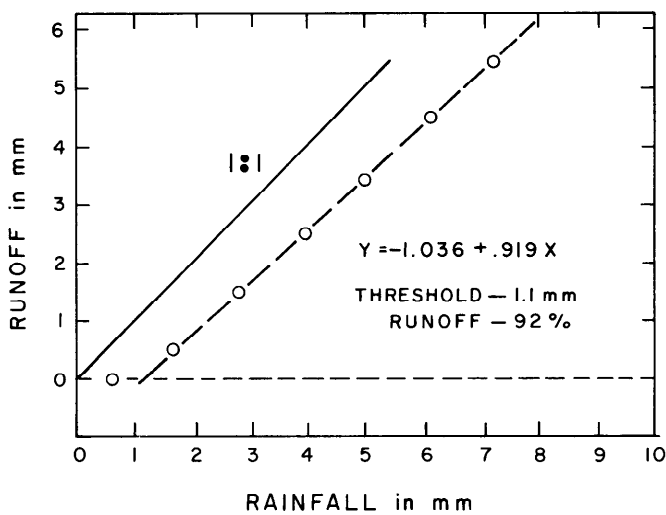
The accumulative runoff from each test was recorded and plotted vs. the accumulative water applied (Fig. 2). The best fit straight line from least square regression analysis was fitted for all points after runoff had started. The X-axis intercept represented the threshold rainfall or the amount of water applied before runoff started. The slope of the line represented the runoff efficiency of the treatment after runoff started. The sprinkler method was compared with actual rainfall results obtained from 11 different types of water harvesting membranes and soil treatments on field-sized plots at the Granite Reef Test Site, located approximately 25 km northeast of Mesa, Ariz. The treatments are described in Table 1. Precipitation runoff from each plot was collected in an underground tank and measured after each storm event by pumping the water through precalibrated water meters. Precipitation was measured with a network of rain gages. For each plot, the actual rainfall threshold and runoff efficiency after threshold was determined by standard linear regression analysis of rainfall-runoff data from individual storm events, but omitting storm events with zero runoff (Fink and Frasier 1977).

Fig. 2. Rainfall runoff relationship as determined with portable plot sprinkler.
