# Contamination Knowledge Report:

## BRDF fabric

**May 27, 2015**

## SEM Imaging and Chemical Analysis of a Fluorinated Hydrocarbon Impregnated Glass Cloth

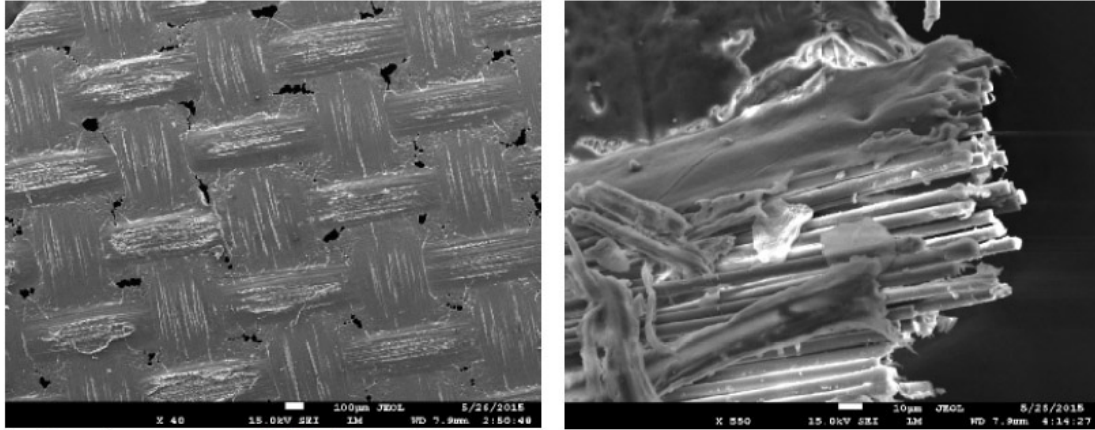
From optical imaging, extended damages on Teflon coating were observed. (See last page of this report). SEM imaging revealed significant shedding and abrasion of Teflon coating and fiberglass strands. Particles ranging from 1 – 100  $\mu\text{m}$  occurring on the surface of the BRDF fabric include fragments of fiberglass, Teflon, carbonaceous particles, and salts. EDX analysis of these materials revealed the following compositions:

Sample was coated with 2 nm of Pt  
All spt taken at 15 kV for 20 seconds

(Note: coating is readily damaged by exposure to the electron beam at 5, 10 and 15 kV)

If the BRDF material is used, we are confident that the Sample Analysis team will be able to identify and distinguish these particles. However, the varied contaminants associated with the material requires us to recommend that the material be cleaned before usage on any part of the spacecraft.
