RESTORATION BENEFITS TO NATURAL SPRINGS IN THE LAKE MARY WATERSHED

Clairisse Nash¹, Aregai Teclé¹, Ashley Craig¹, Andrew Sanchez-Meador¹, and Larissa Yocom¹

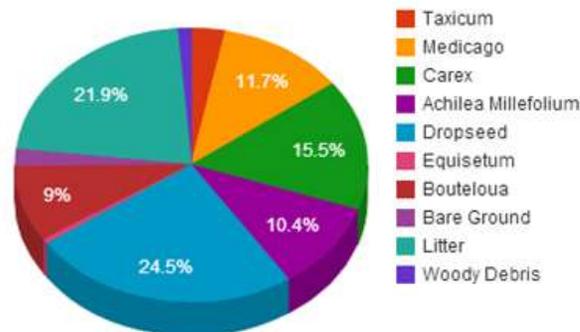
% Cover Type - Treated area

Figure 1. Percent of different Cover classes in the treated site.

Vegetation and other cover classes and their respective percent area covered in the two treatment types (treated and untreated) are shown in Table 1. A special note from the cover class data is that there was the presence of *Carex* sp. in the treated site (in 15.5% of it), but not in the untreated site. Furthermore, there was more *Bouteloua* sp. or “grama” grass (14.1%) in the untreated area compared to a 9% in the treated part. Elk scat/browsing evidence was also present in both treatment types; however, there was 33.33% of it in the treated area, and only very little (0.167%) in the untreated site and within the elk-exclosure fence (see the last row of Table 1 and Figures 1 and 2). In spite of such differences in vegetation cover, there was no significant difference in bare ground and grass cover between the treated and untreated sites (see Figures 1 and 2).

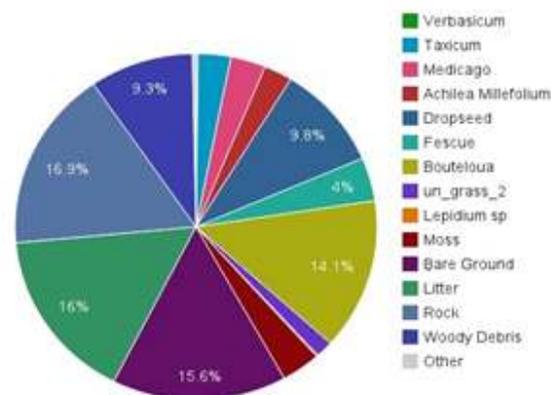
% Cover type - untreated

Figure 2. Percent Vegetation cover in untreated site; % *Carex* =0.

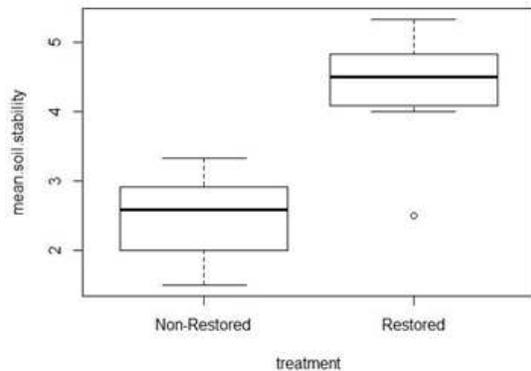
Figure 3. Mean Soil Aggregate Stability Values in treated and untreated plots.

SAG values of the treated plots are 4.4 with a standard deviation of 0.737, while those of the untreated ones are 2.4 with a standard deviation of 0.547 (see Figure 3). These values show that those of the treated plots are almost twice as much as those of the untreated ones with a p-value of 6.833×10^{-8} (see Figure 3). This is very significant since the p-value is way less than the alpha value of 0.005. Under this condition the null hypothesis is rejected in favor of the research hypothesis. This means, at the 95%

confidence level, there is sufficient evidence from the data supporting the statement that the mean SAG value in the treated area was greater than the mean SAG value in the untreated area.

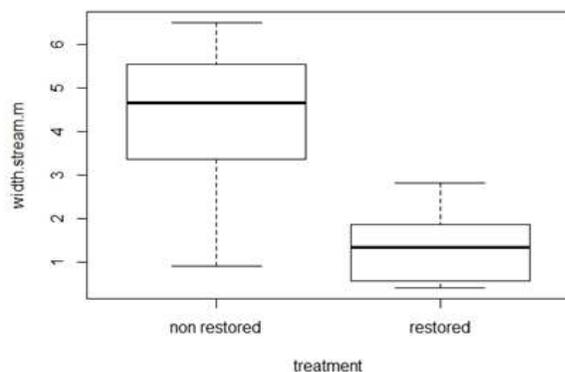
Figure 4. Graphical comparison of mean stream width values in treated and untreated areas.

Two characteristic that are used to determine the stability and or vulnerability of a stream to change are stream width and depth. Generally the streams in the study area follow meandering paths as they flow away from the source springs. We used changes in stream widths as well as the presence or absence of water to compare the conditions in the treated and untreated watersheds. There was water in all of the treated plots, while water was absent in most of the untreated plots. Also as shown in Figure 4, the mean stream width in the treated site is 1.304 m with a standard deviation of 0.791, while the mean stream width in an untreated site is 4.3m with a standard deviation of 1.672. This means the mean stream width in the untreated plots is about three times as wide as that of the streams in the treated plots with a significance p-value of 2.104×10^{-5} ($\alpha=0.05$ ($df=15.688$) (R version 3.0.2 (2013-09-25))).
