Ecological Restoration of Gullies and Stream Channels

Understanding the type of soils and vegetation on top of streambanks can help initiate restoration along streams.

By John Murray

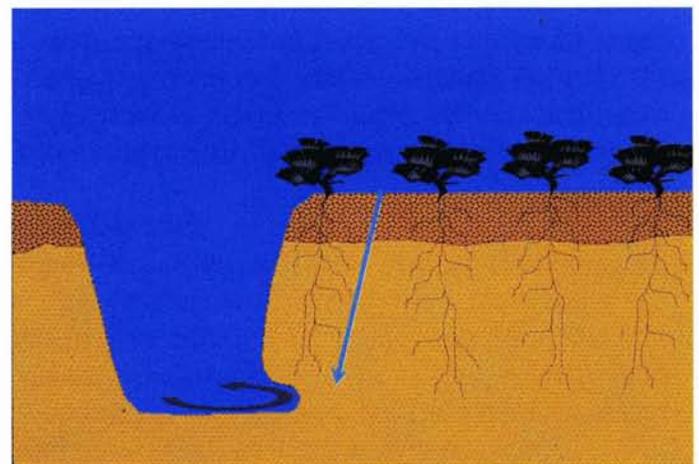
Water flowing in the channel undercuts the bank. With the bank undercut and dry soil to the top of the bank, it becomes too heavy to hold it up. As the soil dries, cracks form on top – Figure 1. This al-

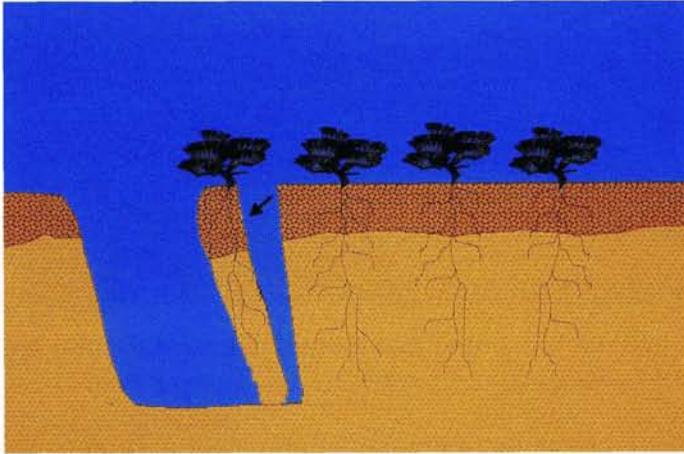
lows moisture to enter and the cracks become bigger. The result is that the bank falls off as a vertical slab – Figure 2. The process starts all over again

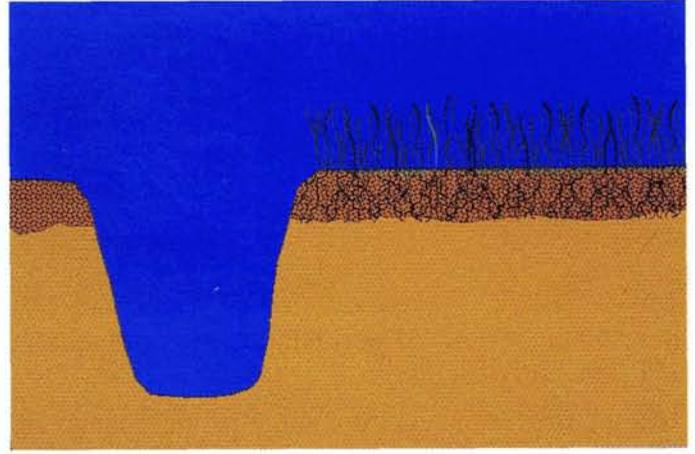
What would happen if the deep tap-rooted species were replaced with a shallower, fibrous root system? Would the bank act the same? If grasses occupy the top of the bank, the grasses will actually absorb and hold the moisture either from snow melt or rain – Figure 4. As the soil absorbs more and more moisture it becomes super saturated and if it continues will actually liquefy and flow. This is a very

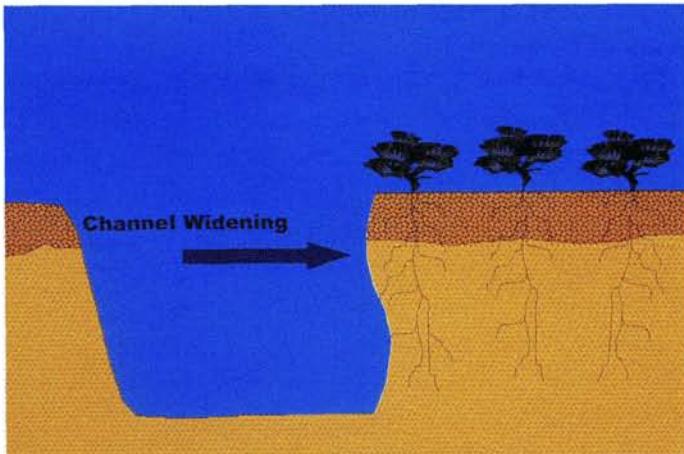
with the water undercutting the bank and eventually falling away. The channel continues to widen – Figure 3.

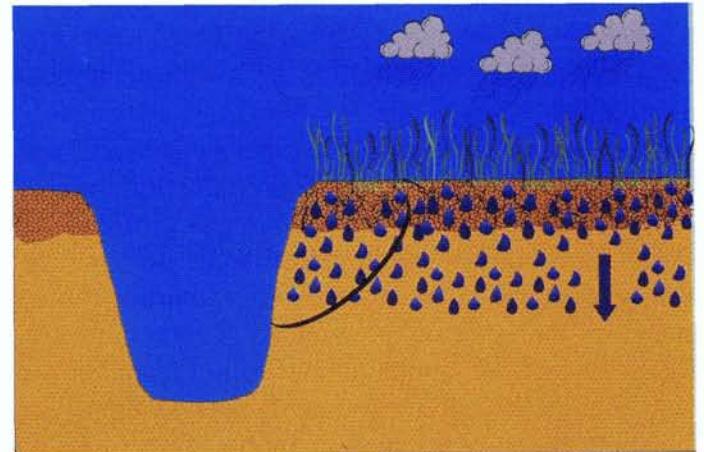
Figure 5

powerful and natural occurrence of certain soils. The difference is that when the bank is undercut, the top does not break off but rather slumps to the

bottom of the channel – Figure 5. This slumping causes small dams and checks to form which in turn slows the flow of water and builds silt behind

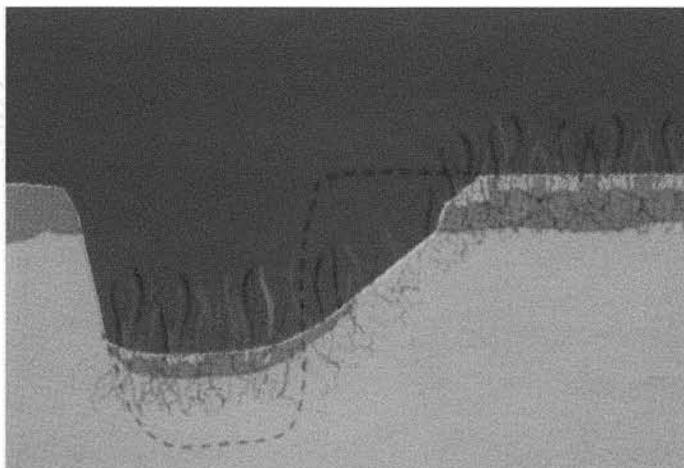
them. The grasses now occupy the bottom of the downcuts and also the sides, thus eliminating the ability of the channel to continue widening – Figure 6. The channel is now confined and the banks are stable. Slope, and gradient of the channel is not a factor in the ability of a system to heal its banks. The factors are the vegetation, soils, water, and the slope of the bank.

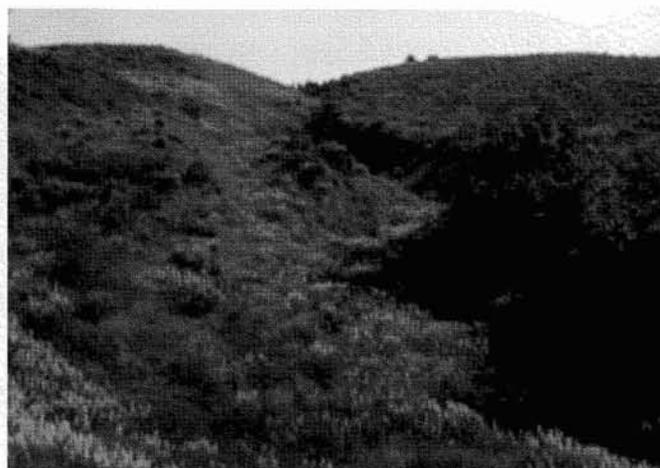
Left side was treated and slumped. The right side was left untreated.
