# *Improved Ditch Sealing Saves Irrigation Water*

A way to save billions of gallons of valuable — and scarce — irrigation water has been developed by ARS water conservation scientists for use in western States.

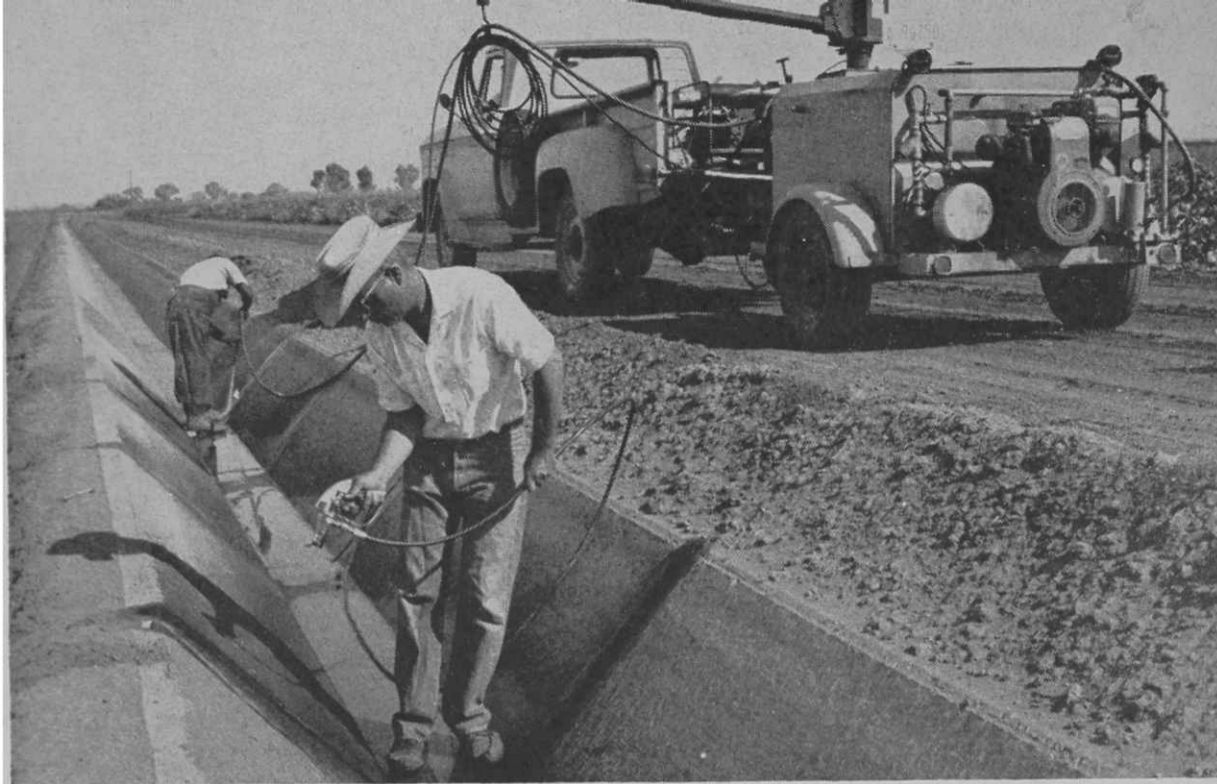
**NEW DITCH SEALING** technique is most efficient with a three-man crew. One ← man jets the cracks, one sprays on the sealer and third drives the truck.

For efficiency, the scientists say, three men are required for the new method of crack treating. One man jets the cracks, one sprays on the sealer, and one drives a truck laden with pumps, sealer, and water supply along the canal.
