# Earth Fissure Map of the Apache Junction Study Area: Pinal and Maricopa Counties, Arizona

June 2019  
Arizona Geological Survey

## Digital Map Series - Earth Fissure Map 2 (DM-EF-2) version 2.0

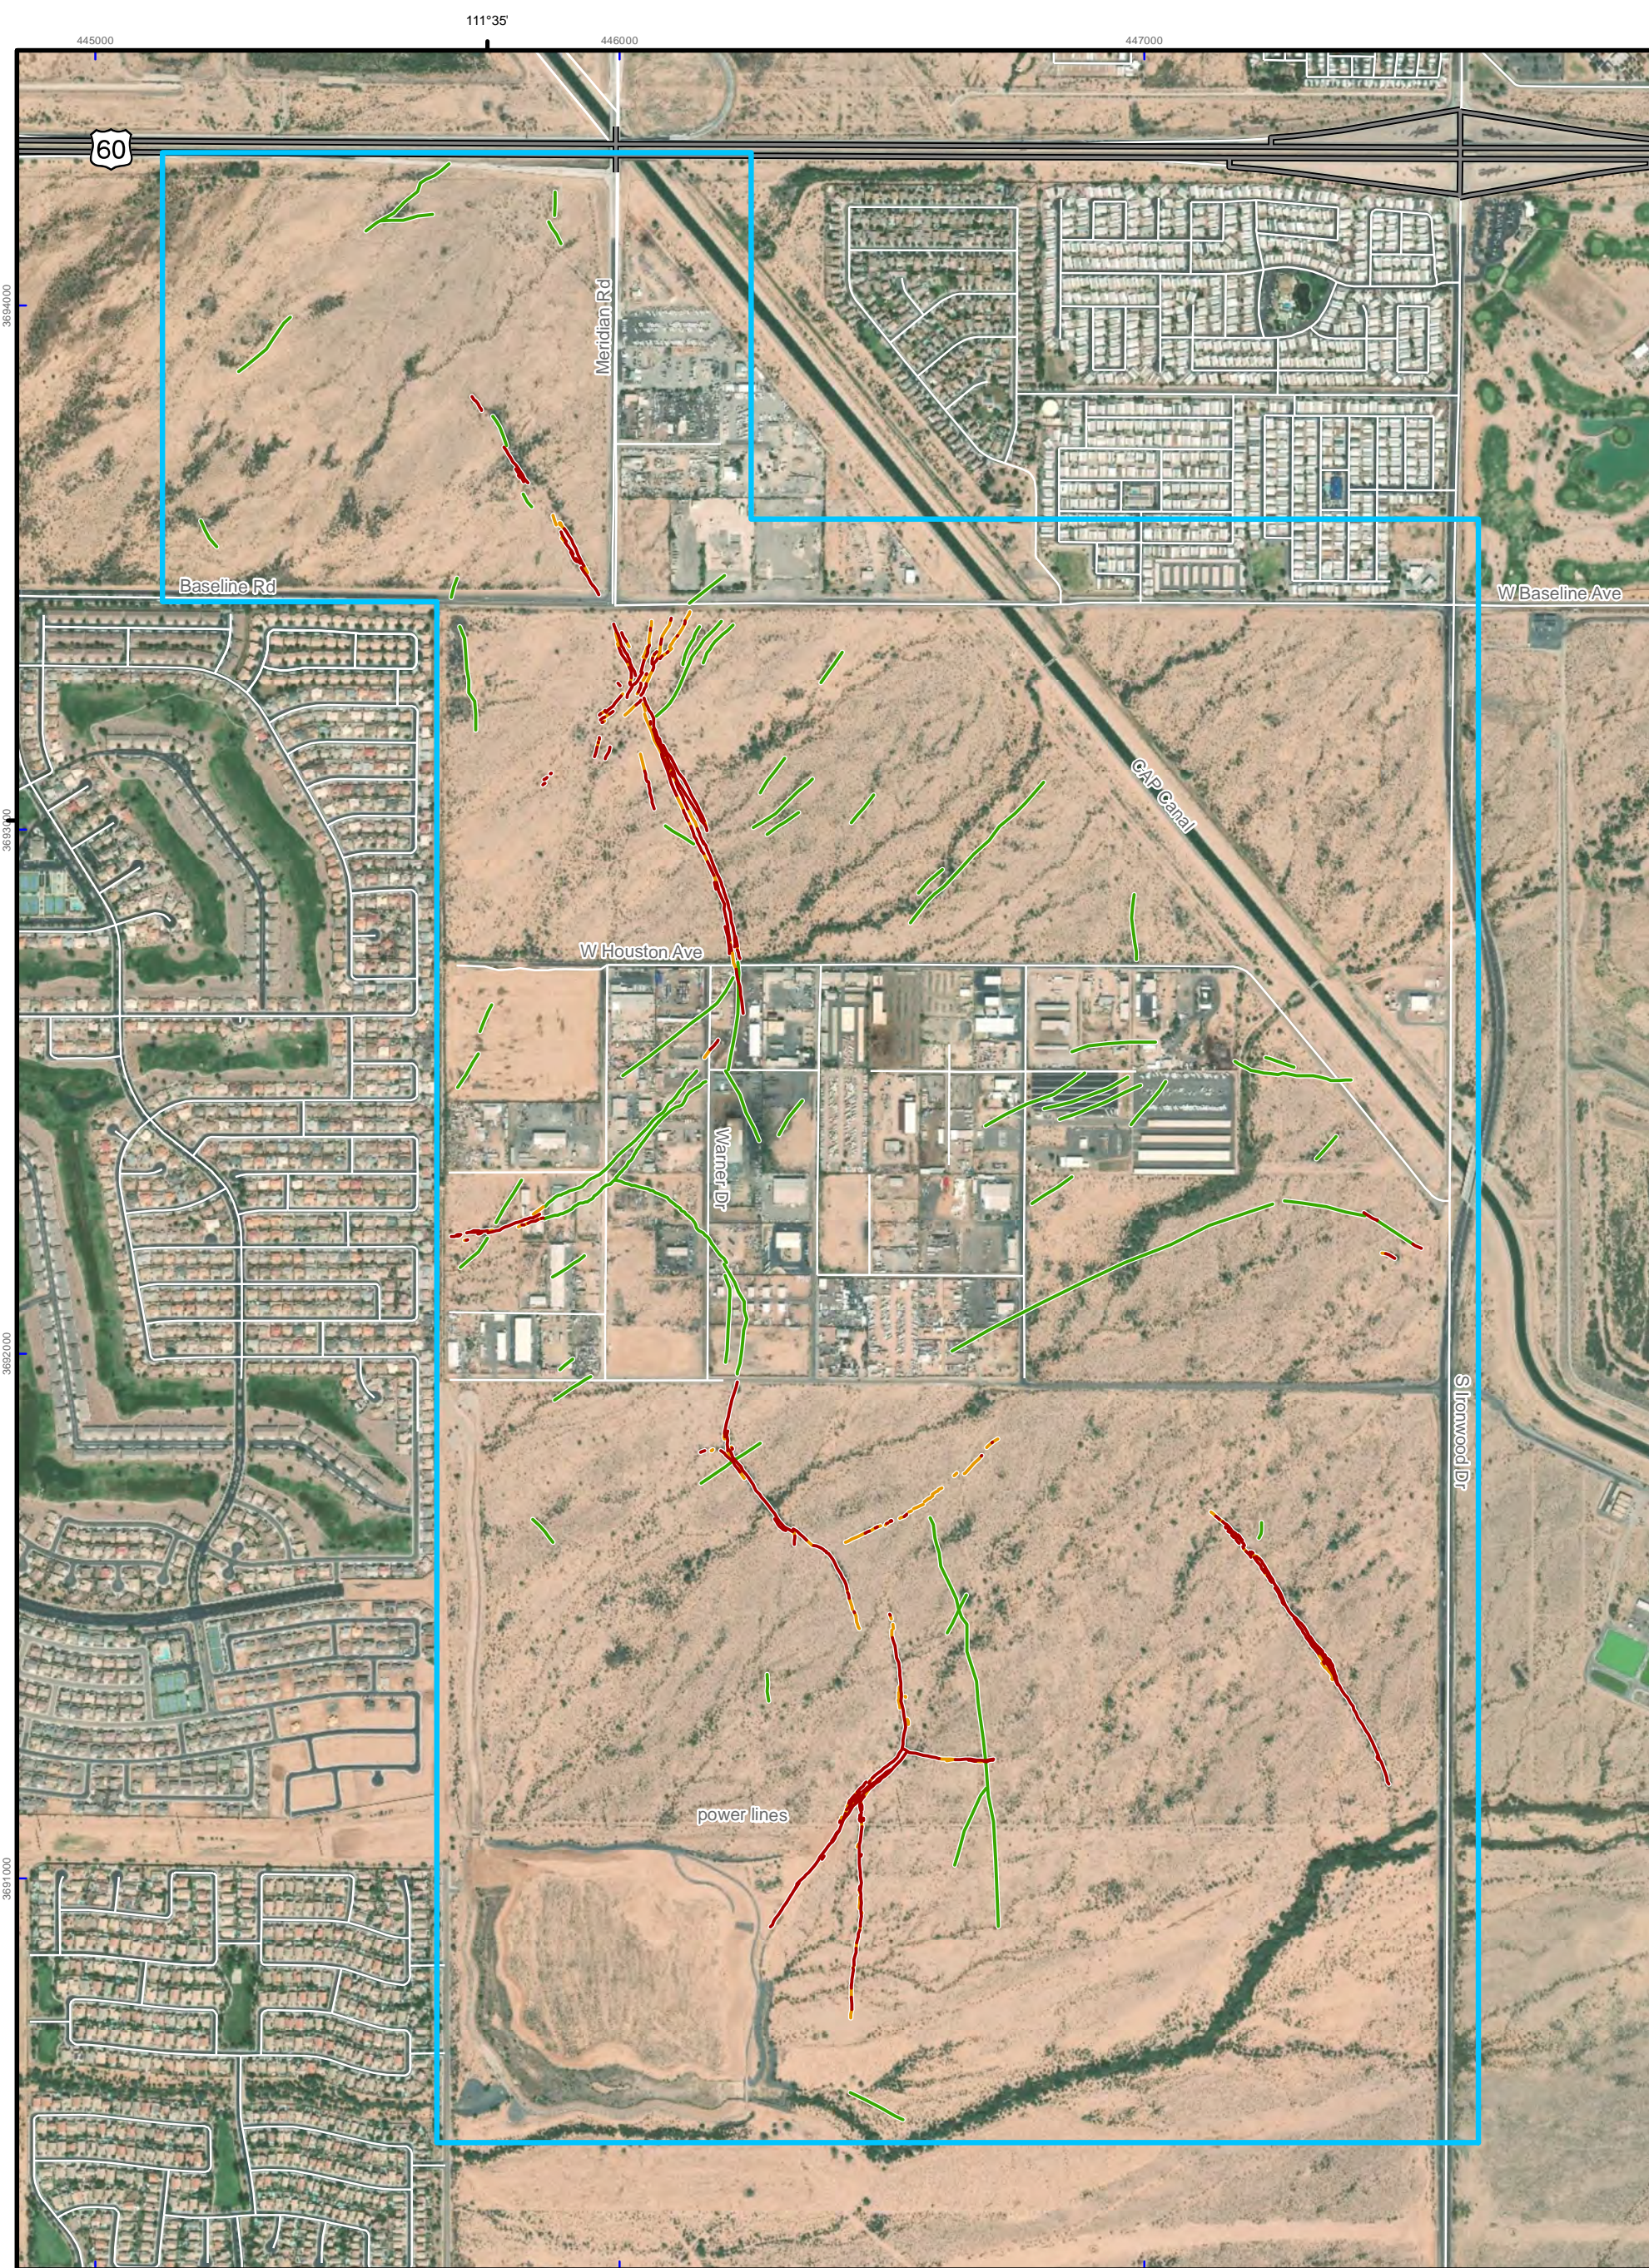
- Red lines represent the location of continuous earth fissures manifested as open cracks or gullies.
- Orange lines represent the location of discontinuous earth fissures manifested as elongated to circular depressions or as abbreviated or irregular linear depressions. These discontinuous surface features frequently represent an incipient surface expression of an earth fissure.

- Yellow lines represent the location of fissures confirmed by non-AZGS personnel or clear evidence of earth fissures on aerial imagery. Traditional field investigation of these features by AZGS was hindered by agricultural or urban modification of the land surface.

- Green lines represent the approximate locations of unconfirmed earth fissures, defined as fissures which could not be confirmed by surface investigations by AZGS geologists, but which have been previously reported by Professional Geologists in published documents or maps.

- The outline of the Study Area is shown in blue. The limits of the study area are based on interpretation of modern and recent ground subsidence data provided by the Arizona Department of Water Resources. Historical and modern aerial photos taken within this area were searched for anomalous lineaments. These lineaments were then investigated in the field to determine if there was any evidence of earth fissures.
